National Pollutant Discharge Elimination System  
Municipal Separate Storm Sewer System  
Permit No. 11-DP-3313 MD0068276  
Permit Term October 9, 2015 to October 8, 2020

# Fifth Annual Report

## October 9, 2020

Maryland Department of Transportation  
State Highway Administration  
Office of Environmental Design  
707 North Calvert Street, C-303  
Baltimore, MD 21202

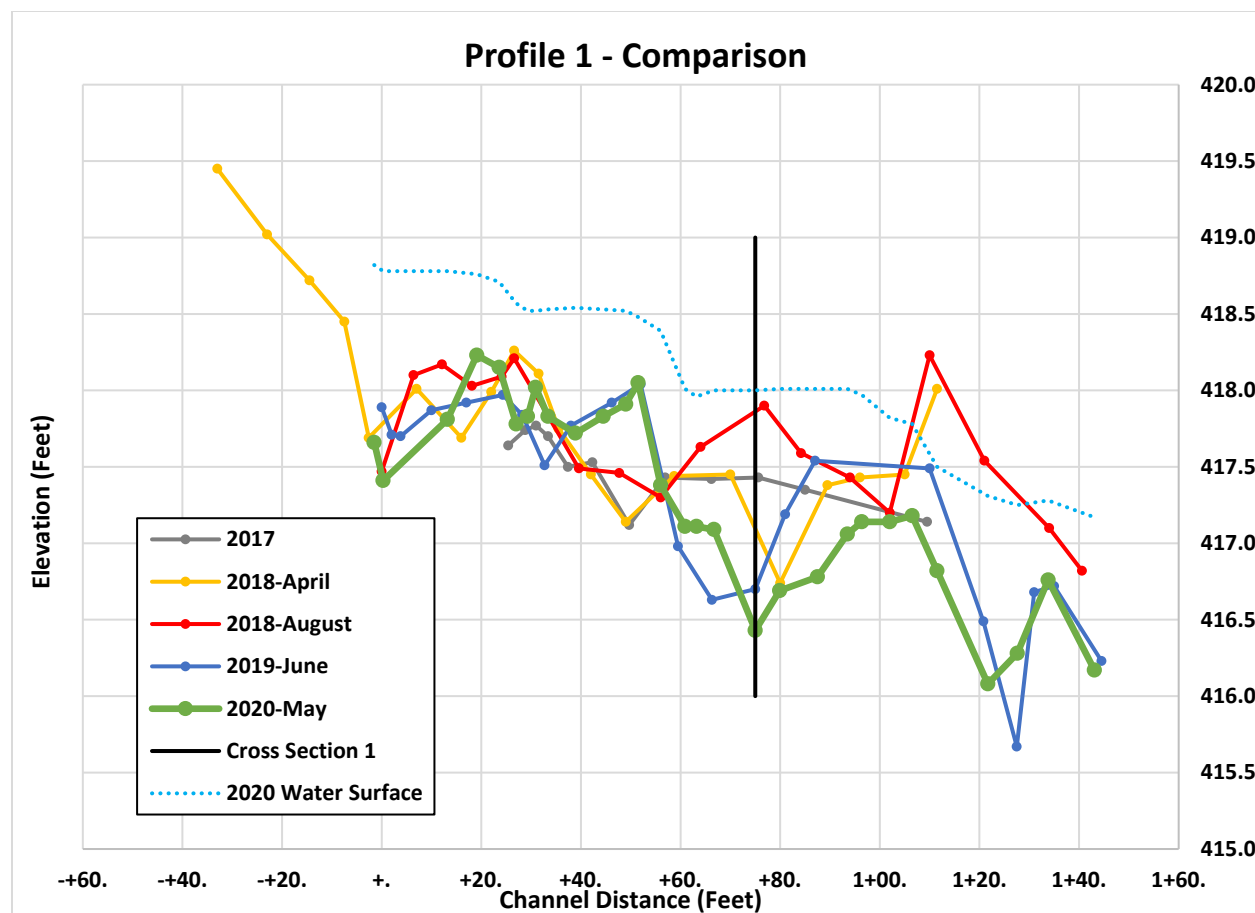
Figure 9 - Profile P-1 Comparison (2017 to 2020)

The historical results of this section show a grade control feature appears to have formed between 2017 and April 2018 at station 1+10 (Figure 9). With the exception of a large depositional feature filling in the pool between station 0+70 and 0+90, the profile was largely unchanged between April and August of 2018. As of 2019, scour occurred at the confluence at station 0+59 creating a large pool where the cross section is located. A mid channel bar that was observed in 2018, has now split the channel flow beginning approximately 100 feet upstream of the cross section just upstream of the start of the profile. The confluence of the split channel is approximately 15 feet upstream of the cross section at station 0+59.5. This is causing the large scour pool and significant shift in the profile.

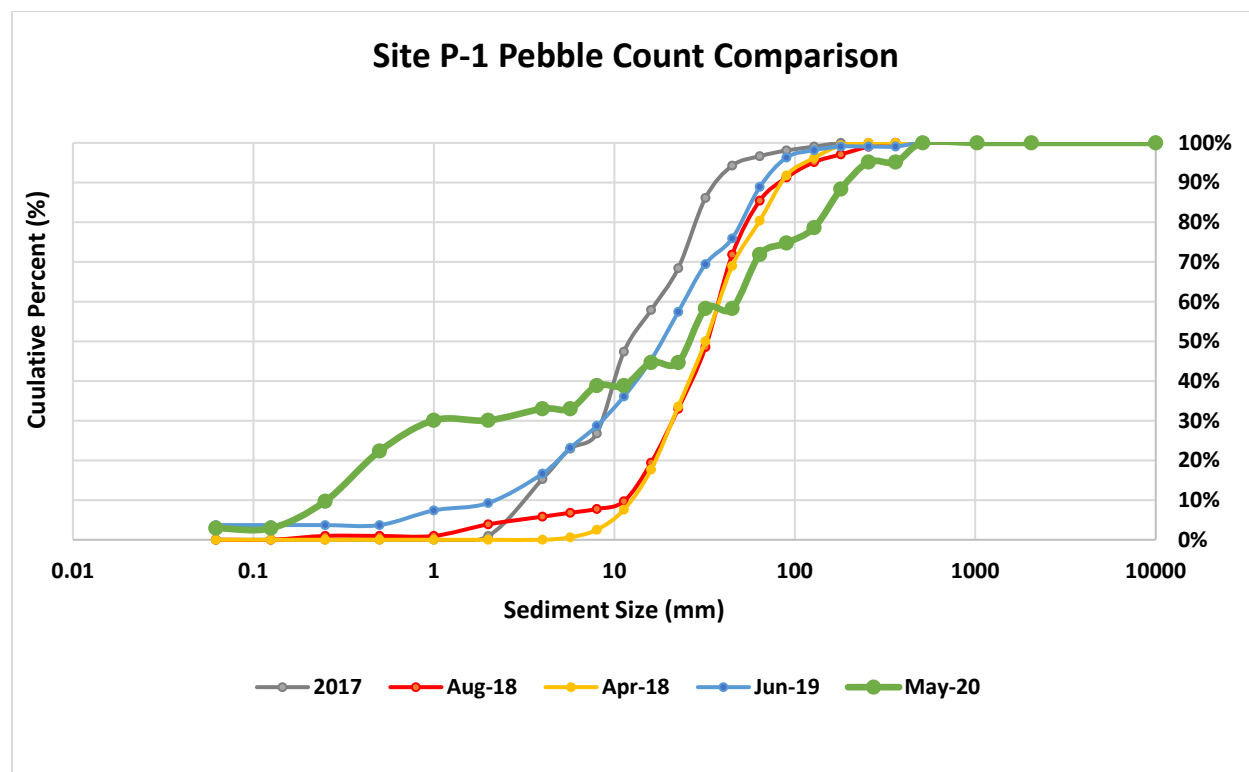
Figure 10 – Section P-1 Riffle Bed Material Comparison (2017 to 2020)

Based on historical pebble counts, the channel material appears to have coarsened between 2017 and 2018 and in 2019 deposition of finer material was deposited. The D50 and D84 increased from 12.3mm (medium gravel) and 31.3mm (coarse gravel) in 2017 to 33mm (very coarse gravel) and 62mm (very coarse gravel) in 2018. As of June 2019, the D50 decreased (18mm) closer to what was observed in 2017 (12.3mm). The D84 decreased in 2019 but was still classified as very coarse gravel.

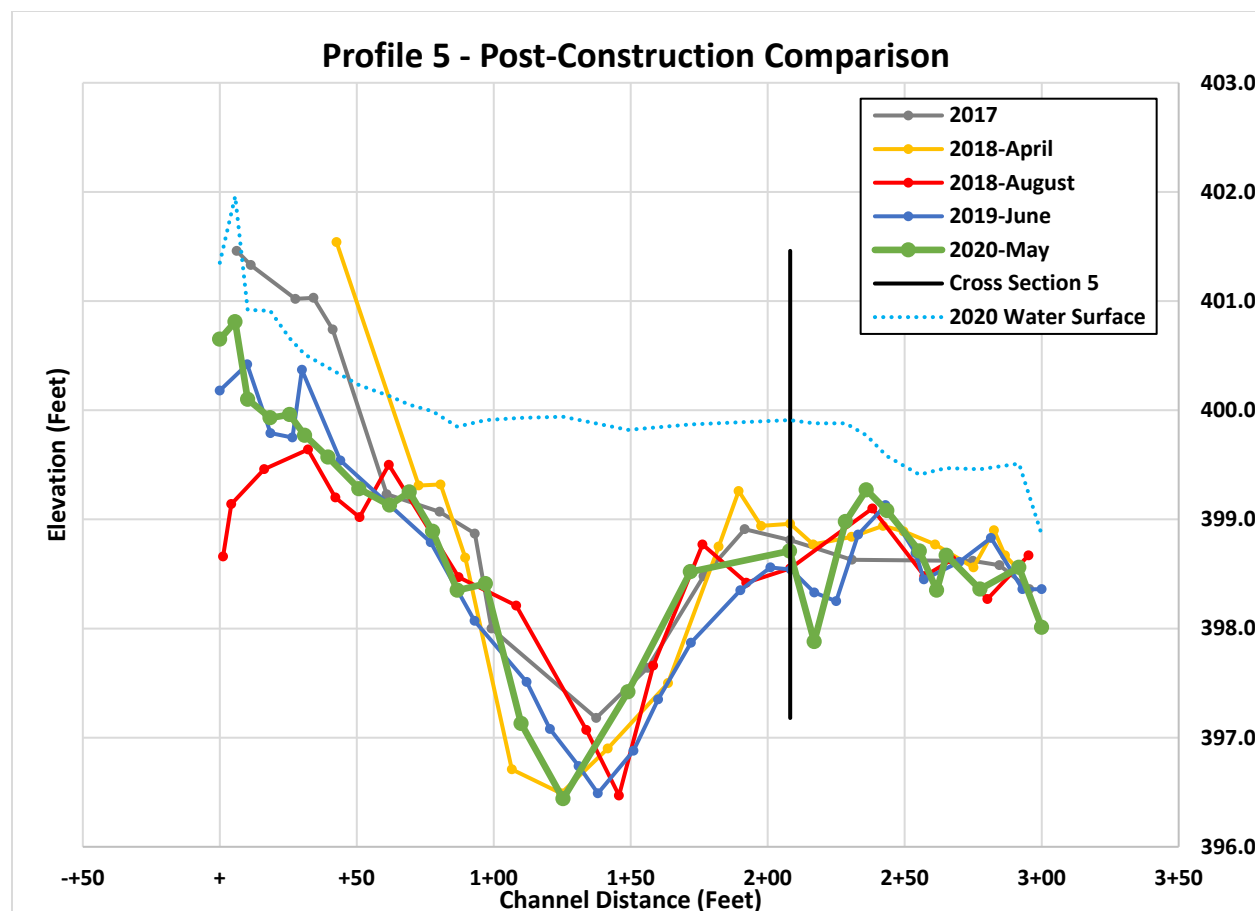
Figure 21 - Profile P-5 Comparison (2017 to 2020)

Historical survey results indicate the channel slope at Section 5 became steeper compared to 2019. The slope was 0.66% in 2019 and 0.70% in 2020. The area upstream of Station 0+60 received flows approaching 1800 cfs through a confined section of the floodplain which caused large shifts in the bed profile between 2018 and 2019.

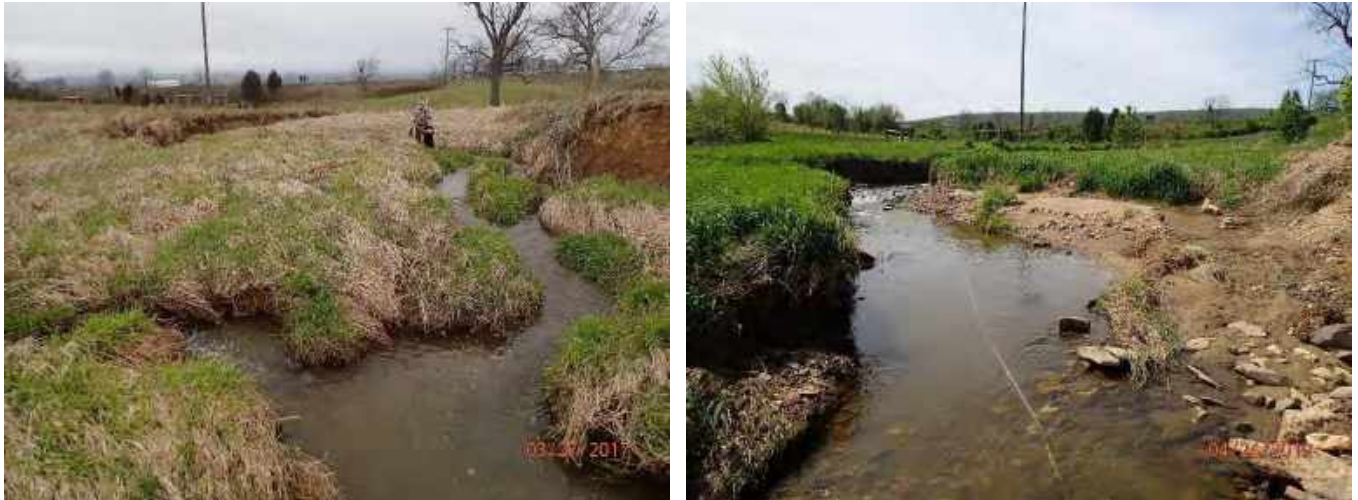
At the time the sites were visited during the 2019 spring index period, all five unrestored sites in the Little Catoctin Creek study area exhibited damage from flooding during the 2018 extreme rain events.

Figure 11a. Photos displaying stream channel alteration occurring between 2017 and 2019, respectively, at control site PRFR-205-X.

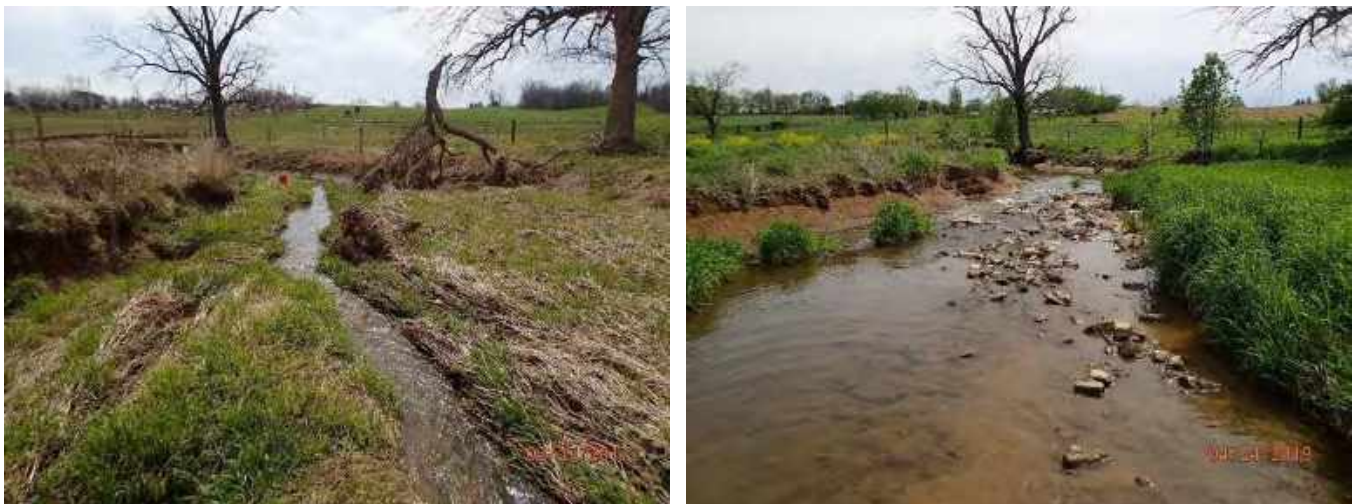
Figure 11b. Photos displaying stream channel alteration occurring between 2017 and 2019, respectively, at control site PRFR-206-X.

Crews noted “much channel alteration” due to high flows at upstream control sites during 2019. Riparian buffer consisted primarily of pasture, tall grasses, and regenerating deciduous trees and shrubs. Few mature trees were observed in the riparian zone at PRFR-206-X-2019. This site was channelized for 11 meters on the left bank and three meters on the right bank. Site PRFR-107-X-2019, located on the tributary to Little Catoclin Creek, exhibited minimal buffers totaling 9 meters between the two banks, beyond which was pasture in both riparian areas. The left bank, right bank, and bottom of the stream was channelized for 5 meters by concrete. A cattle crossing passed through the site’s midpoint (Figure 12).

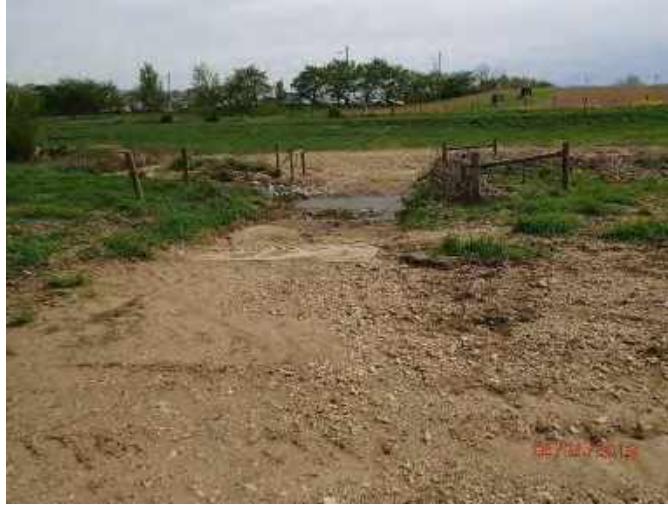
Figure 12. Photo of the cattle crossing at tributary control site PRFR-107-X-2019.

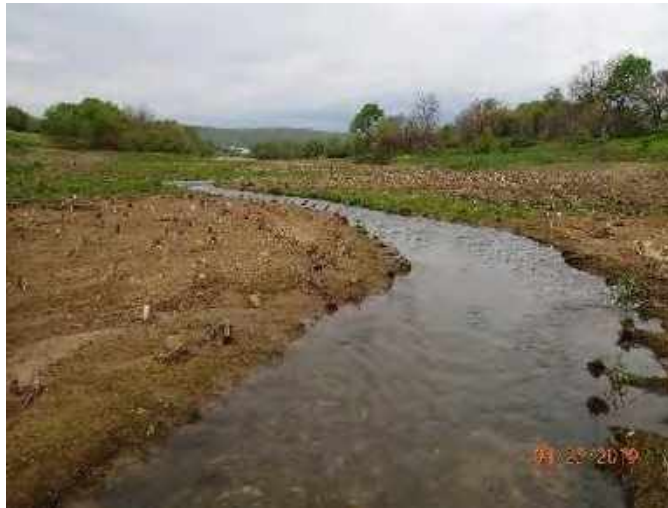
Bank reshaping in the restoration reach had evidently occurred shortly before the sites were surveyed in spring 2019. Banks were largely unvegetated for more than 50 meters on each side and stabilized only with staked landscaping matting (Figure 13).

Figure 13. Photo of the restored reach viewed from the Jefferson Pike (Route 180) road crossing.

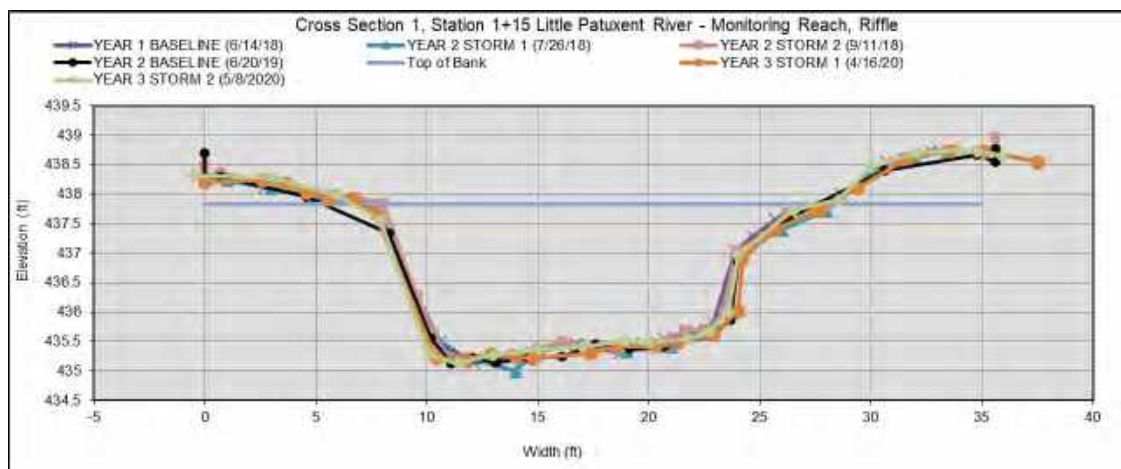
Figure 15. Cross Section 1 Survey Comparison

At Cross Section 1, the left bank has eroded vertically by about 6 inches while the right bank has eroded laterally approximately 6 inches between the Year 1 baseline (06/14/18) and Year 3 Storm 2 (05/08/20). Minor erosion of the riverbed can also be observed between Stations 10 and 23.

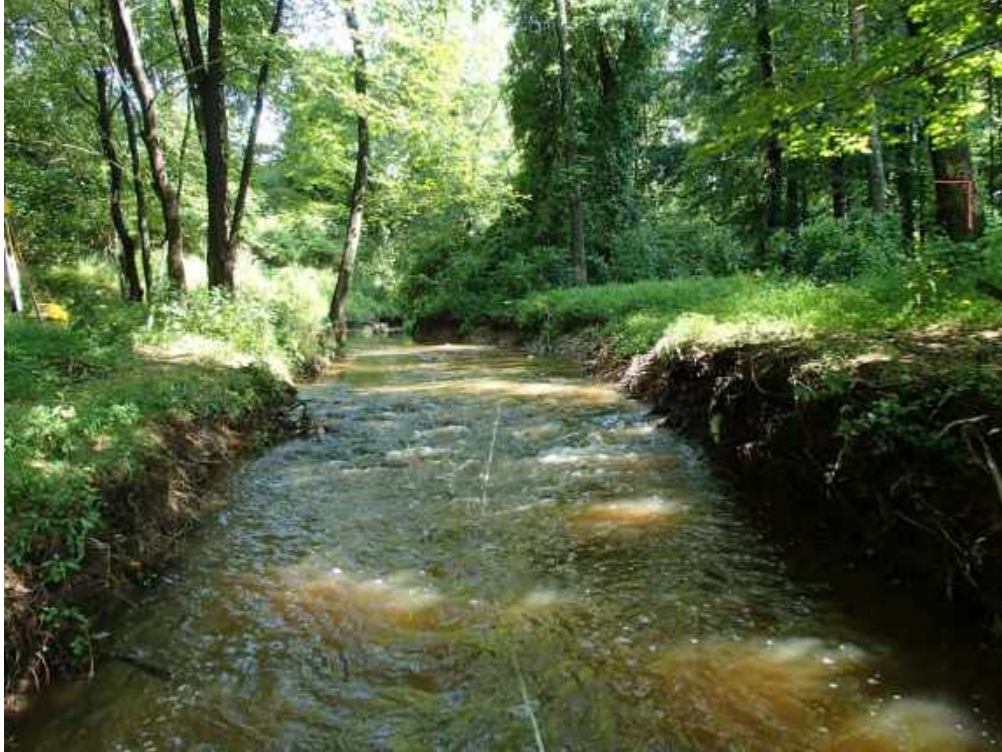
*Figure 20. Vegetated top of banks with exposed roots along monitoring reach on July 26, 2018*

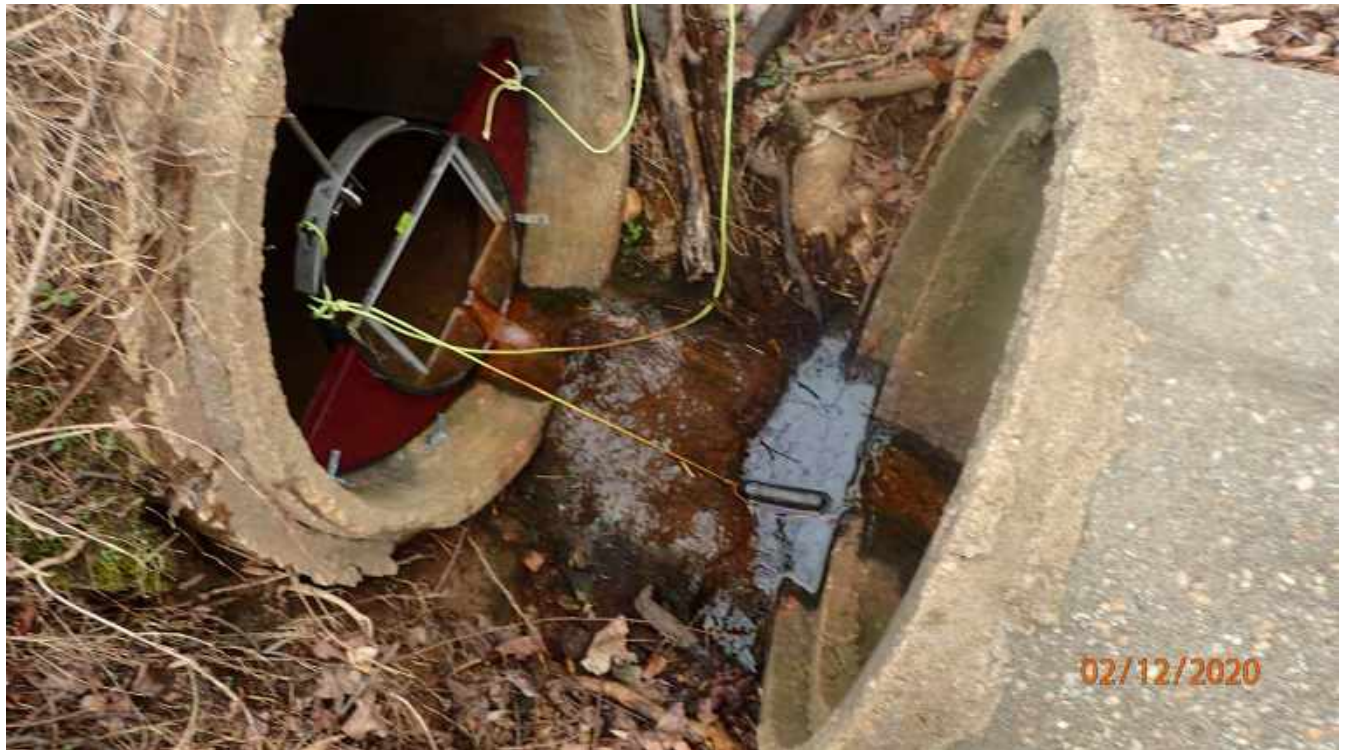
*Photograph 130. 2/12/2020 Year 3 Monthly Download and Maintenance, Flow Station 2, logger replaced*
