National Pollutant Discharge Elimination System  
Phase I MS4 Permit No. 99-DP-3313 MD0068276

# **Third Annual Report October 21, 2008**

***Highway Hydraulics Division  
Maryland State Highway Administration  
707 North Calvert Street, C-201  
Baltimore, MD 21202***

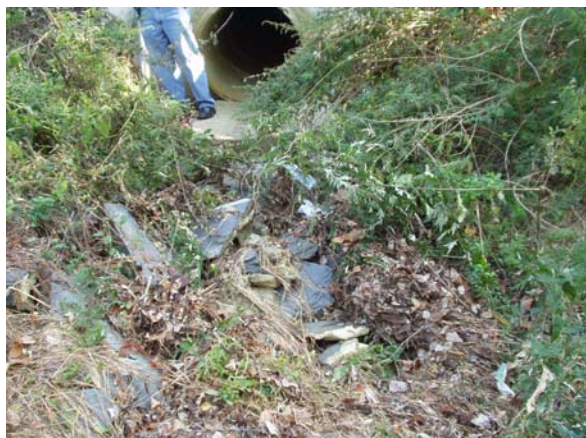
**Failed Pipe Outfall at Site 43 in Harford County**

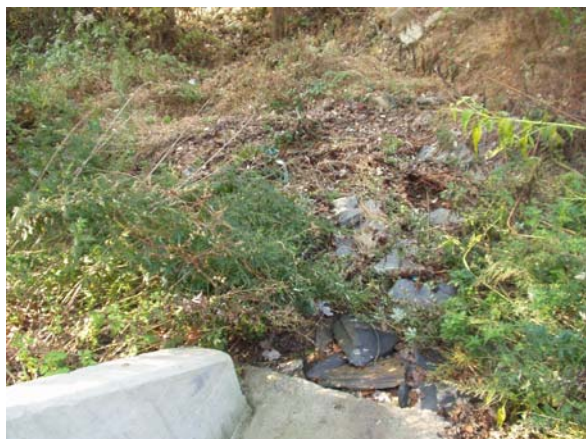
**Failed Outfall at Site 43 in Harford County**

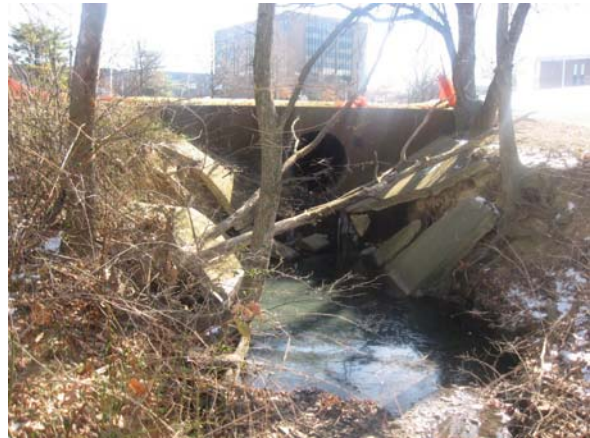
**Failing Infrastructure and Outfalls within Degrading Reach of LDB**

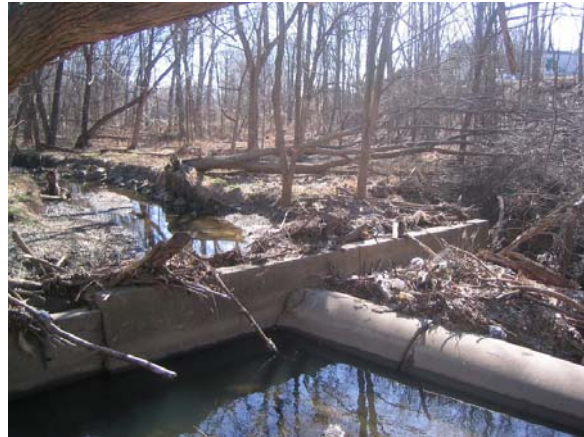
**Dam with Upstream Debris and Sediment**

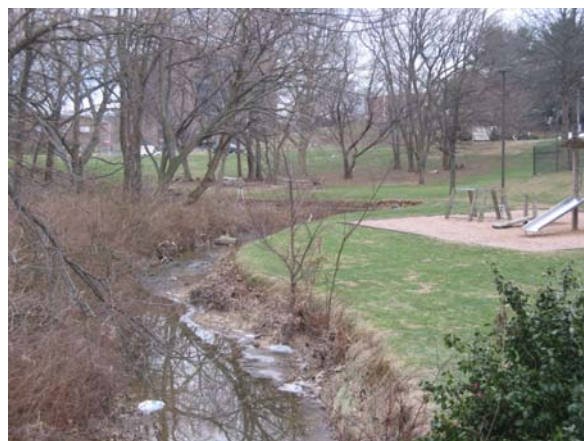
**Instability and Rapid Migration of Stream Channel**

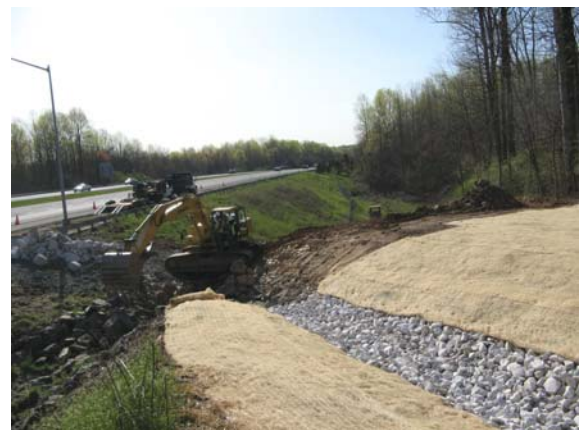
**Figure 3-3: Inflow Channel Stabilization (BMP13007) - during construction**

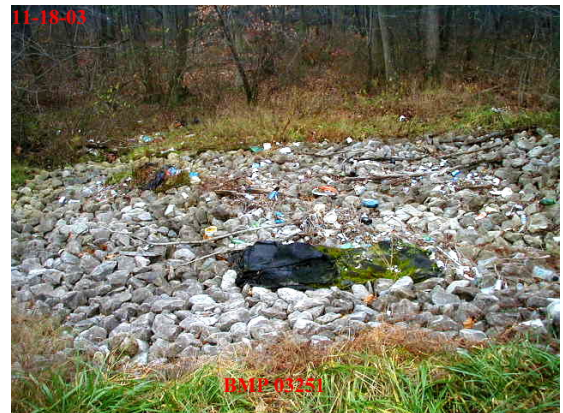
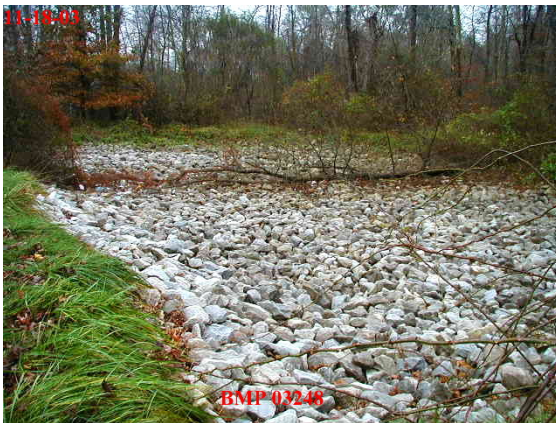
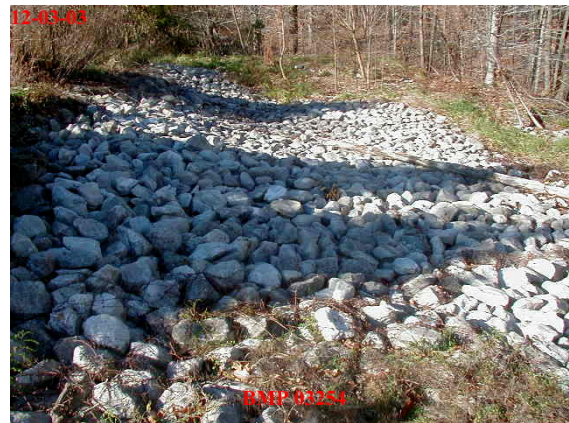
**Figure 3-6 Infiltration Trench Investigation / Remediation Project along MD 43 – sites targeted for enhancement and retrofit**

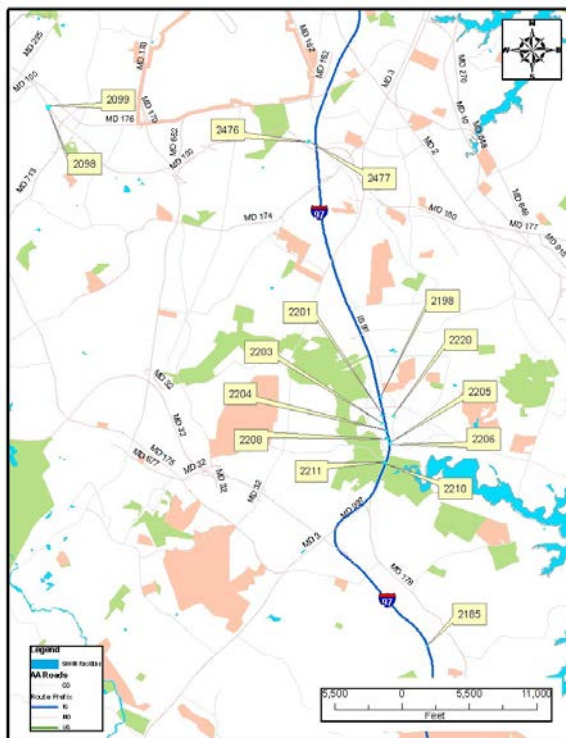
**Figure 3-11 SWM Functional Upgrades Sites Along I-97 in Anne Arundel County**

SHA continues the final design efforts with SWM Functional Upgrades project in Anne Arundel County. The selected sites are shown in Figure 3-11. and summarized in Table 3-8.

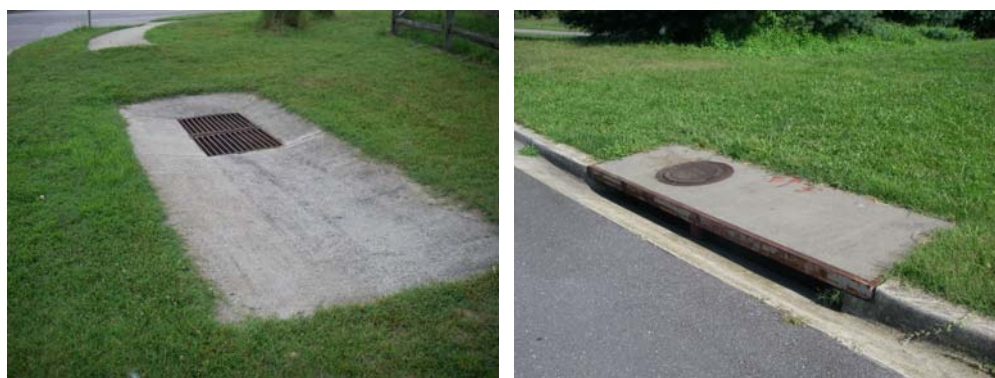
**Inlets (IN)** are hydraulic structure chambers below surface grade that collect storm drain runoff. An inlet either has a grate or open sides/curb to allow runoff to enter the storm drain system. Inlets are often constructed of concrete, masonry brick, or concrete block.

**Example of inlet structures**

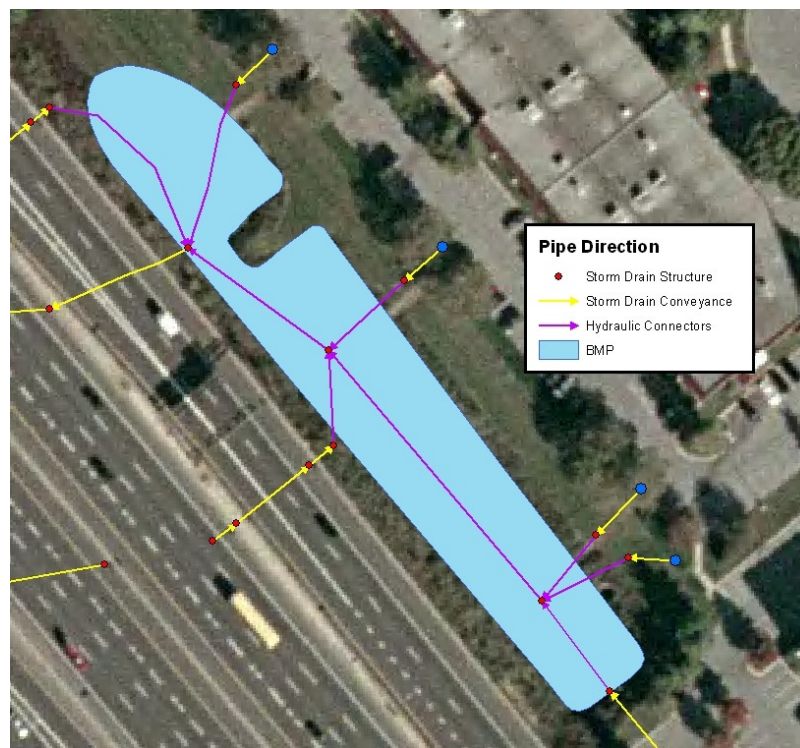
**Figure 2.8a – Pipe Direction Example 1**

*This BMP has four private inflows. The upstream structures on the private inflows could not be found so a pipe direction feature was inventoried in the direction of the pipe.*

Figures 2.8a and 2.8b show examples of how pipe direction features should be inventoried.

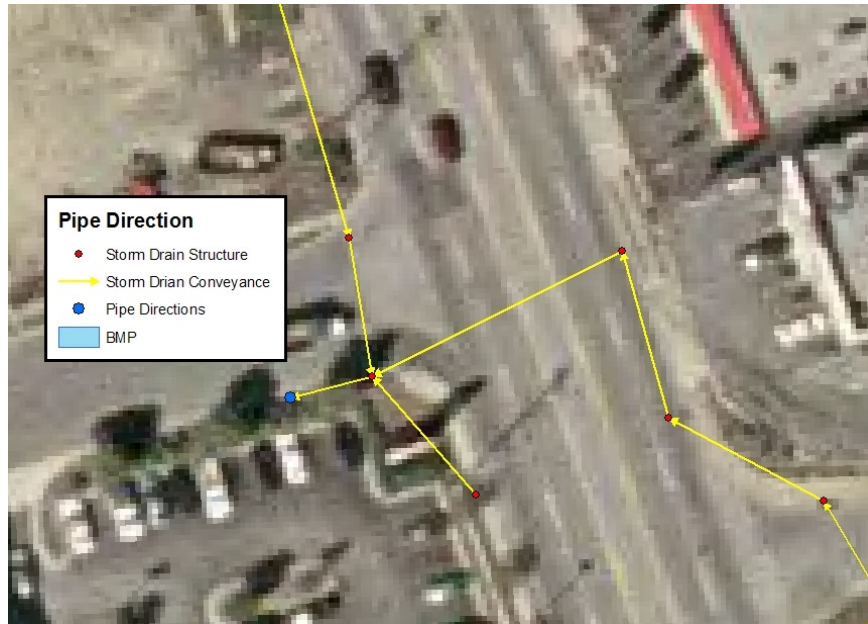
**Figure 2.8b – Pipe Direction Example 2**

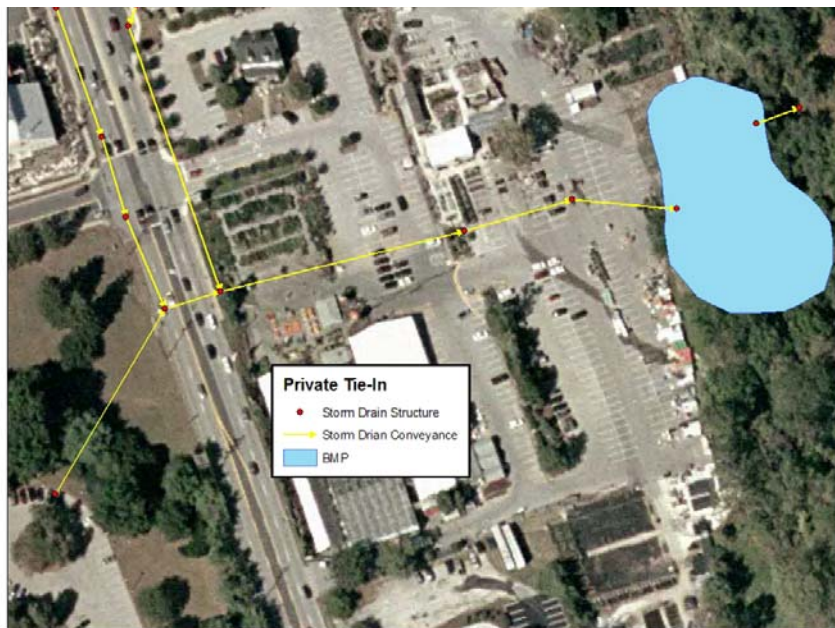
**Figure 2.9 – Private Storm Drain Feature Collection**

- When SHA storm drain systems flow into or from a private system, the first private downstream or upstream feature outside of SHA ROW is inventoried and included in the SHA system.
- When SHA storm drain systems flow into or from a private system, but the private downstream or upstream feature outside of SHA ROW cannot be found, a pipe direction feature is inventoried in the pipe direction as discussed in Section 2.2.3.3.
- If an SHA system conveys to a major outfall or to a stormwater BMP located outside of SHA ROW, then the private structures along the main trunk line to the major outfall or BMP are inventoried as in Figure 2.9.

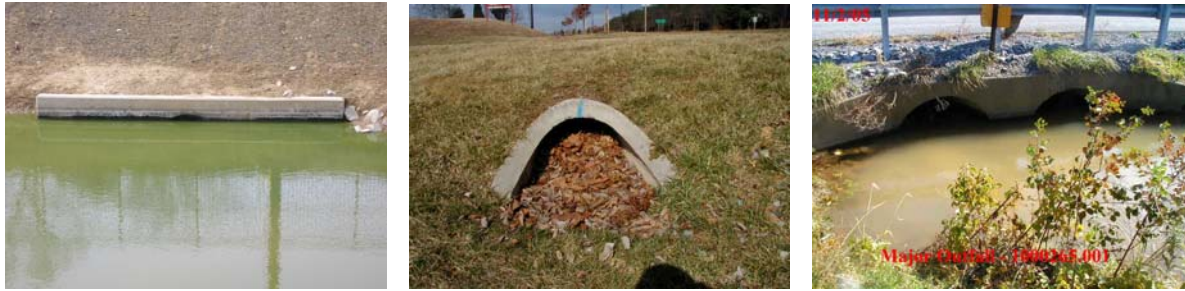
2(N) – The condition exists, but no action needs to be taken at this time. An example of this would be minor damage to an outfall wall off the shoulder, outfall pipes submerged, and structures that could not be accessed. This value should be verified in the field.

**Examples of structures that would receive a “2” value for structure issues, such as submerged structures or structures with minor accumulation of debris and sediment.**

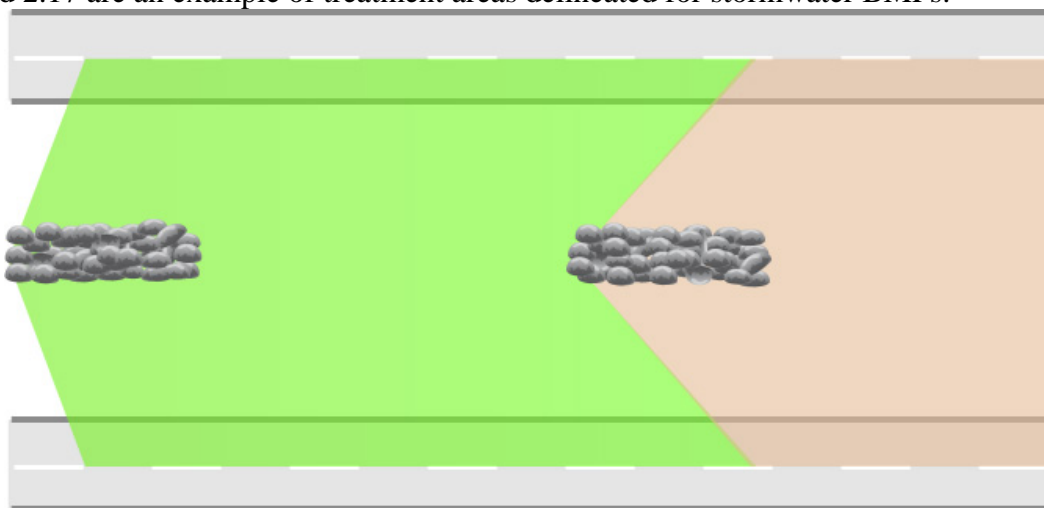
**Figure 2.16 – Treatment Area Example 1**  
*Treatment area for two infiltration trenches in series*

Figure 2.16 and 2.17 are an example of treatment areas delineated for stormwater BMPs.

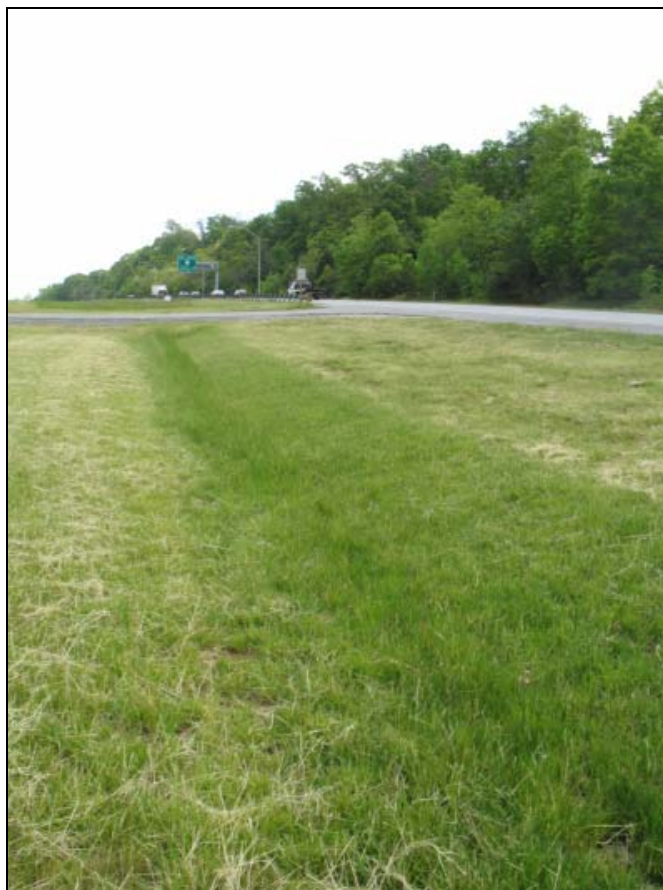
**Figure 1.** Grass swale with filter strip located on Maryland Route 32

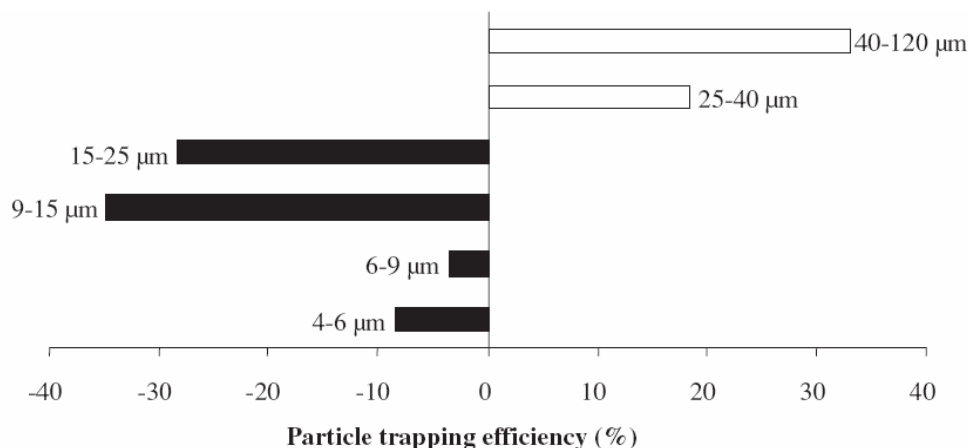
In other words, swales trapped larger particles more efficiently than smaller particles especially if the vegetation is thin. This phenomenon can be seen in the simulated runoff event study by Backstrom 2003 (Figure 2-2) where particles larger than 25  $\mu\text{m}$  were retained in the swale while particles range between 9 to 15  $\mu\text{m}$  were easily transported out of the swale.

**Figure 2-2.** Particle trapping efficiencies observed at the Sodra Hamnleden site (Backstrom 2003).

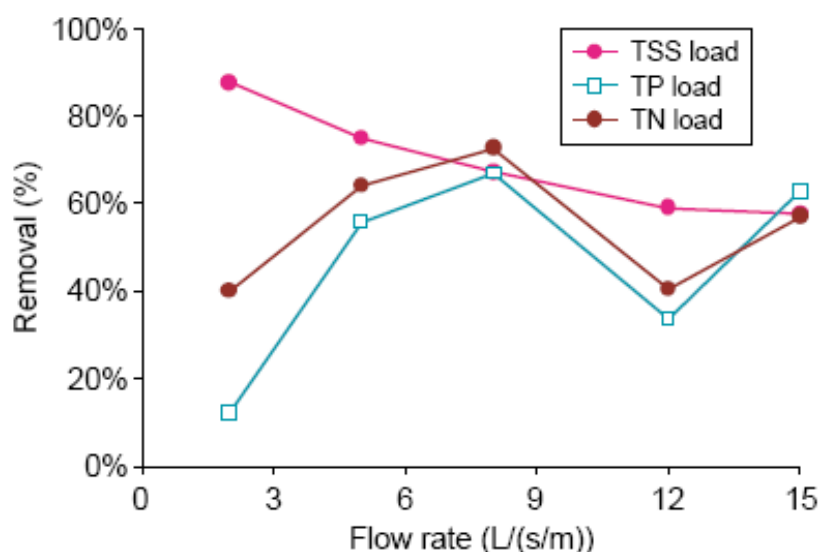
The study in Brisbane placed more emphasis on treatment performance for TSS, total phosphorus (TP) and total nitrogen (TN). The results indicate that the form of the exponential decay is a function of flow. The higher the flow rate, the less sediment is deposited. With higher flow rates, less time is available for filtration to occur and therefore, less deposition to occur. This phenomenon is shown in Figure 2-3.

**Figure 2-3.** Removal of TSS, TP and TN load percent as a function of flow rate; the Brisbane swale (Deletic and Fletcher 2006).

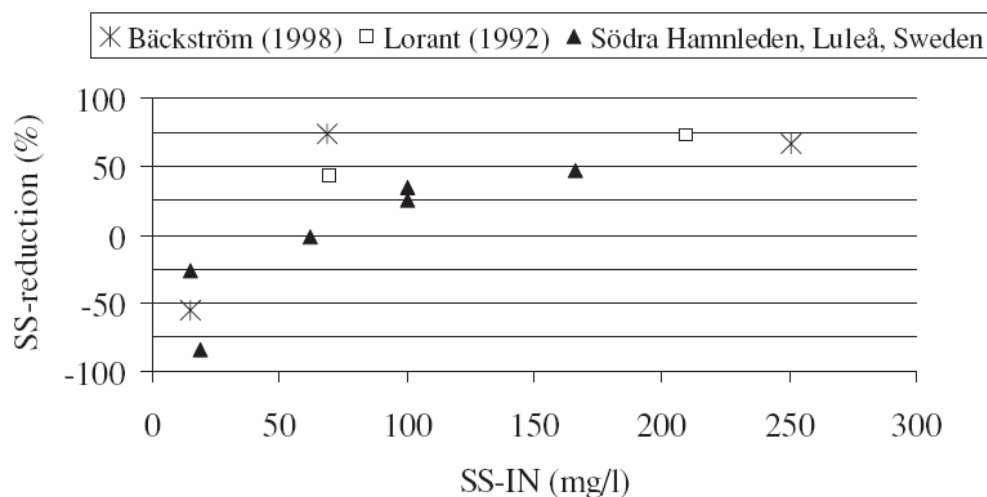
than 50%) when influent suspended solids concentrations are above 100 mg/L. The Backstrom (1998) was done on a 70 m long trapezoidal swale in a residential area in Sweden while the study in 2003 was done a 110 m long triangular swale along the roadside. Although the influent loading rate is truly site specific, the influent water quality is still an important site condition that influences the pollutant removal performance (Barrett et al. 1998).

**Figure 2-4.** Reduction in Suspended Solids (SS) concentration at different influent SS concentrations for three different studies (Backstrom 2003).

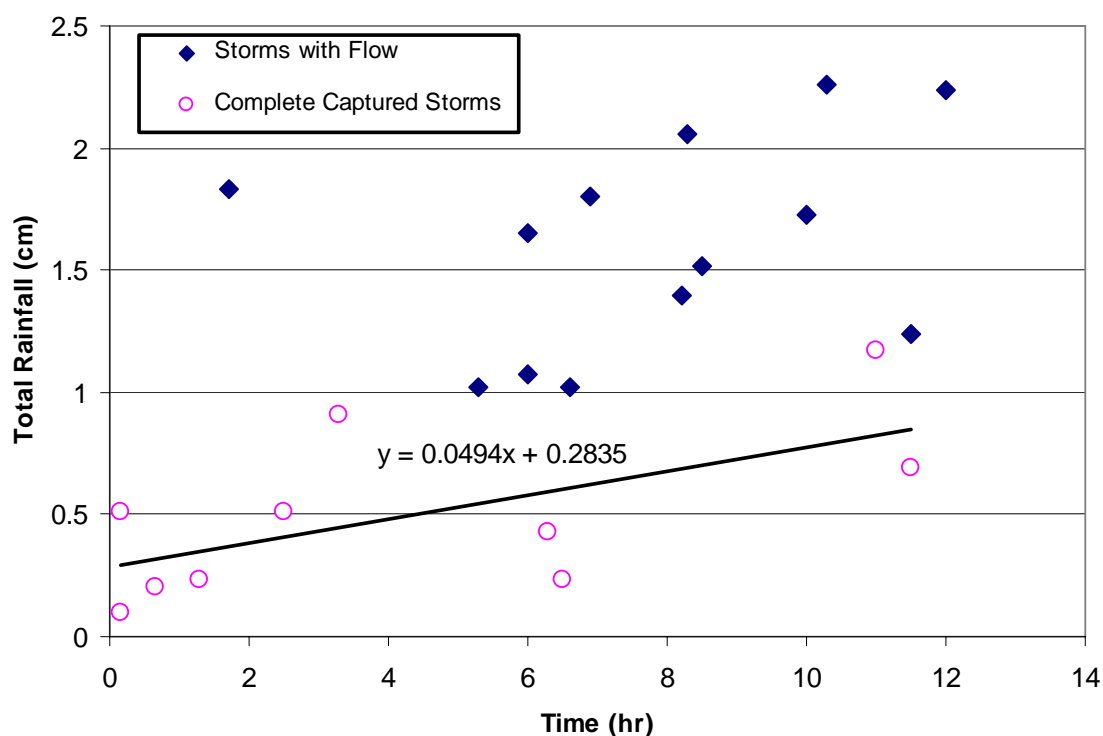
A graph of total rainfall depth at different rainfall durations is drawn from data listed in Table 4-1 (Figure 4-3). For this graph, complete captured storms and storms with discharge flow are clearly distinguished. Therefore a relationship between total rainfall and storm duration for the complete captured events can be obtained by linear regression between these two variables.

**Figure 4-3.** Total Rainfall Depth versus Duration. Plot showing completely captured storm events as empty circle (○) and storms with discharge as filled diamond (◆).

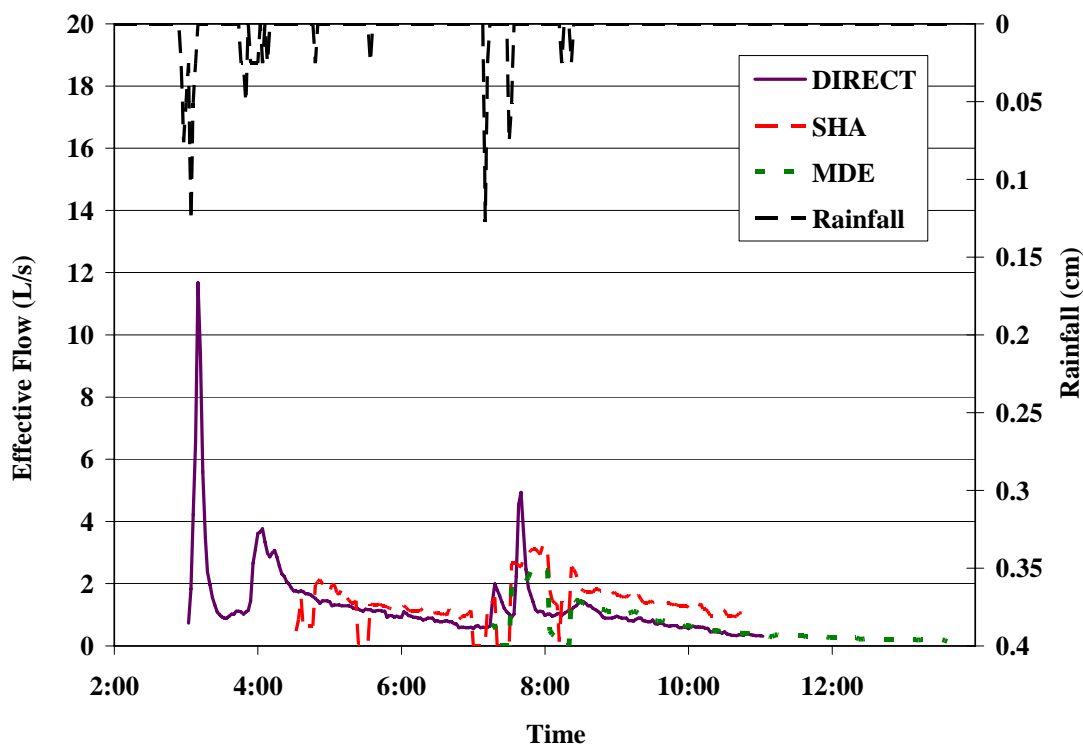
**Figure 4-4.** Effective Flow for 4/4/07 Storm Event at Rt. 32 Swales

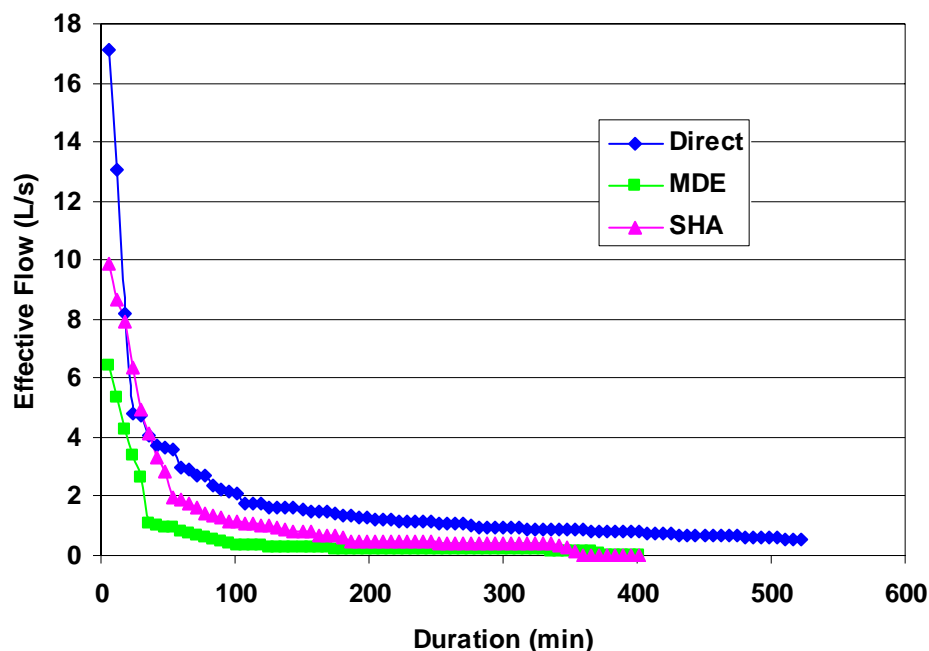
**Figure 4-9.** Effective Flow for storm sampled on 6/3/07 at Rt. 32 versus Storm Duration

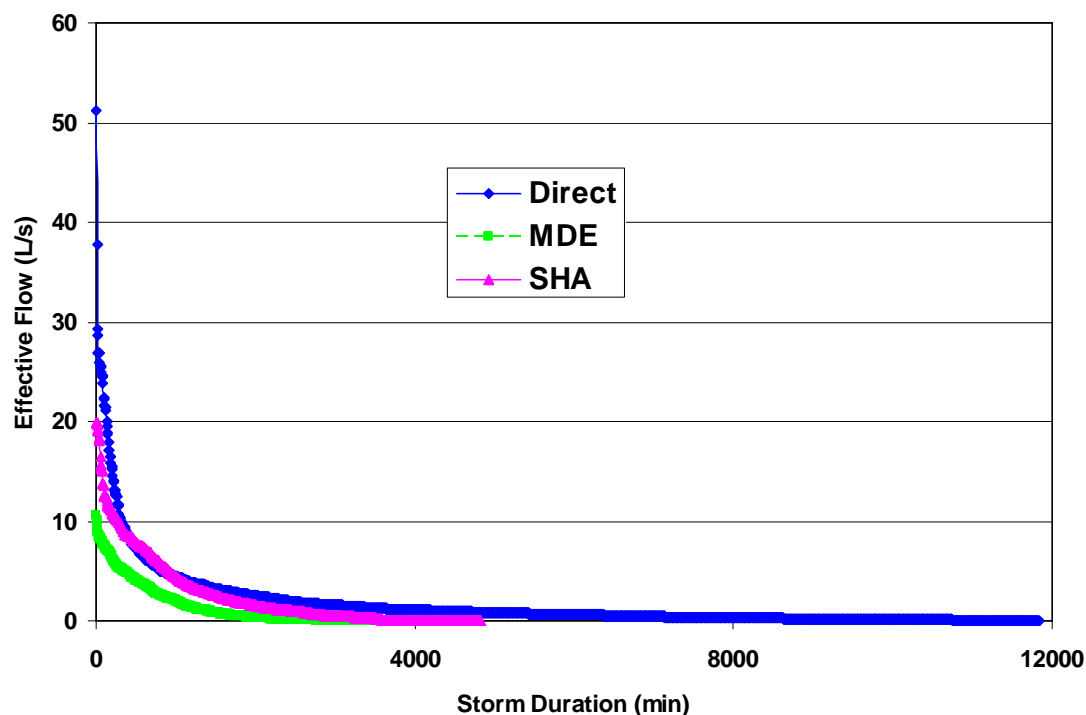
**Figure 4-10.** Cumulative Effective Flow for all 24 events sampled at Rt. 32 versus Storm Duration

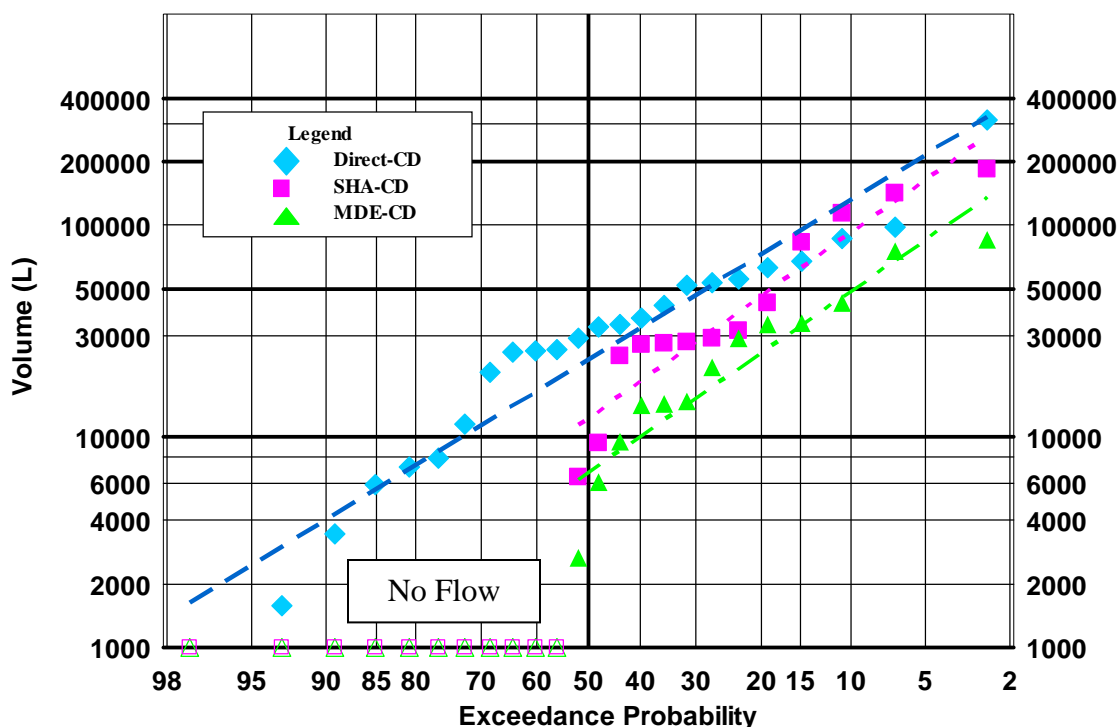
**Figure 4-11.** Total Volume for each sampling point at Rt. 32 for 24 events.

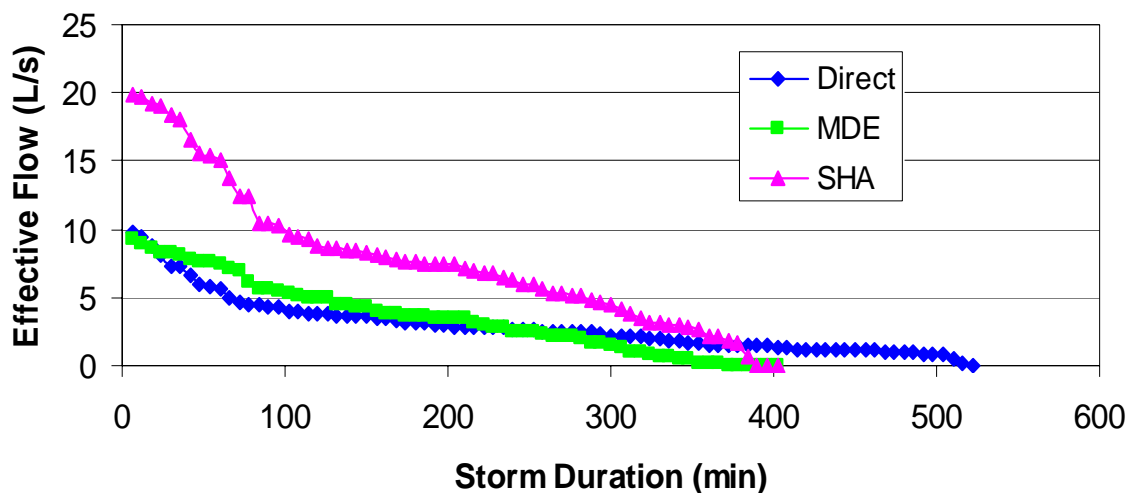
**Figure 4 – 12** Cumulative Effective Flow versus Storm Duration at Rt. 32 (12/14/07)

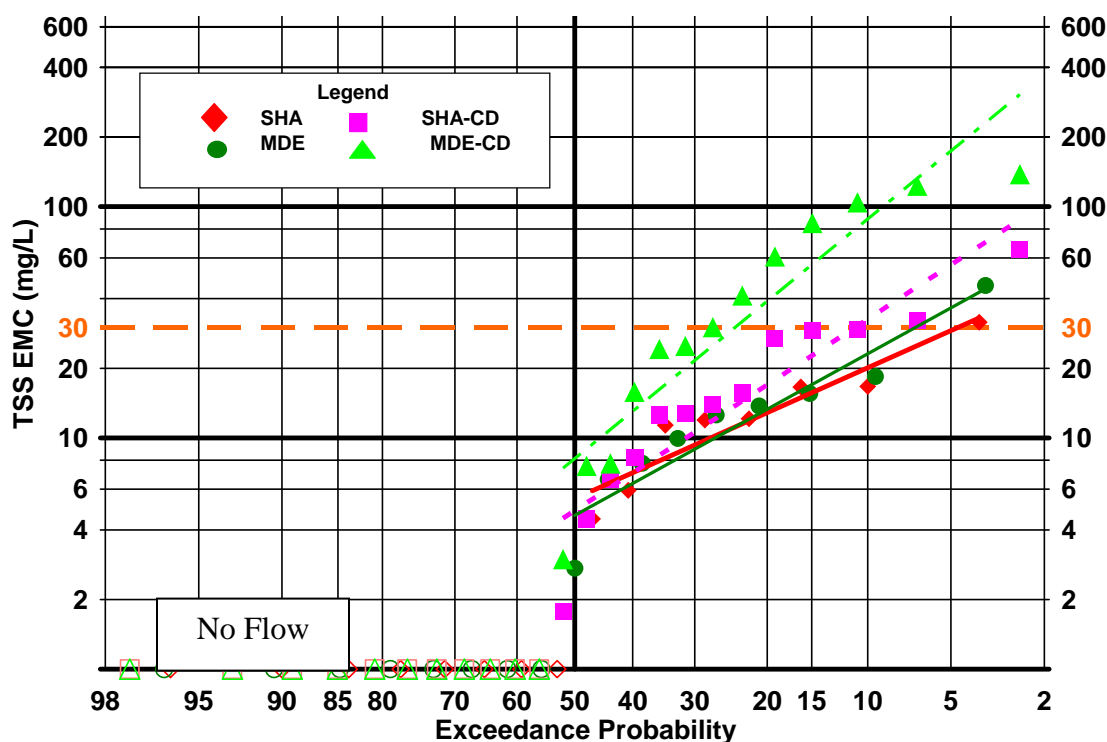
**Figure 4-16.** Probability plot for TSS EMCs at Rt. 32 Swales  
(Current study vs Stagge (2006)).

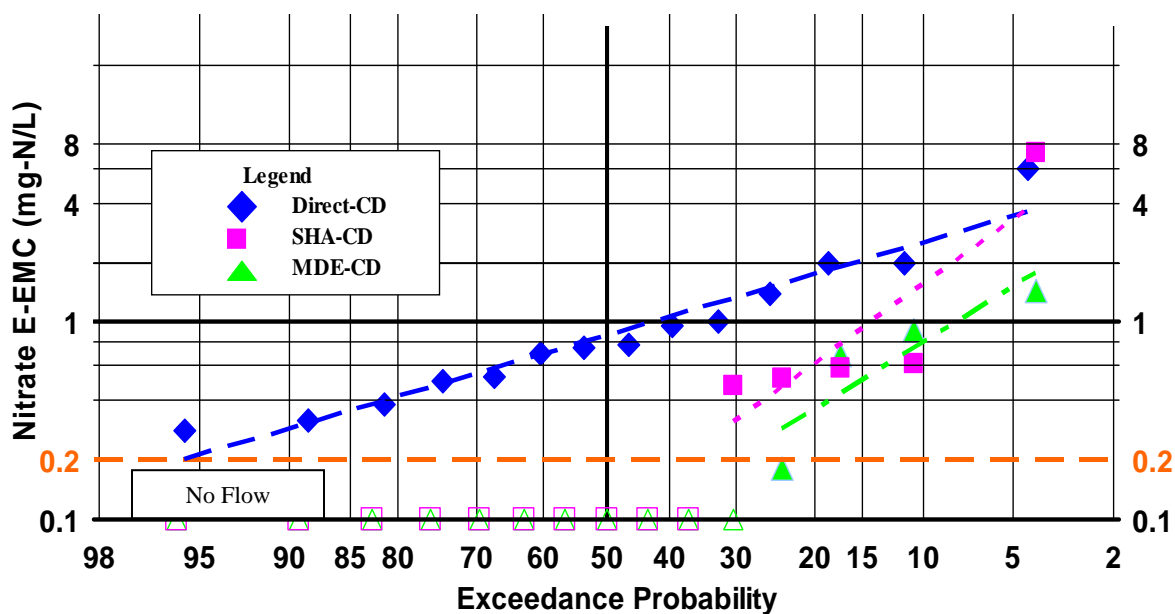
**Figure 4-19.** Probability plot for Nitrate E-EMCs at Rt. 32 Swales

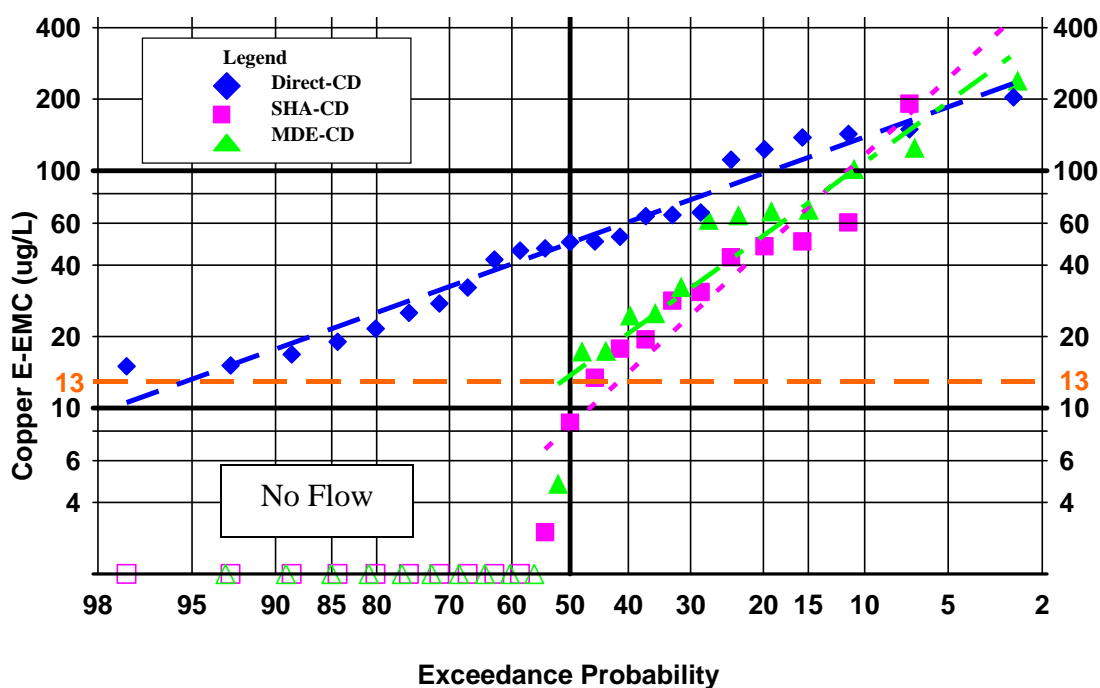
**Figure 4-31.** Probability plot for Copper E-EMCs at Rt. 32 Swales.

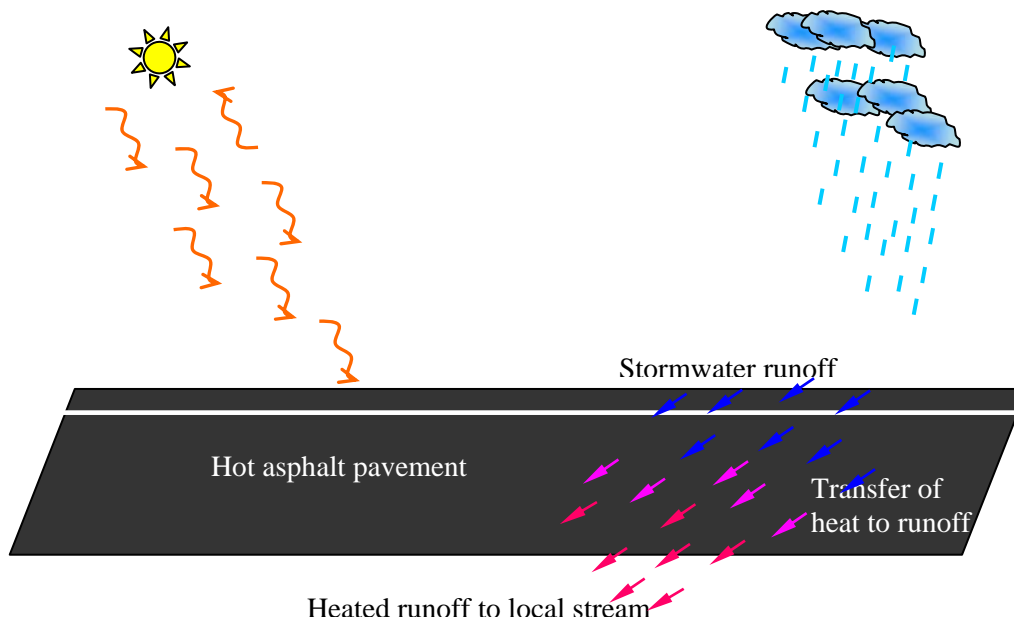
**Figure 1-1.** Schematic diagram showing the transfer of heat to stormwater runoff  
Elevated water temperature levels can have negative impacts on the stream habitat. Biotic

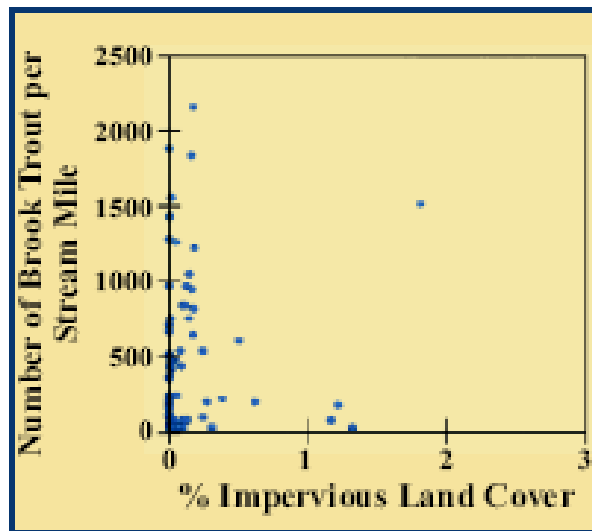
**Figure 2-1.** Sensitivity of Brook trout population to percentage watershed imperviousness  
(Source: Boward et al. 1999)

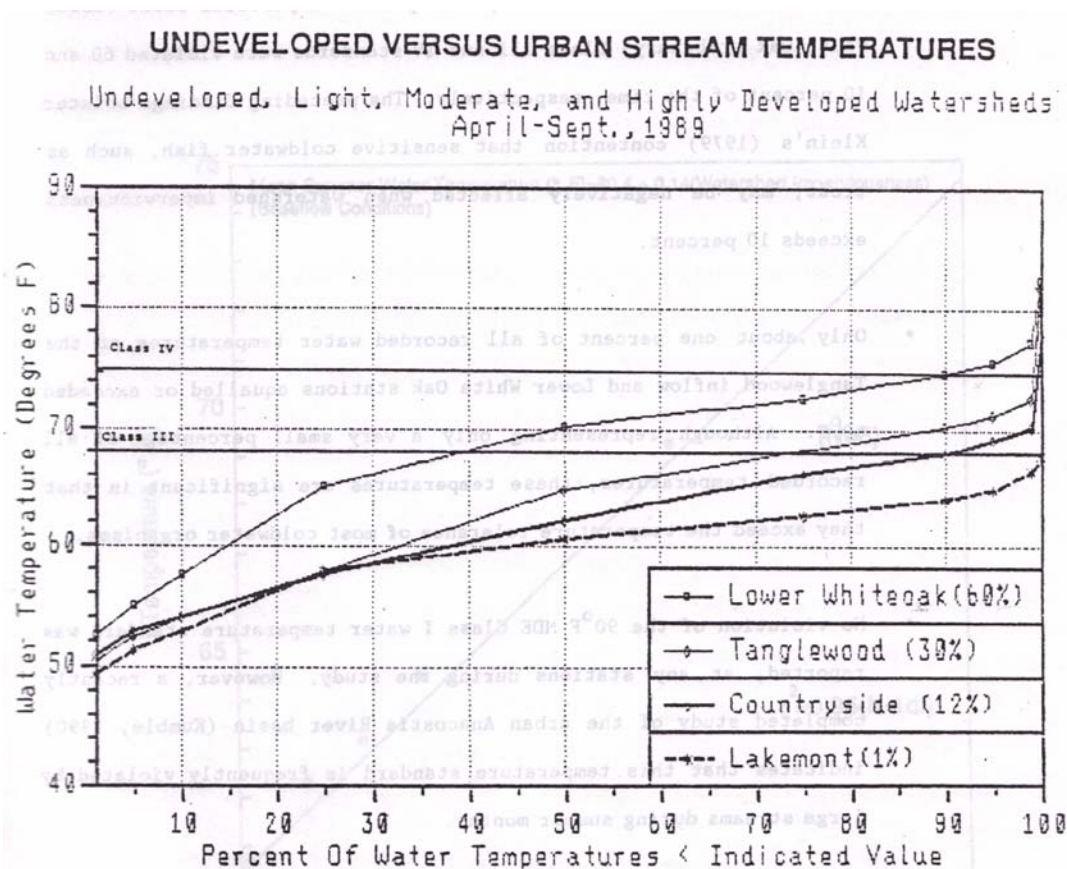
**Figure 2-2.** Effect of development on six headwater stream temperatures in Maryland (Source: Galli 1990)

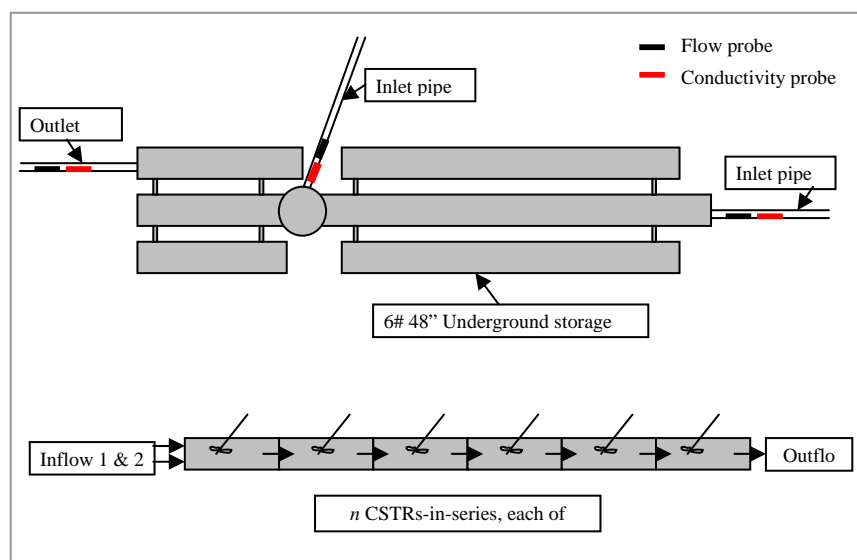
**Figure 3-10.** Schematic representation of underground system and model design

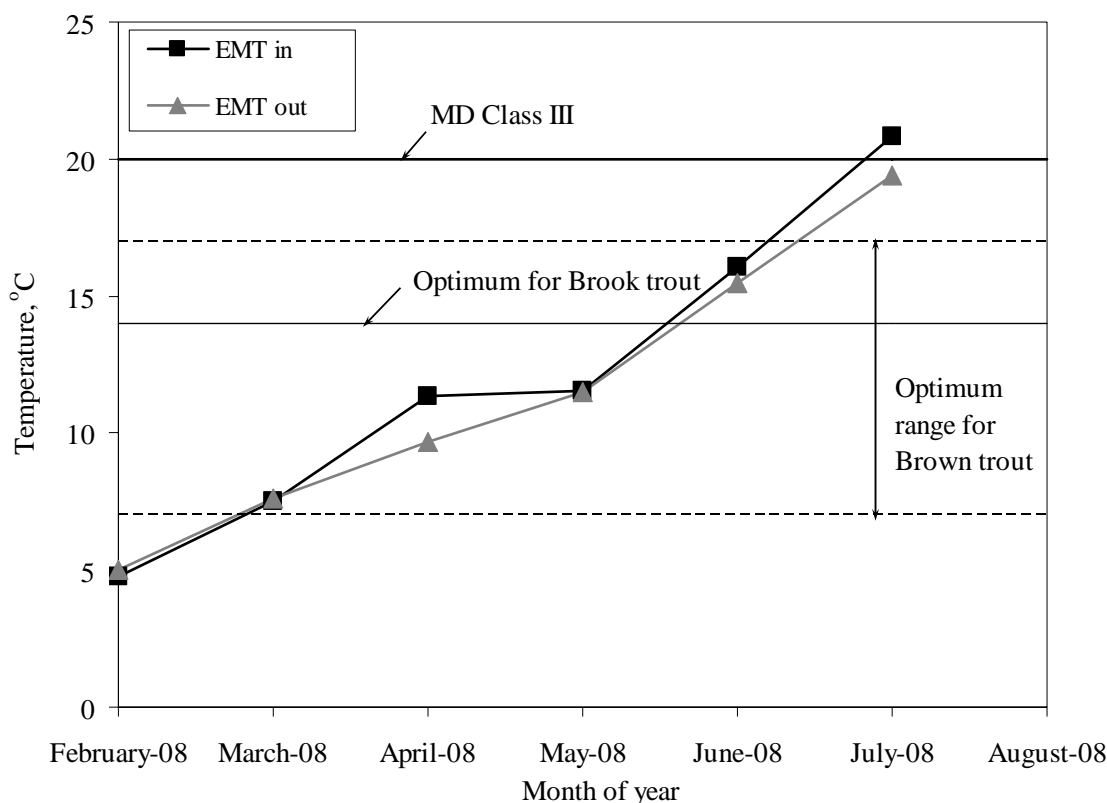
**Figure 4-2.** Flow-weighted mean monthly temperatures for BMP 3007

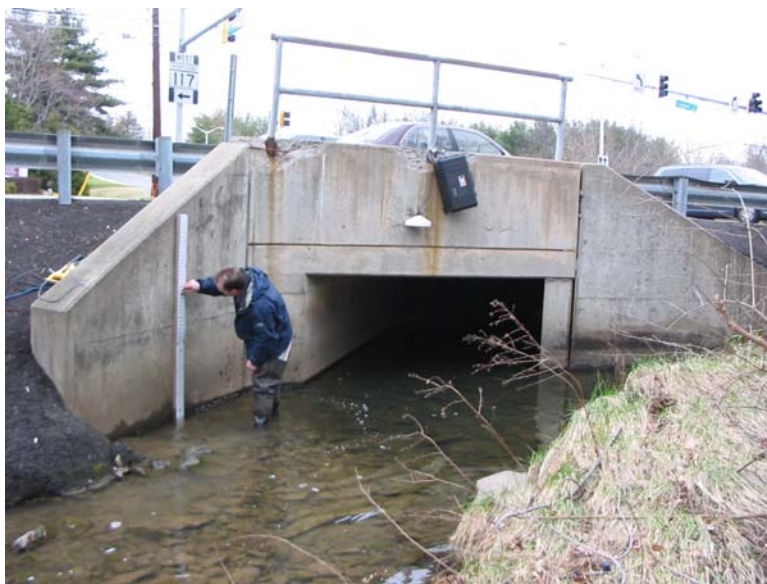
**Figure 2.2: Continuous water level meter at upstream monitoring site**

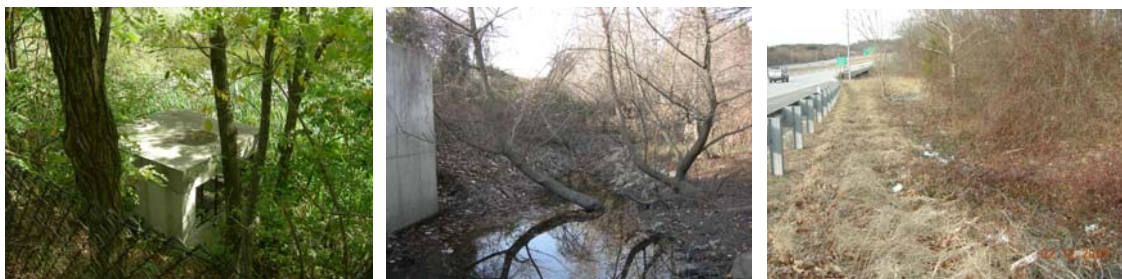
### **7.4.3.3 Recommendations to Repair a Separated Pipe or Endwall**

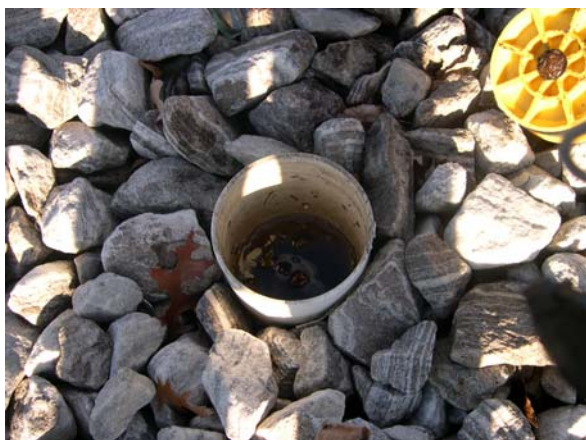
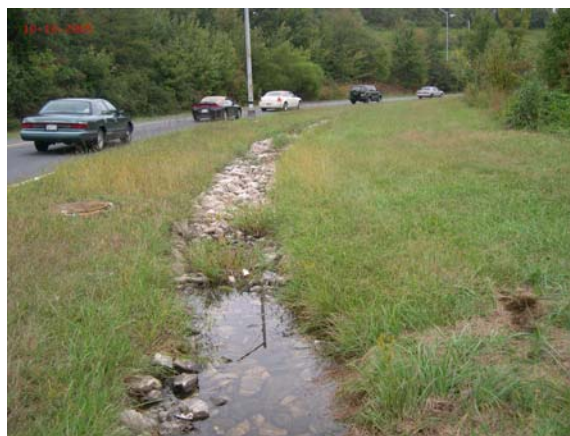
The most feasible method for correcting a blocked infiltration trench is to replace the stone media. The recommendation in the report should indicate that the media should be excavated and replaced in-kind. The contractor should have material to replace the media on-site at the time of the excavation. If the excavated media is not covered with sediment as a result of a blockage, then it can be reused. The on-site inspector should be alerted to look for other indicators that may have caused the failure, so that the contractor can receive proper instructions to correct the trench deficiencies. The contractor should not blindly replace the media, because there may be indications of a high water table or poor drainage in the surrounding soils which caused the failure. In this situation, the contractor should place the excavated material back in the trench and abandon the site. The inspector should then notify HHD that the facility could not be maintained and was therefore abandoned. The recommendation report must clearly reflect all of these steps, where appropriate, so that the trench media can be replaced when it is feasible or the trench will need to be abandoned.
