National Pollutant Discharge Elimination System
Municipal Separate Storm Sewer System
Permit No. 11-DP-3313 MD0068276
Permit Term October 9, 2015 to October 8, 2020

Seventh Annual Report

October 28, 2022

Appendix F: Little Catoctin Creek Watershed Monitoring Implementation Document

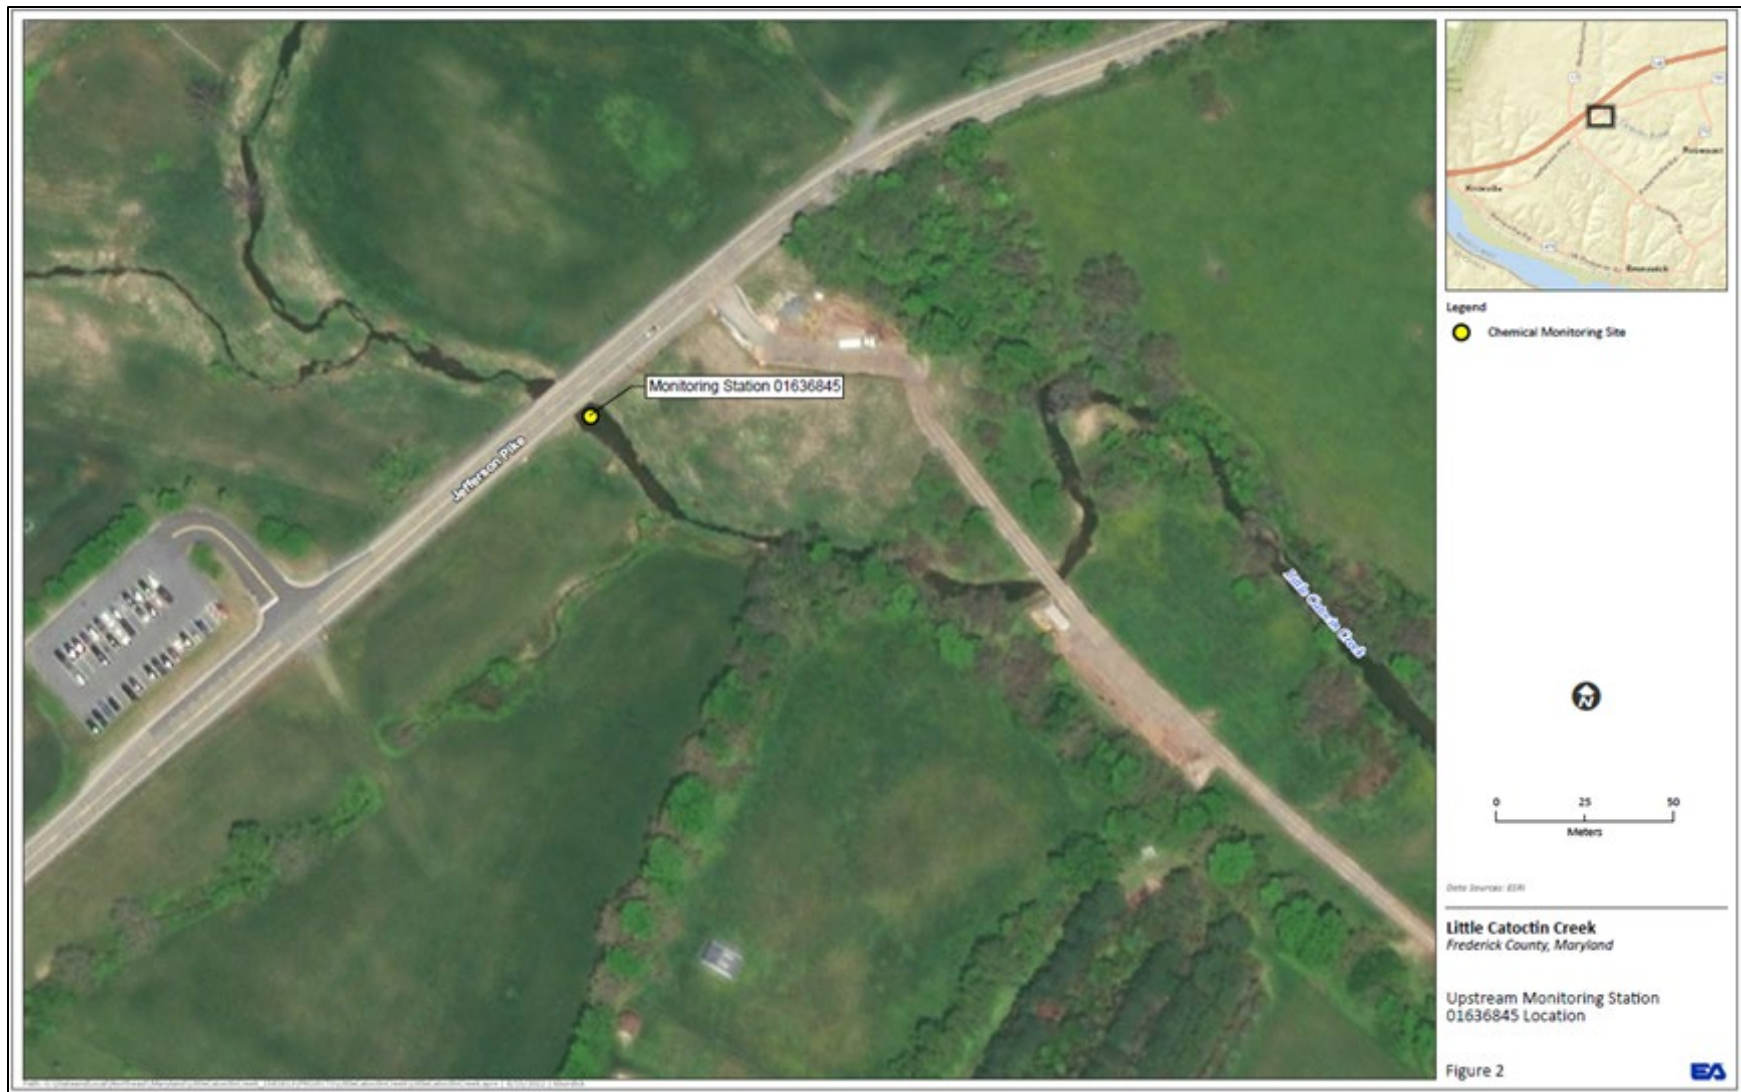
Figure 2. Upstream chemical monitoring station (01636845)

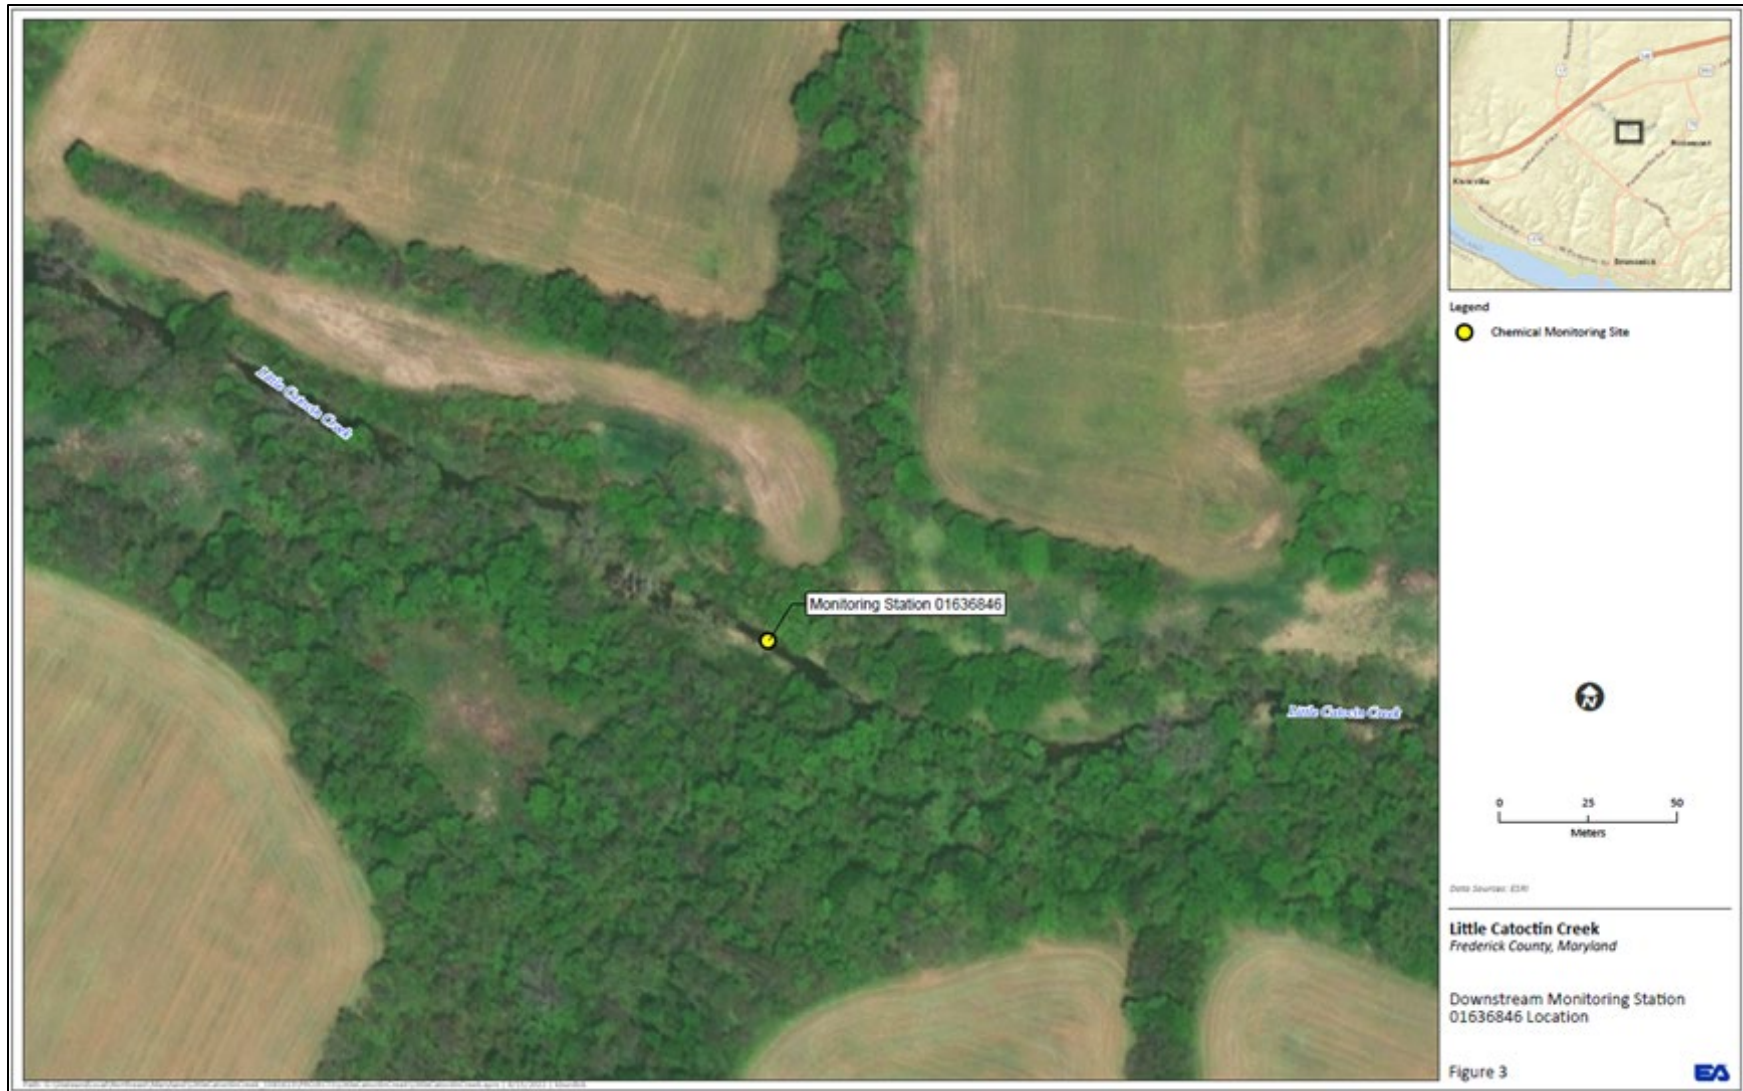
Figure 3. Re-located downstream monitoring station (01636846)

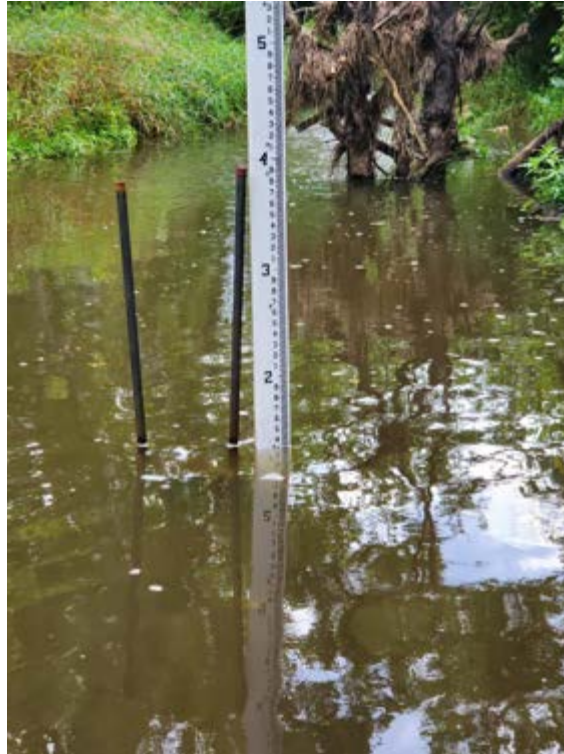
Figure 4. FY22 relocated downstream station (Site ID 01636846) on Little Catoctin Creek near Rosemont, MD. The photo shows the HOBO logger and stream gage.

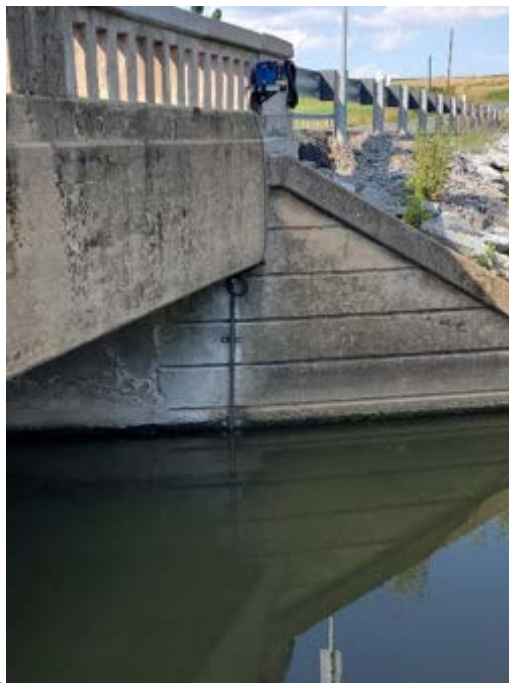
Figure 5. FY22 upstream station (Site ID01636845) on Little Catoctin Creek near Rosemont, MD. The photo shows the ISCO velocity and area flow module.

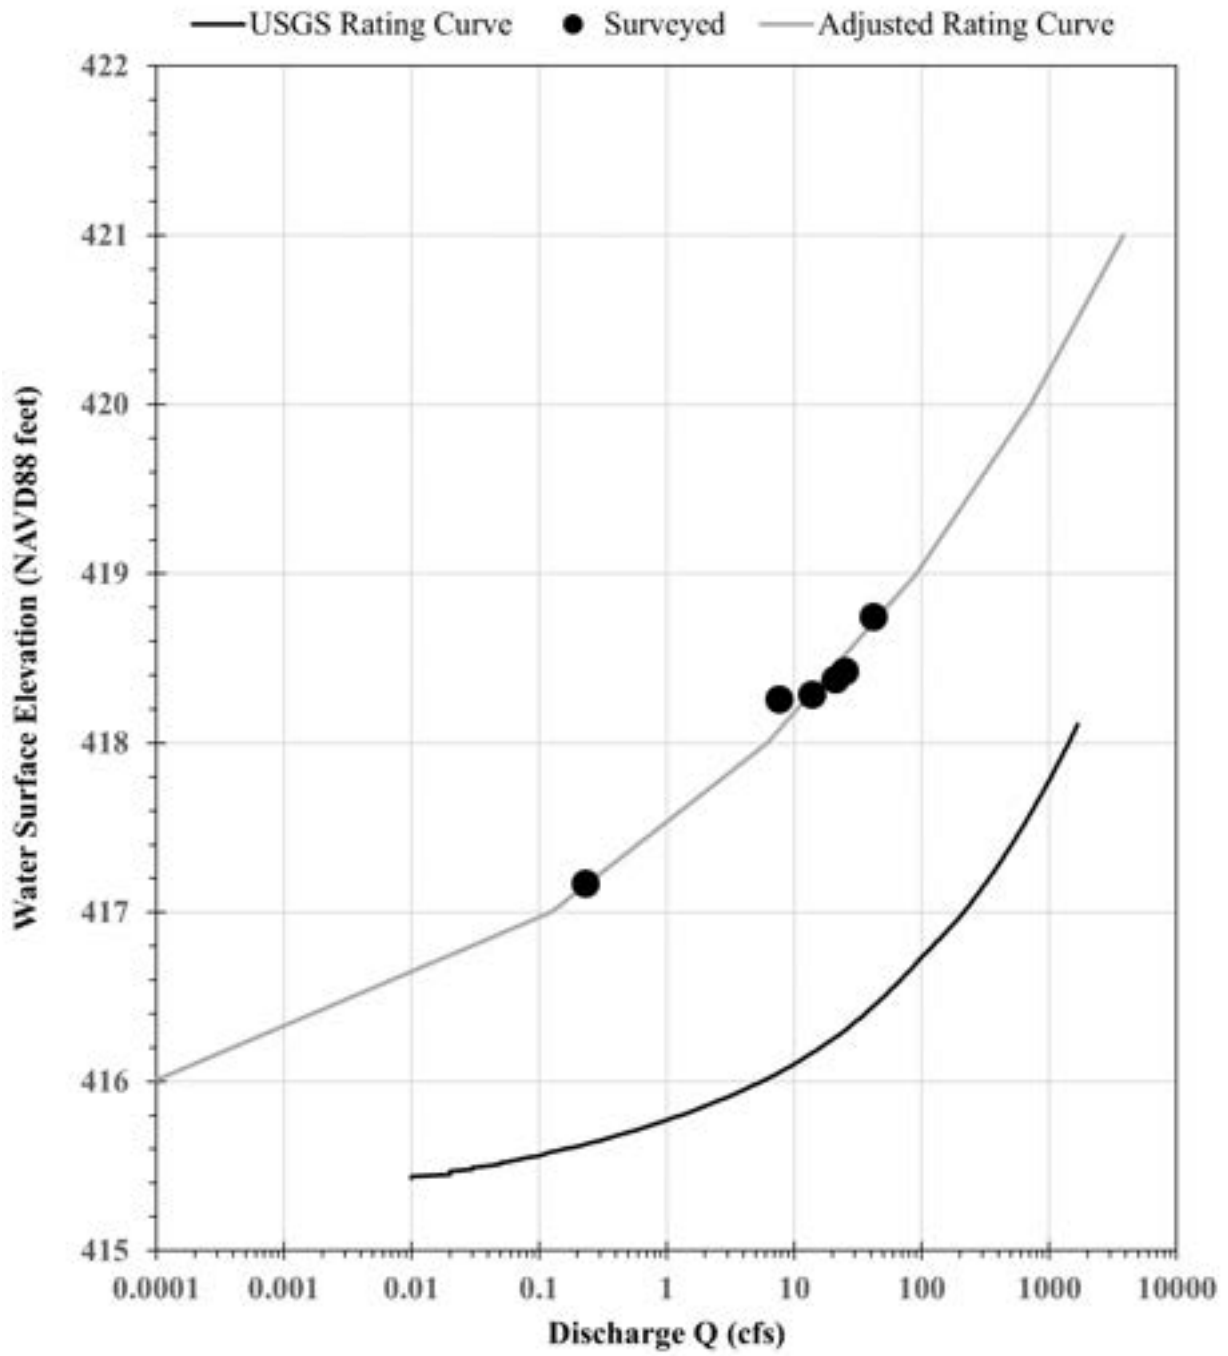
Figure 6. Upstream station (Site 01636845) rating curve

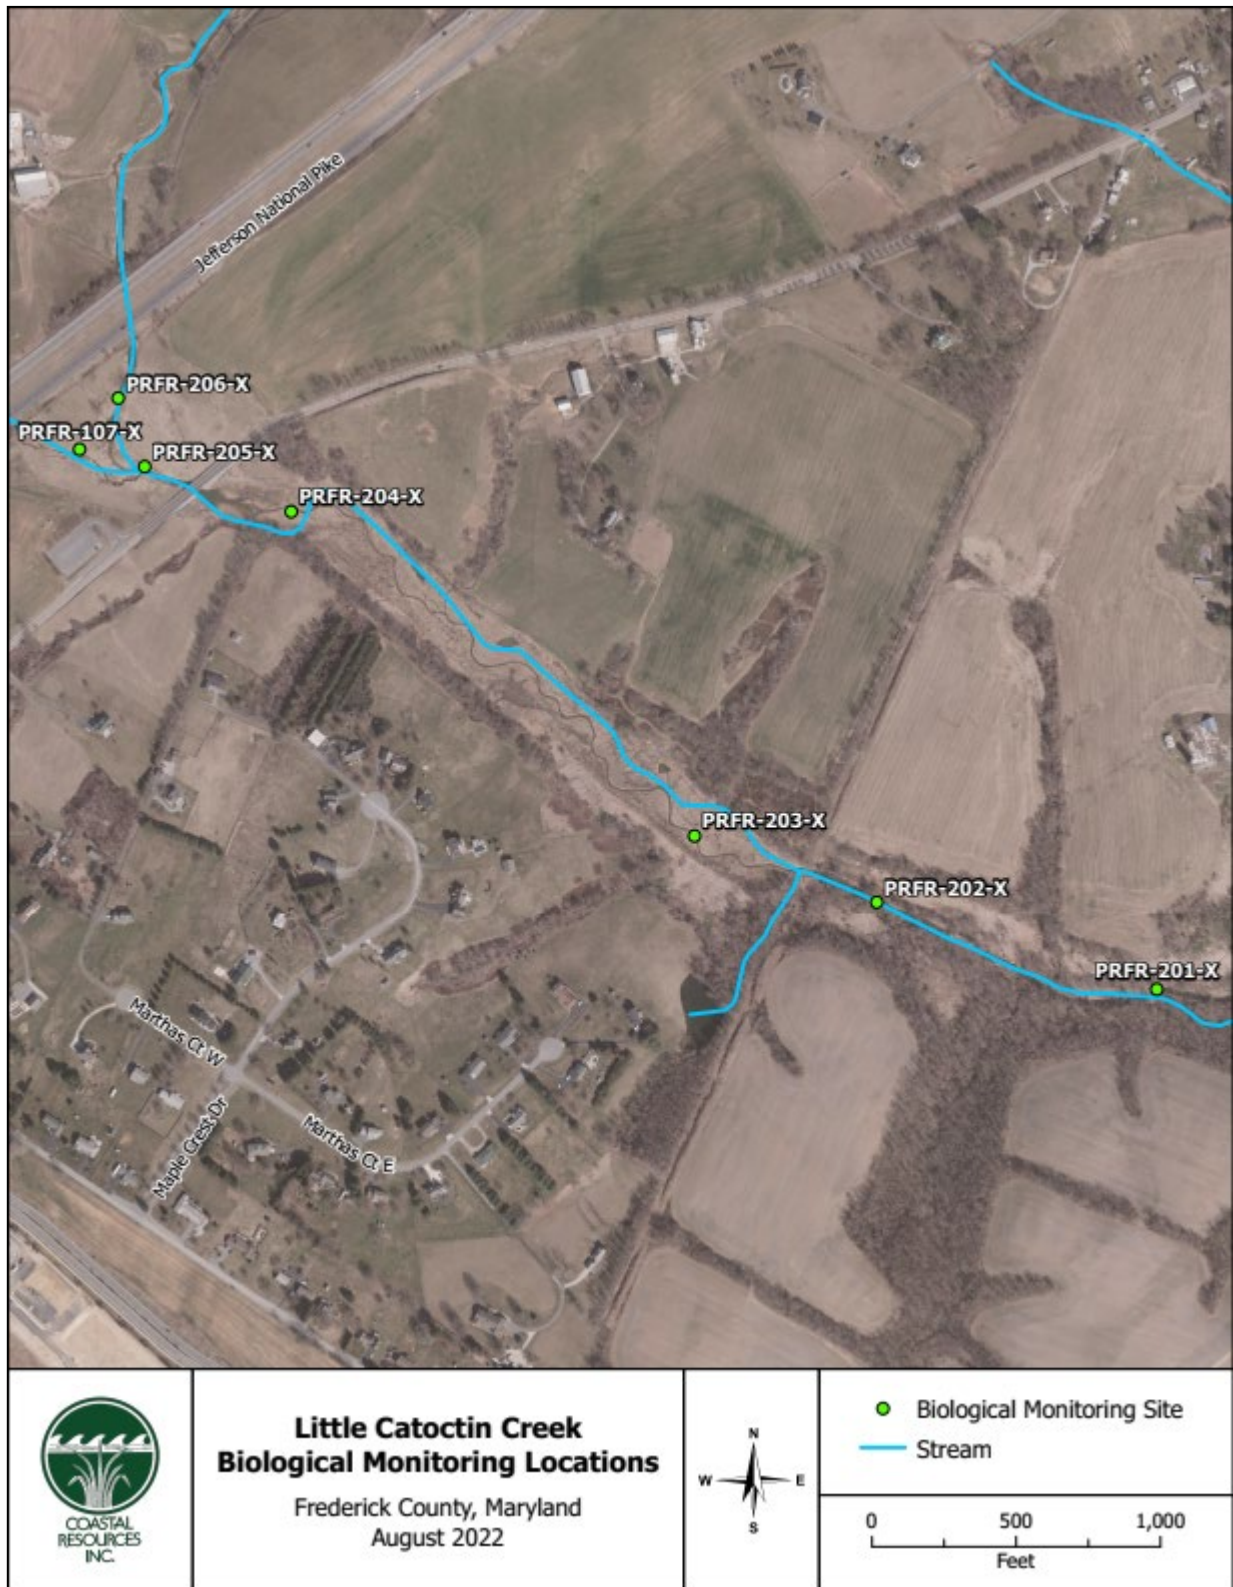
Figure 8. Locations of the seven biological monitoring sites in Little Catoctin Creek.
