BICYCLE & PEDESTRIAN
PRIORITY AREA PLAN

City of Hagerstown &
Maryland Department of Transportation State Highway Administration

May 2020

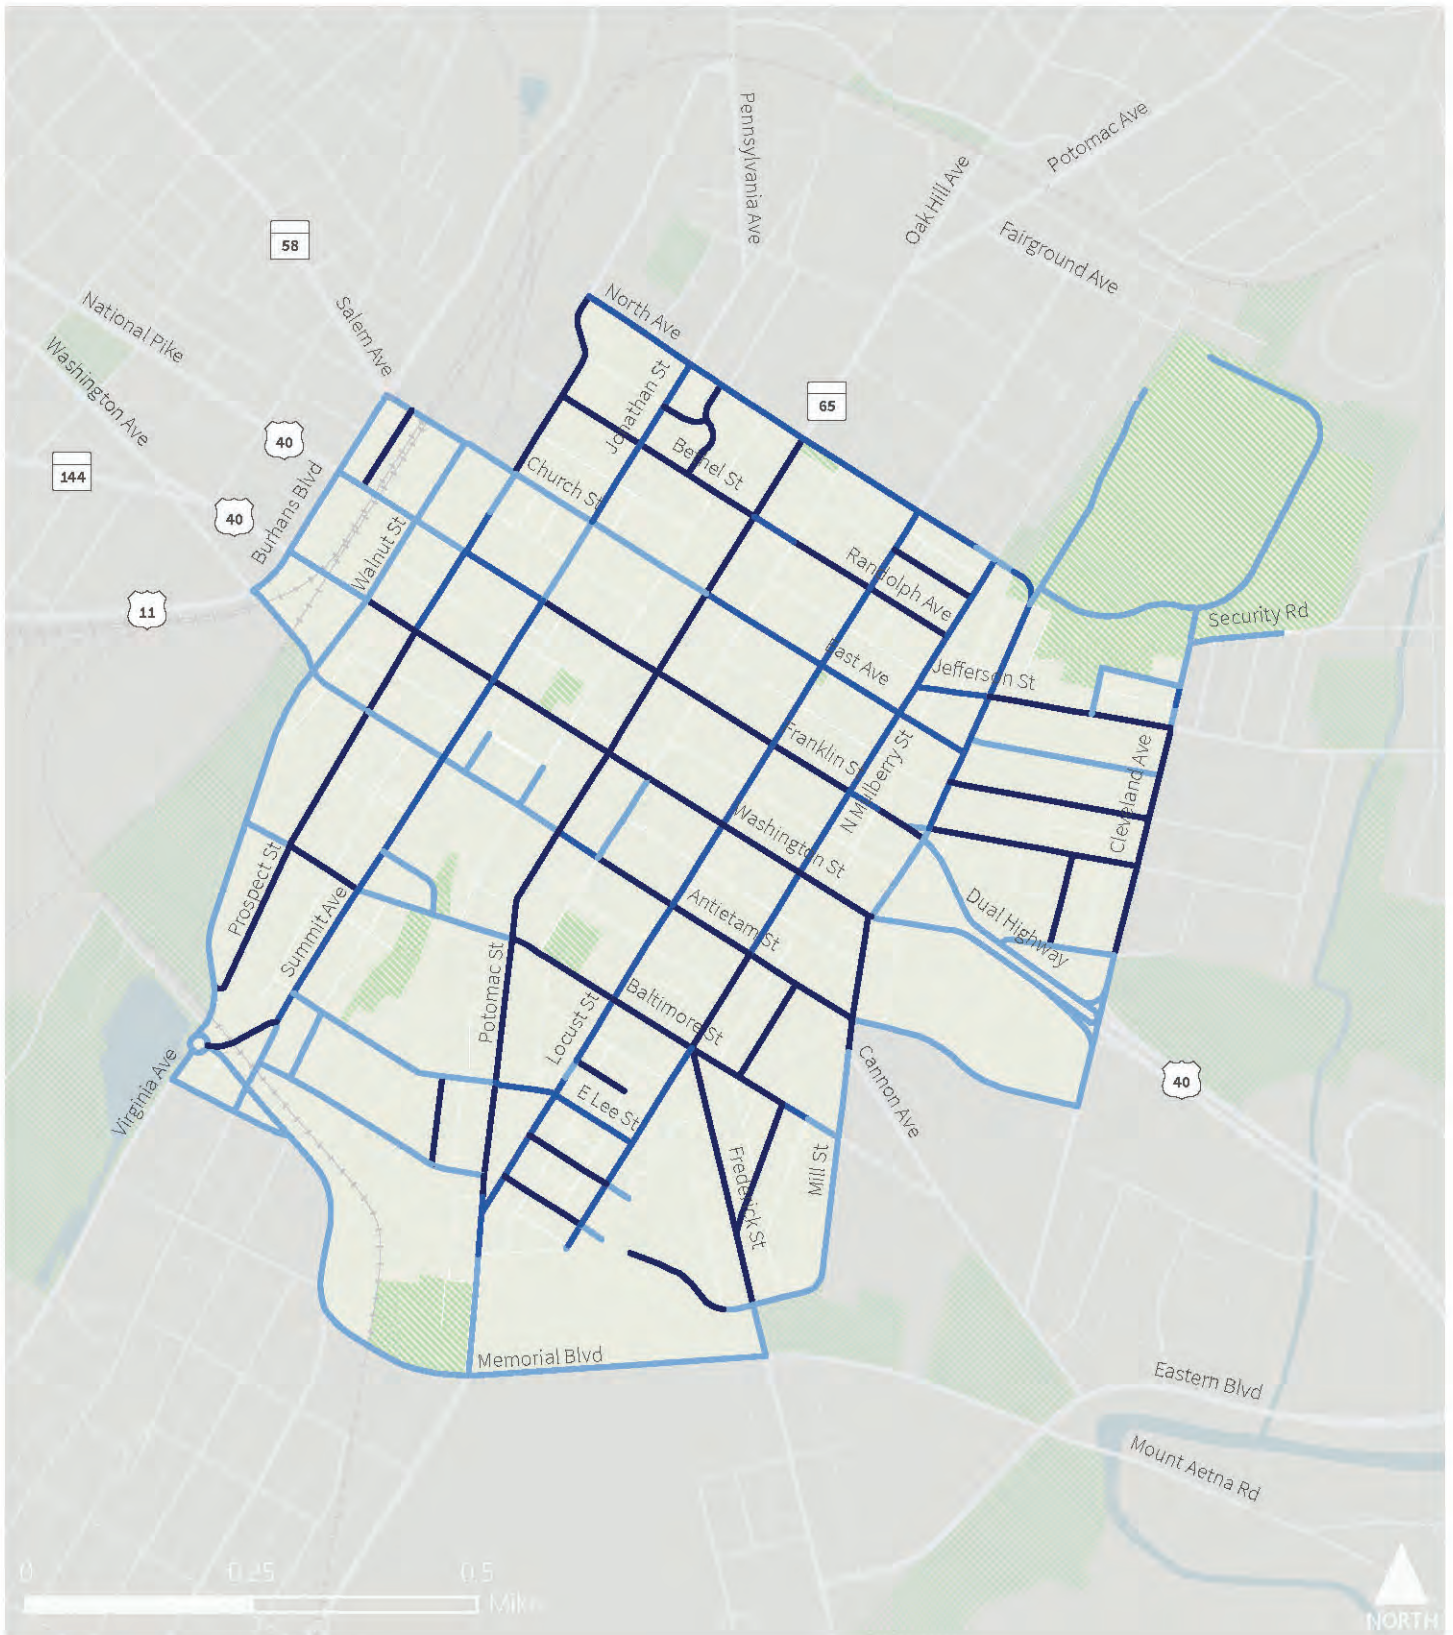
Figure 6. Intersection Control Types

Most of the major intersections have pedestrian signals/indications. There are many examples of best practice pedestrian signalization including crosswalks on all approaches; use of pedestrian indication and audible pedestrian signals (for the blind); leading pedestrian intervals and stop bars in advance of the crosswalk at intersections such as at Franklin Street at Jonathan Street, Potomac Street at Antietam Street, and Baltimore Street at Locust Street. At some locations, crosswalks are enhanced by beacons and rectangular rapid flash beacons (RRFB) as shown in **Figure 6**. There are locations without traffic control, which is common for low volume intersections and effectively results in an all-way yield. One of these locations has experienced a major injury crash - Jefferson Street at Wood Street.

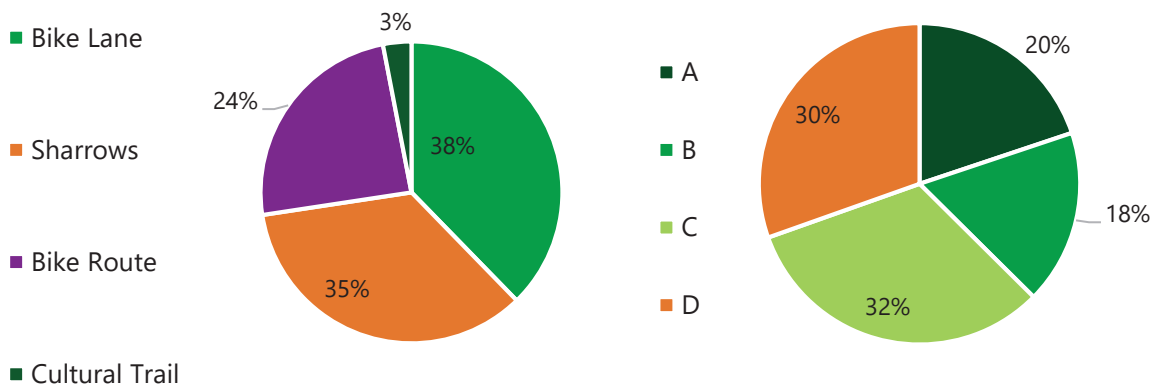
Figure 8. Bicycle Network and Level of Service in BPPA

The BPPA has about 11 miles of existing bicycle facilities. About 35% of bicycle network length is sharrows, where the auto lane is shared with cyclists using pavement marking, and 38% is bike lanes. Bike routes with traffic signage only and no pavement marking are about 25% of the bike network. While some of the northbound-southbound roads such as Prospect Street, Summit Avenue, and Locust Street have

bike lanes, there are no major roads in the east-west direction with bike lanes except East Lee Street between Summit Avenue and Potomac Street. Bicycle level of service (BLOS) is a useful tool to evaluate cycling comfort. BLOS combined with bicycle demand can identify safety concerns and network gaps where bicyclists are at risk of biking under less desirable conditions.

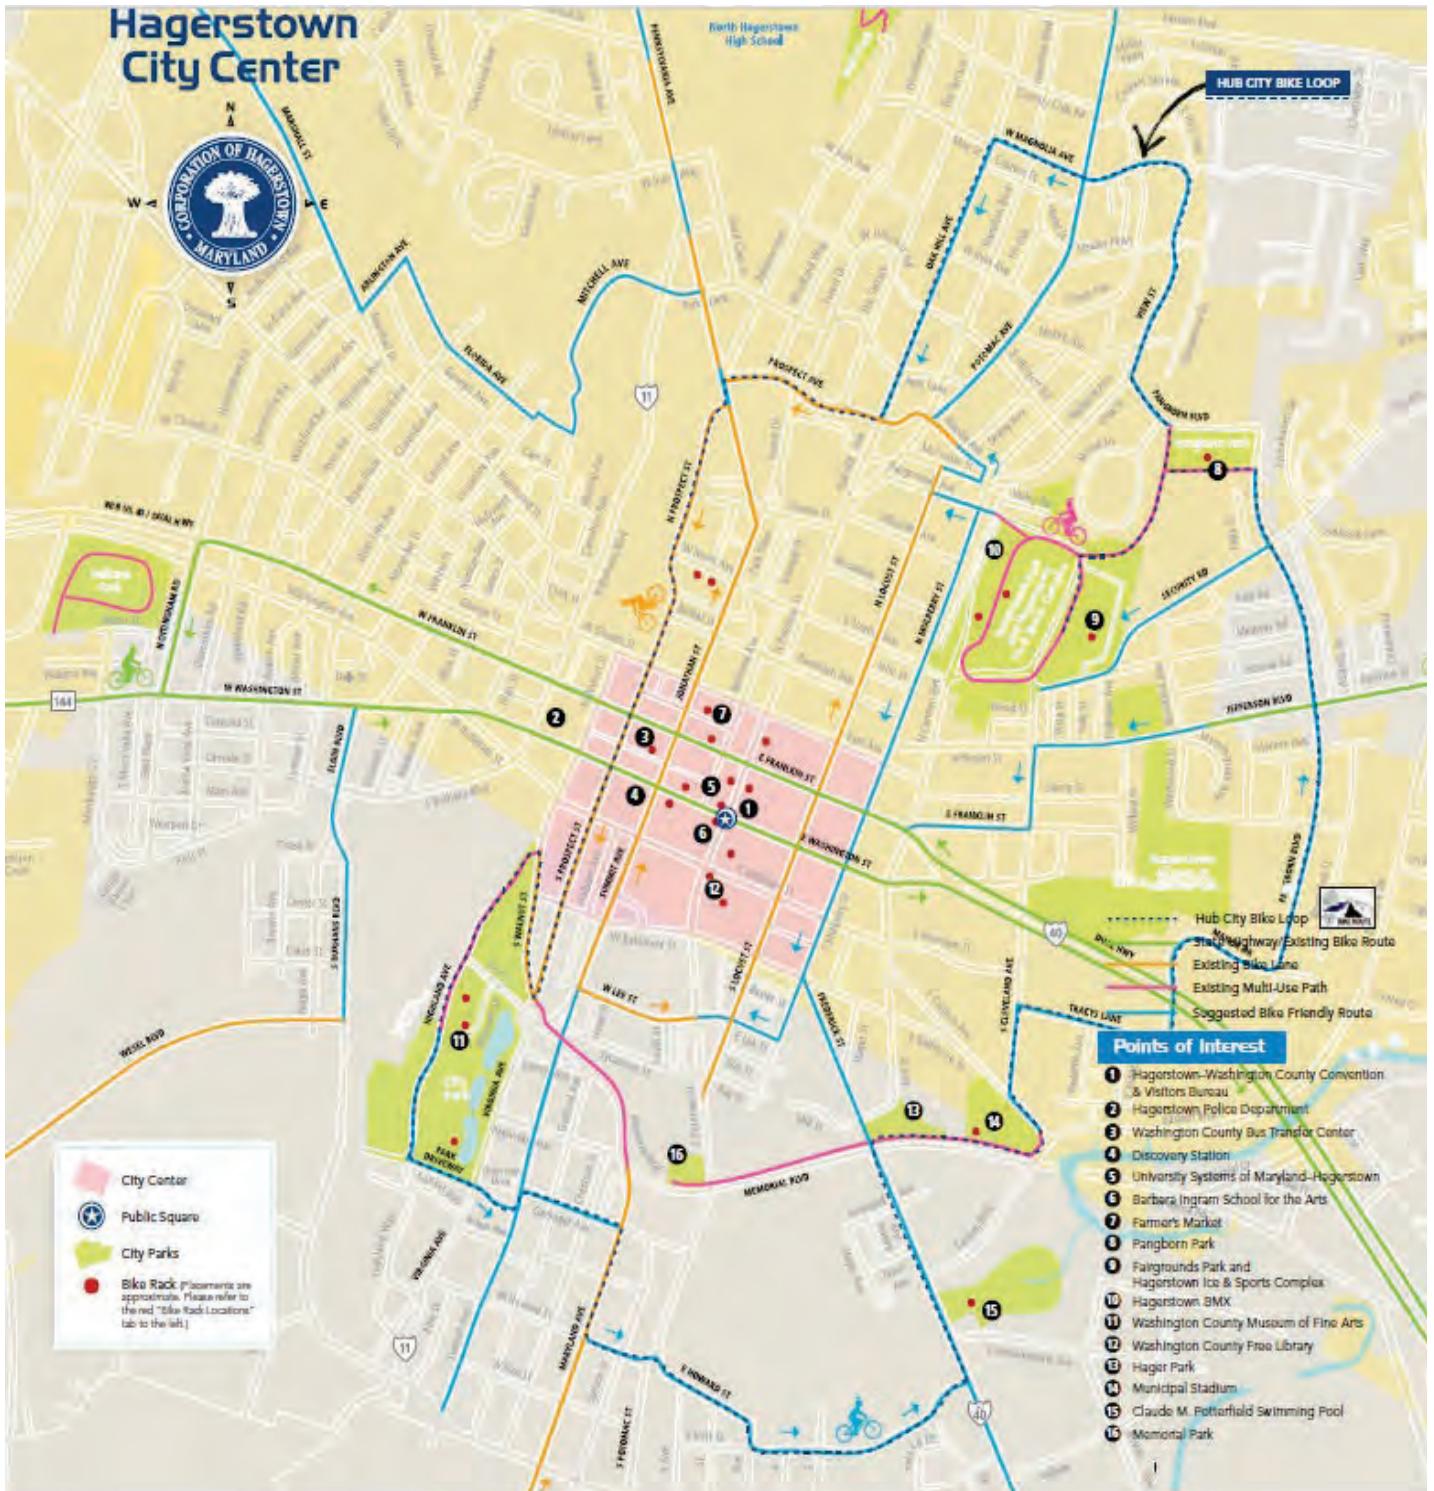
Figure 10. Hub City Bike Loop

The Hub City Loop is a 10-mile bicycle route through Hagerstown (some of which is in the BPPA) that includes off-street paths, on-street bike lanes, and lanes shared with vehicles (**Figure 10**).³

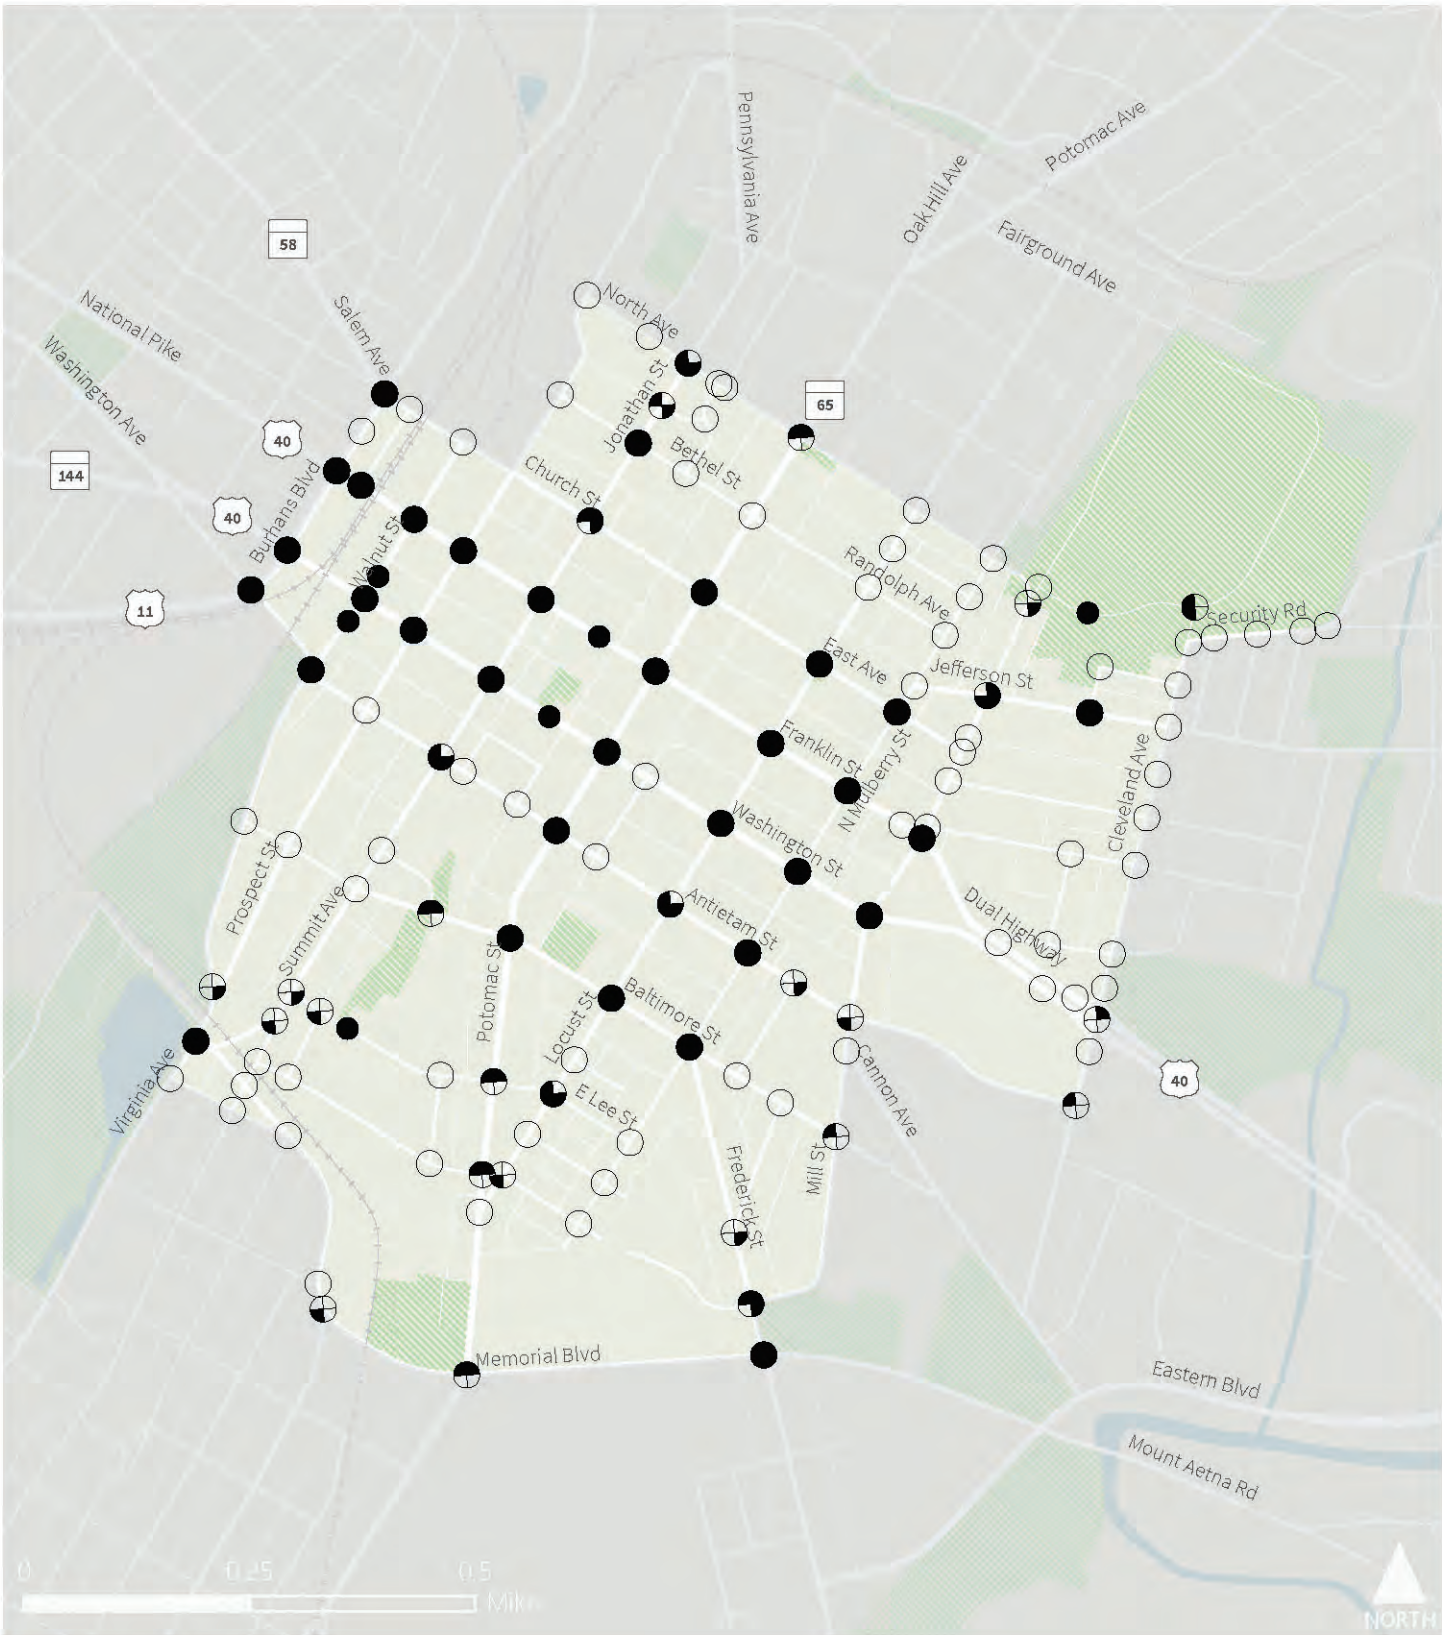
Figure 11. Existing Pedestrian Crosswalks

Note: Black slices show existing crosswalks per direction and blank slices show missing crosswalks per direction.

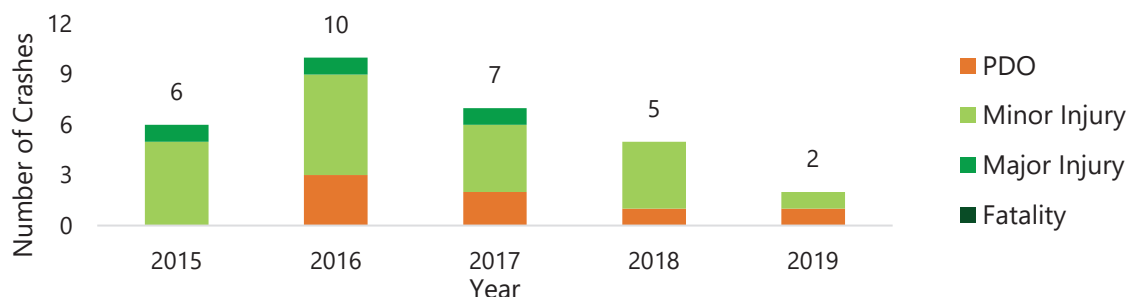
Figure 13. Bicycle-Related Crashes by Severity and Year

Figure 13 presents the severity of bicycle-related crashes by year. The number of bicycle-related crashes peaked in 2016, then fell each of the following years. Additionally, there were no bicycle-related crashes that resulted in major injuries in 2018 or 2019 (through August 18, 2019).

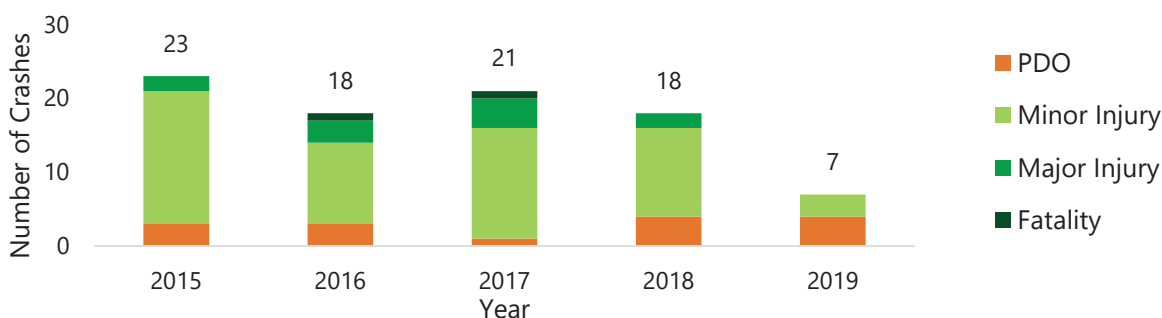
Figure 14. Pedestrian-Related Crashes by Severity and Year

As shown in **Figure 14**, the number of pedestrian-related crashes was relatively constant between 18 and 23 reported crashes each year from 2015 to 2018. Through August 18, 2019, there were seven (7) pedestrian-related crashes none of which resulted in major injuries or fatalities.

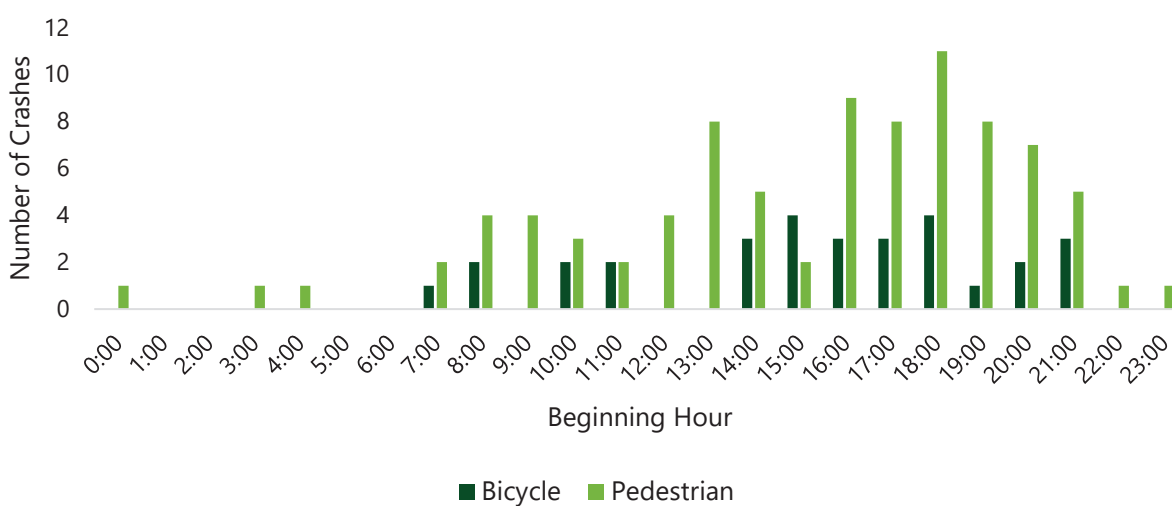
Figure 15. Bicycle- and Pedestrian-Related Crashes by Time of Day

Approximately 57% of bicycle-related crashes occurred between the hours of 2:00 PM and 7:00 PM. Pedestrian crashes peaked during the hour between 6:00 PM and 7:00 PM. Slightly less than half (49%) of pedestrian-related crashes occurred during the evening hours between 4:00 PM and 9:00 PM (**Figure 15**). The spatial dataset for the study area did not provide detailed information about lighting conditions; therefore, it is difficult to assess whether lighting was a factor in the crashes in the early evening hours. There were no bicycle-related crashes reported during the study period during overnight hours between 10:00 PM and 6:00 AM. During these overnight hours, there were five reported pedestrian-related crashes over the study period.

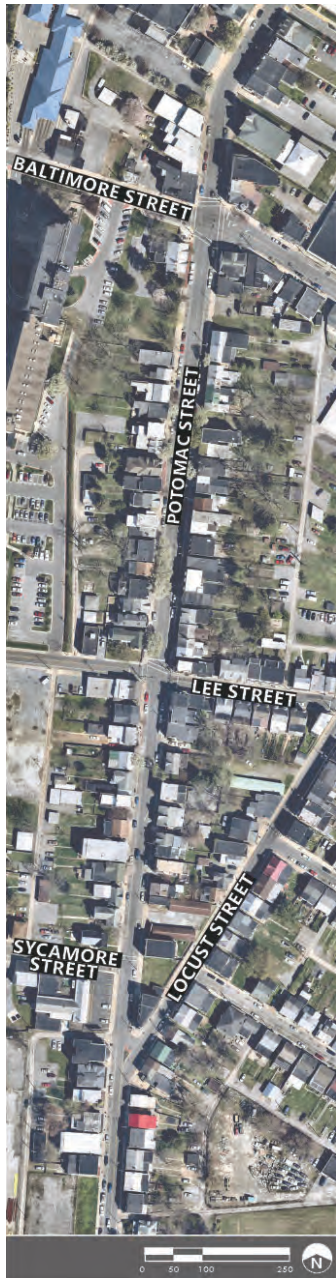
The reclaimed space, which represents 8 to 10 feet as shown in the cross-section image below, could also be used for a community arts project, stormwater management facilities, and/or dedicated corrals for resident’s trash cans.

Potomac Street between Baltimore Street and Locust Street.

For pedestrians, the sidewalk could be formally widened, or the pedestrian area could be extended into the street through the use of planters, wheel stops or flex posts as lateral buffers. If flex posts are preferred, an on-street parking demand survey is recommended. No parking occupancy data is available at the time of this report, but if the parking is generally well-utilized, bollards will likely provide enough of a barrier between pedestrians and motor vehicles traveling along Potomac Street. If the parking is not well-utilized, pedestrians may feel exposed or unsafe without a more formal barrier between them and moving traffic.

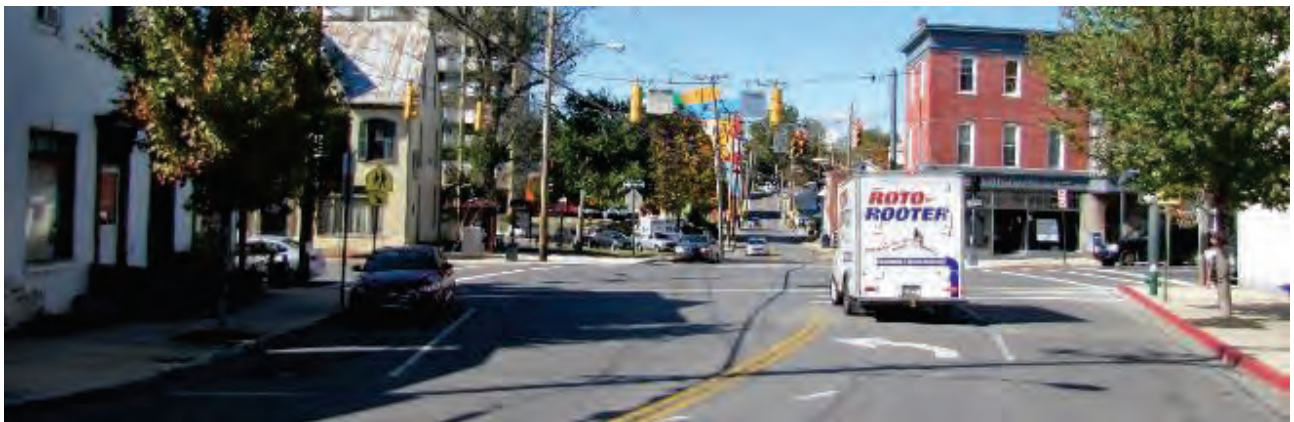
As depicted in the aerial and photo below, the westbound approach along Baltimore Street is far wider than the receiving lanes west of the intersection. This results in skewed crosswalk design and a long pedestrian crossing along the east crosswalk leg. Not only are there pedestrian challenges to this intersection design but it also is an unconventional experience for drivers - vehicles traveling westbound through the intersection must track left in order to end up on the receiving lane west of the intersection.

Super wide two-way two-lane Baltimore Street intersects with Potomac Street.

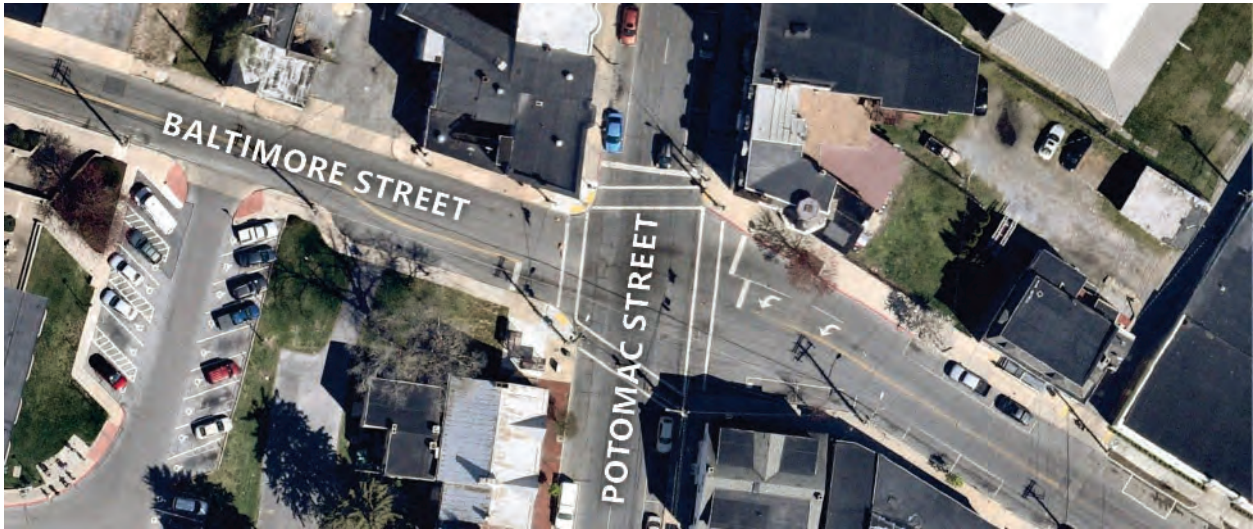
Satellite image shows Potomac Street at Baltimore Street intersection.

To improve the intersection, it is recommended that both the northeast and southeast corner curbs be modified, either through soft-scaping (flex posts, striping and the like) or hardscaping (raised curbs and the like). In response to the updated curbs, the crosswalks would be realigned. This adjustment would maintain sufficient right-of-way for both the existing westbound left-turn and through lanes, but it would improve safety and comfort for travelers through the intersection. The sketch concept below depicts roughly what the new intersection design could look like.

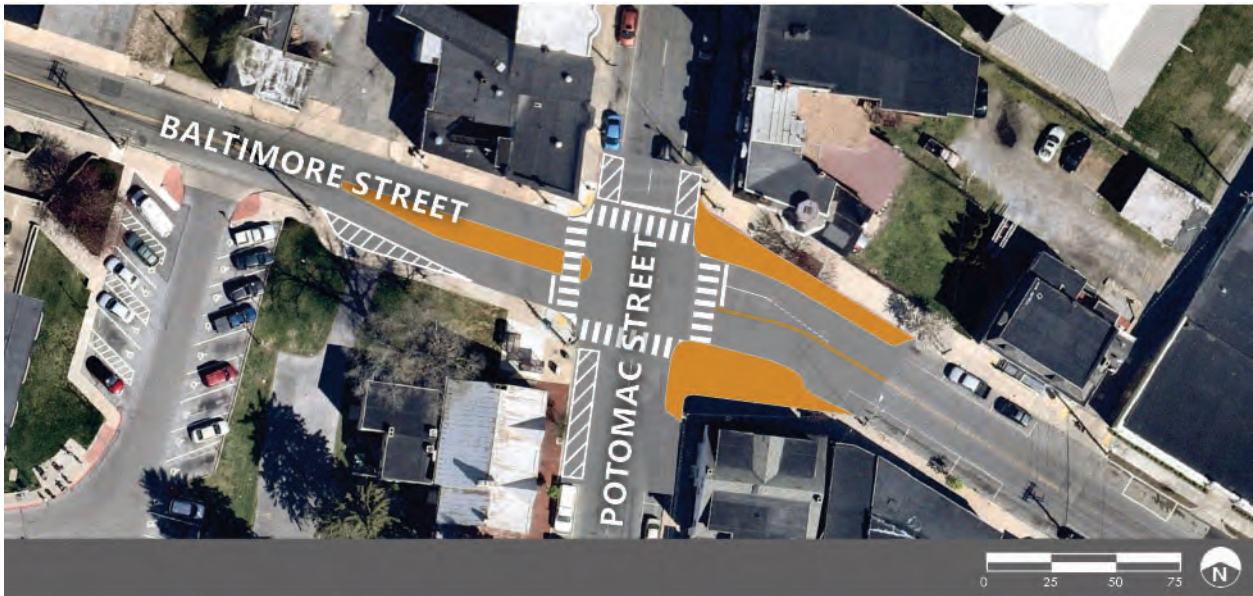
Extending the curb and reducing the crossing distance will improve pedestrian safety and visibility.

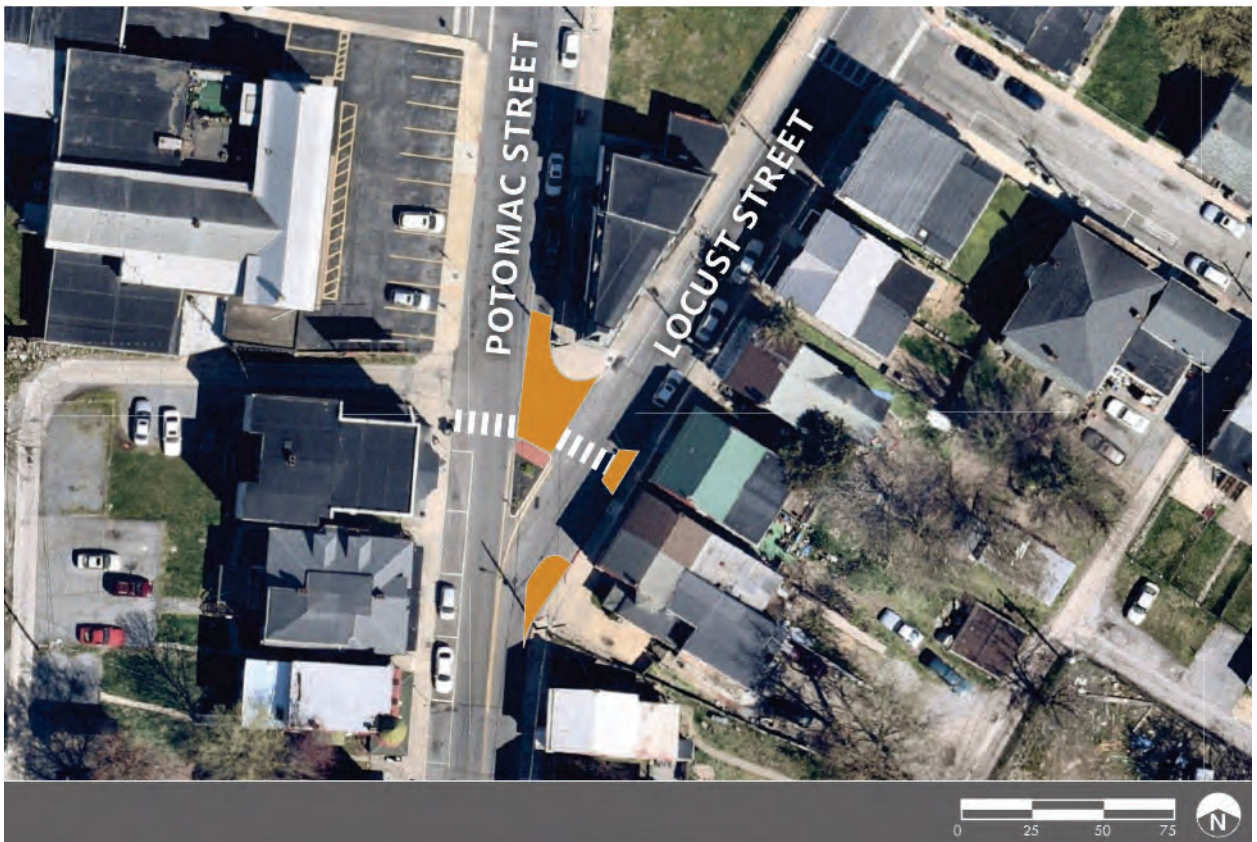
Closing the cut-through could improve pedestrian safety.

- **Closed Cut-Through with High Visibility Crosswalks:** By closing the cut-through to vehicle traffic, Hagerstown can create a small community meeting space in front of Locust Point Market. This space could be filled with chairs or picnic tables for residents or market patrons. In addition, high-visibility crosswalks are recommended across both Potomac Street and Locust Street, providing a direct crossing across the two roadways. The high-level concept included below provides an example of what revised intersection alignment could look like; a 2-stage crosswalk allowing pedestrians to cross a single lane of traffic.

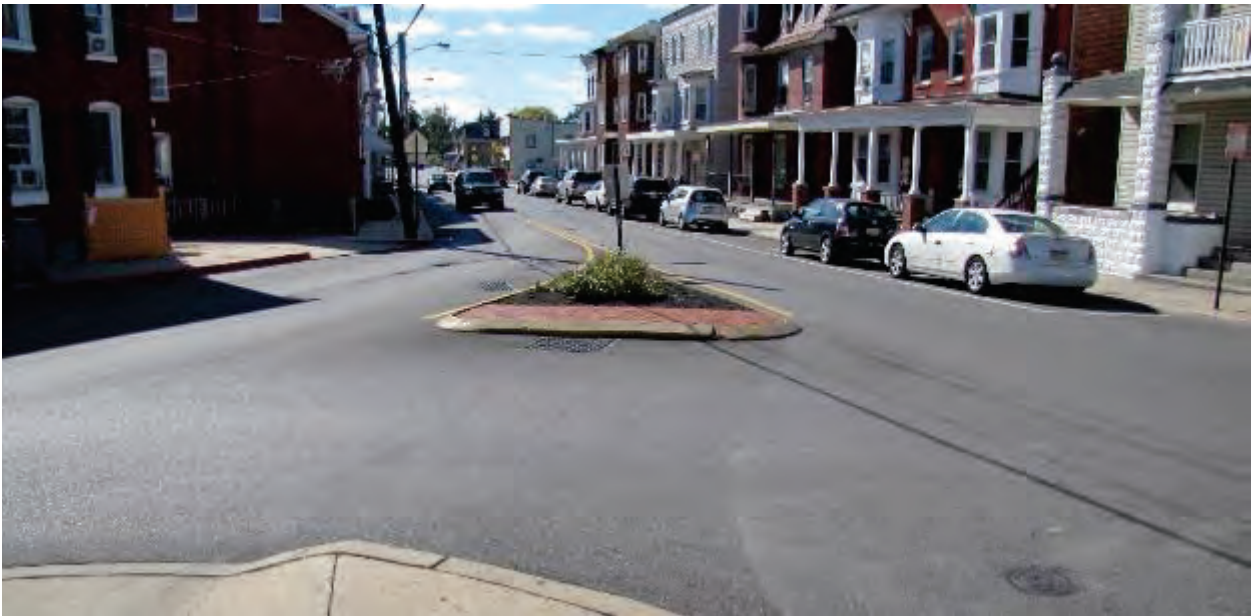
Lack of crossing marking or signage at Potomac Street and Locust Street can be a potential safety risk.

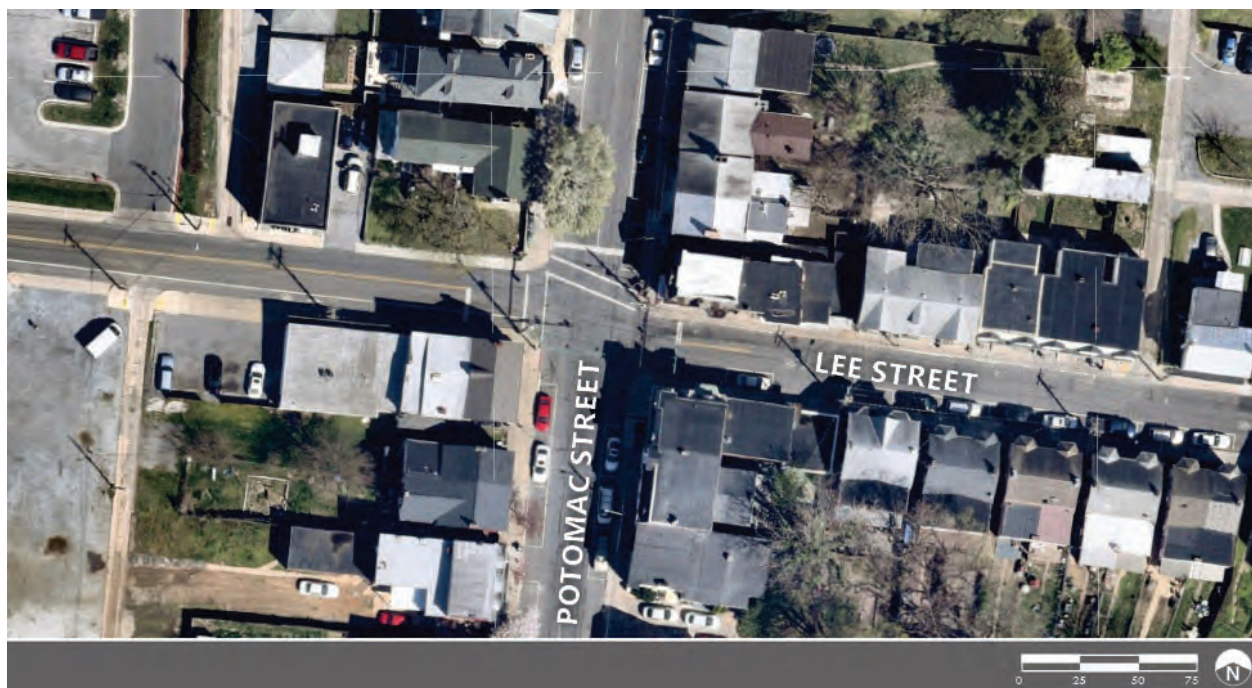
Satellite image shows Lee Street and Potomac Street showing incomplete crossing at the intersection.

The curb extension should be designed conscious of the right-of-way and drainage constraints, and it could be designed as stormwater management infrastructure for dual benefits of safety and environmental sustainability.

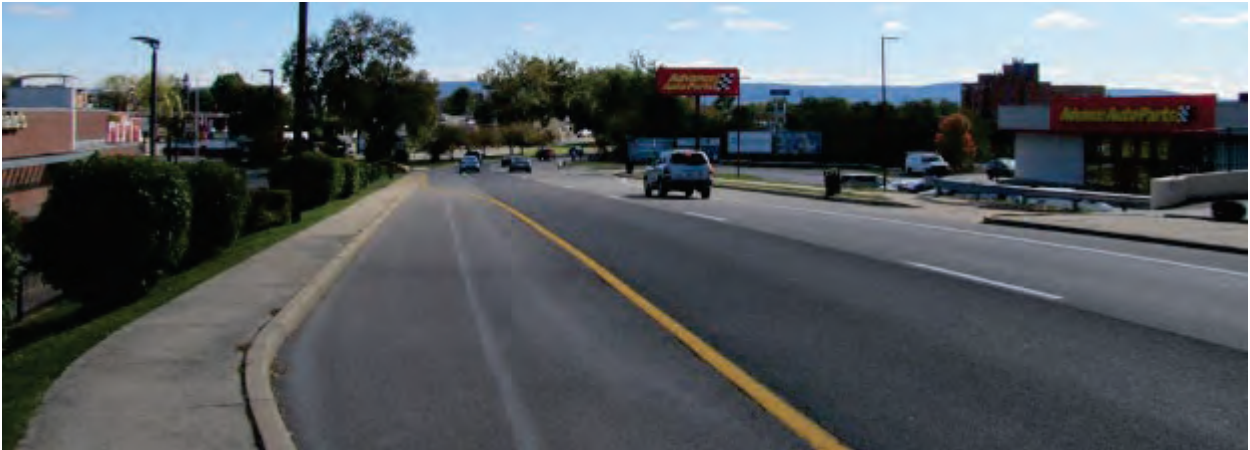
At East of Cannon Avenue, the roadway context changes from a dense grid with mainly mixed-use development to a high-speed arterial.

While drivers may anticipate seeing pedestrians on the grid network west of Cannon Avenue, they may not expect to see pedestrians or bicyclists east of Cannon Avenue. The change in block size, fronting improvements, and built form, like building set back from the street, creates a sense that this is an auto-centric place. The sidewalk gap in this area is likely contributing to pedestrians crossing the street through desire lines are also a factor. However, there are several destinations south of Washington Street, north of Franklin Street, and between the two streets that people travel to on foot or by bicycle. To address the safety concerns through this area, the following improvements are recommended:

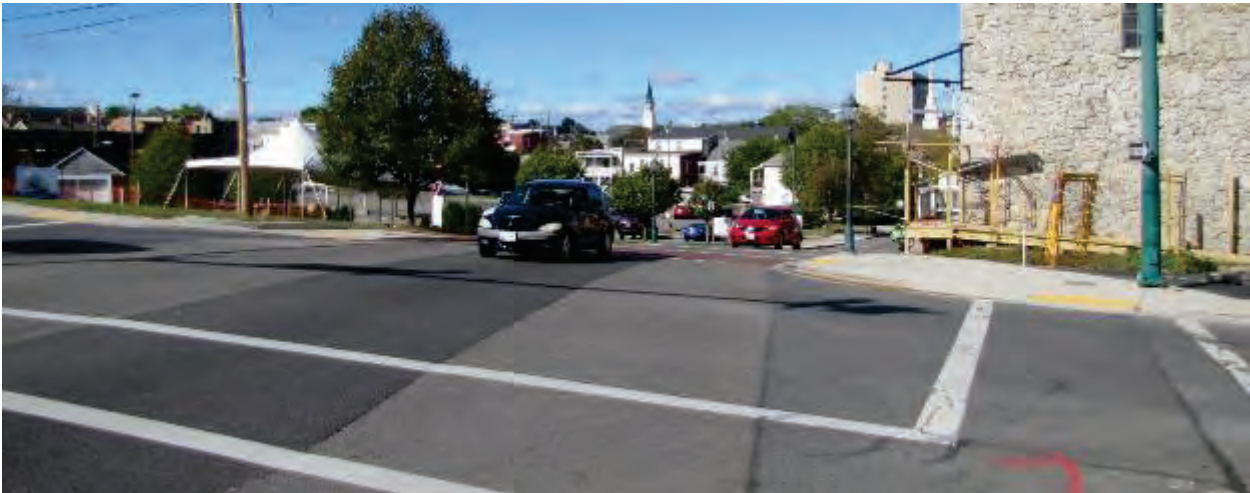
Drivers have poor sight distance over the hill, before the intersection of Washington Street and Cannon Avenue.

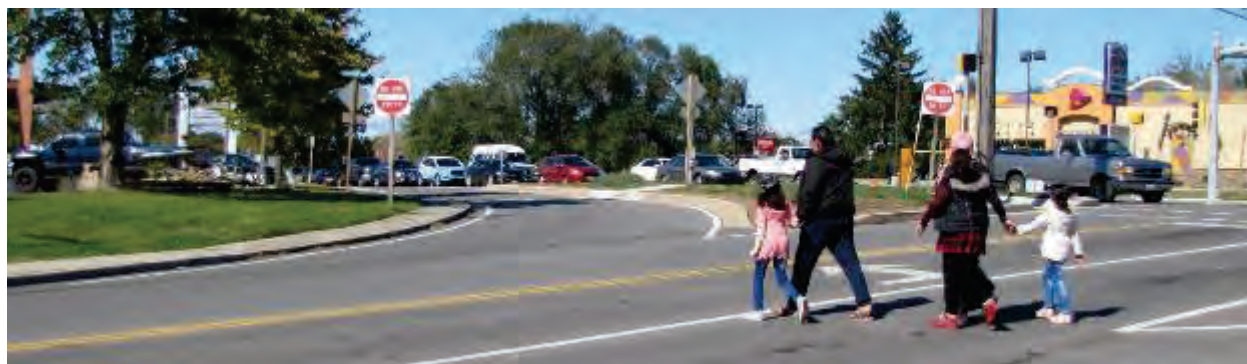
Pedestrians jaywalk across Cleveland Avenue rather than utilize the new crosswalks.

Even since the recent installation of crosswalks, unsafe crossings have been observed. Pedestrians generally want to take the shortest route possible and do not always use the designated crosswalk. Given the intersection configuration, pedestrians crossing Cleveland Avenue must cross three crosswalks: Cleveland Avenue itself as well as two channelized right-turn lanes (there are channelized right-turn islands at all intersection approaches). Removing the eastbound channelized right-turn has been discussed but has not been prioritized for implementation.

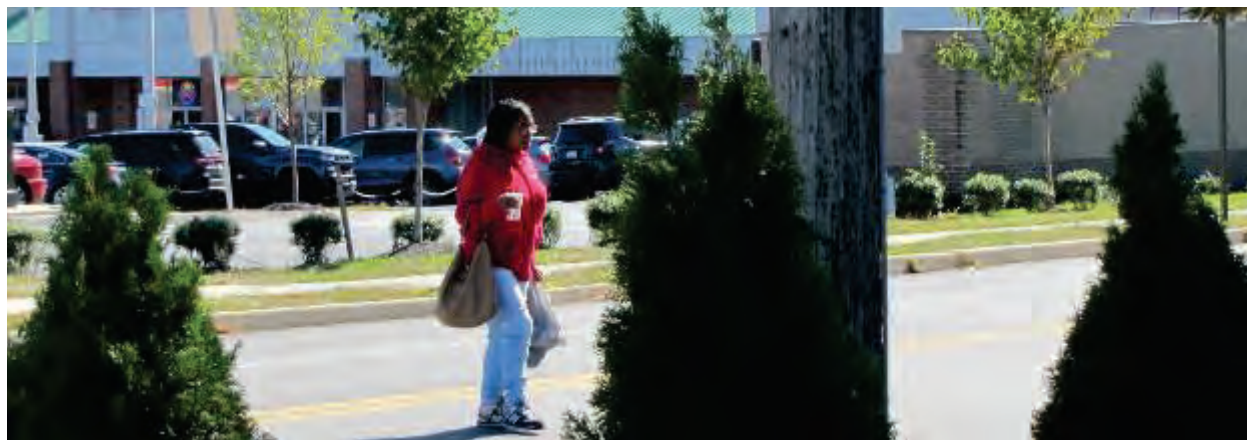
Unsafe mid-block crossing occurs with at Cleveland Avenue near Dual Highway.

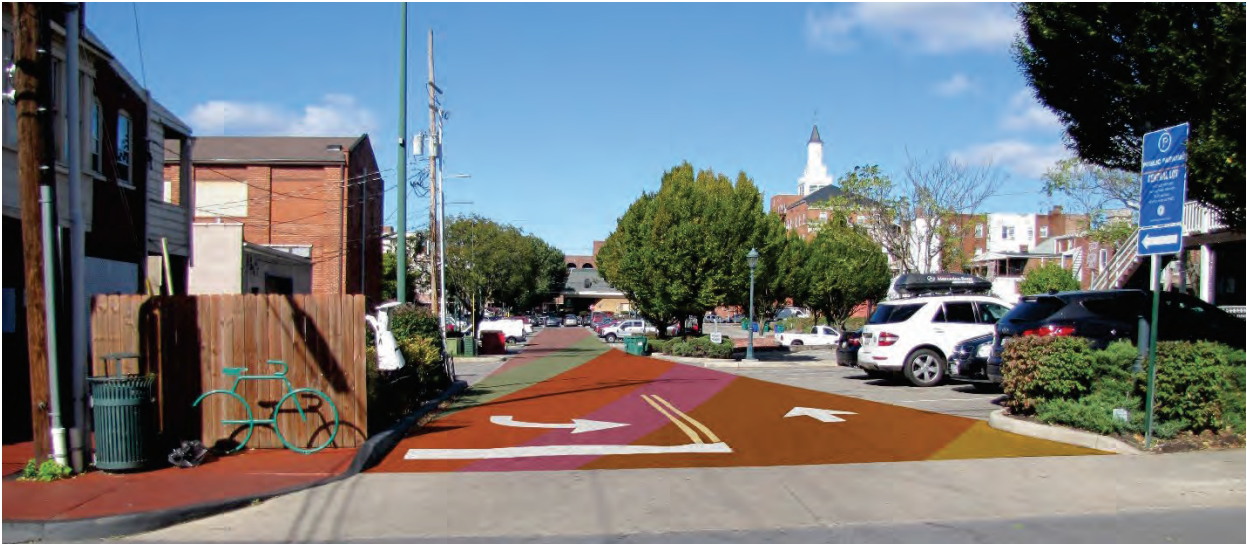
Use pavement colorization or pavers (opportunity to reduce impervious surface of the alley) to demarcate the bike and pedestrian travel route

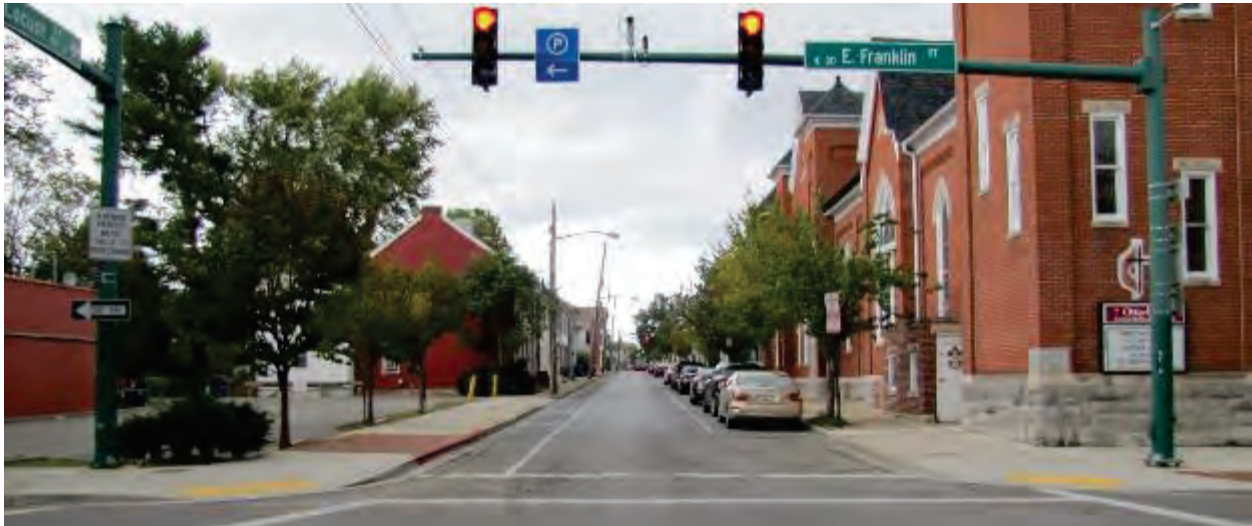
While there are marked crosswalks at the intersection of Franklin Street and Locust Street, there is no pedestrian signal indicating when pedestrians should cross.

A pedestrian signal head provides traffic signal indications exclusively intended for controlling pedestrian traffic. The signal indications generally consist of illuminated symbols of a walking person (symbolizing “walk”) and an upraised hand (symbolizing “don’t walk”). All signalized intersections with marked crosswalks are candidates for pedestrian signal heads.

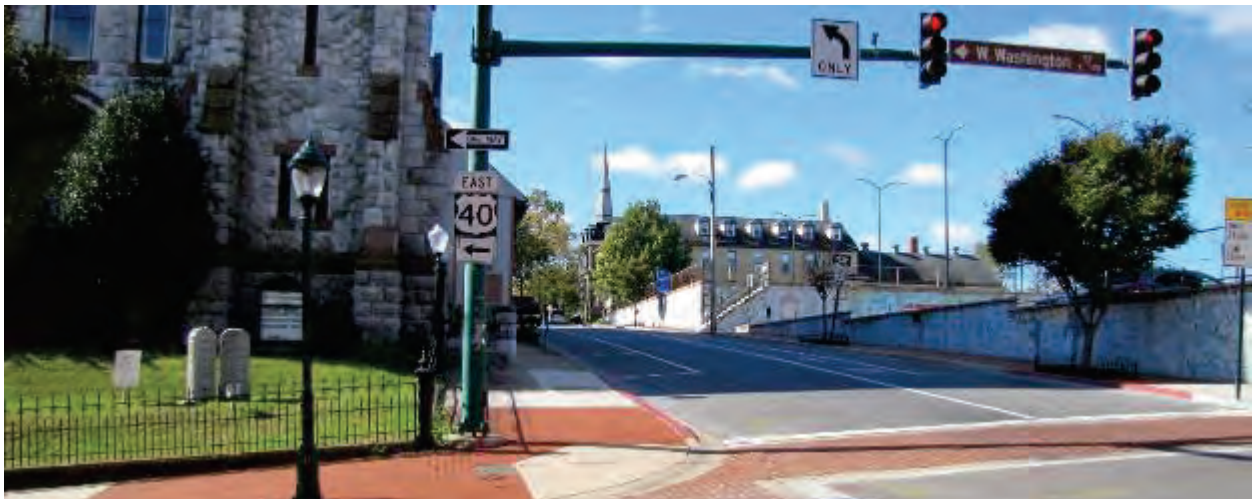
The intersection of Washington Street and Prospect Street includes a decorative crosswalk. Adding a pedestrian signal head would indicate to pedestrians when it is permitted to cross the street.

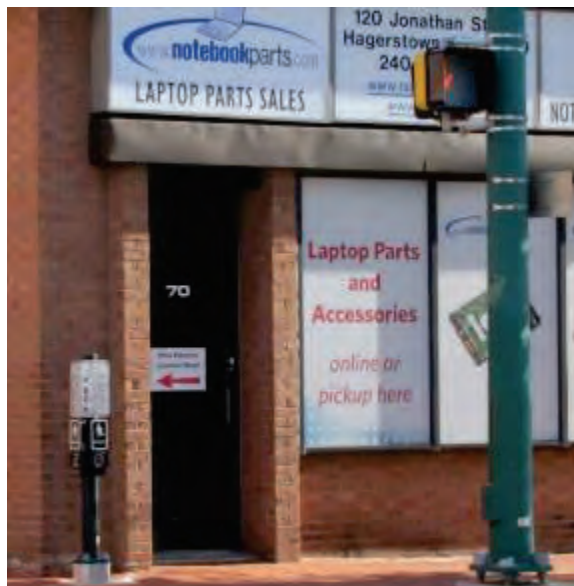
The pedestrian push buttons at Franklin Street and Jonathan Street are co-located and do not have an audible notification to pedestrians.

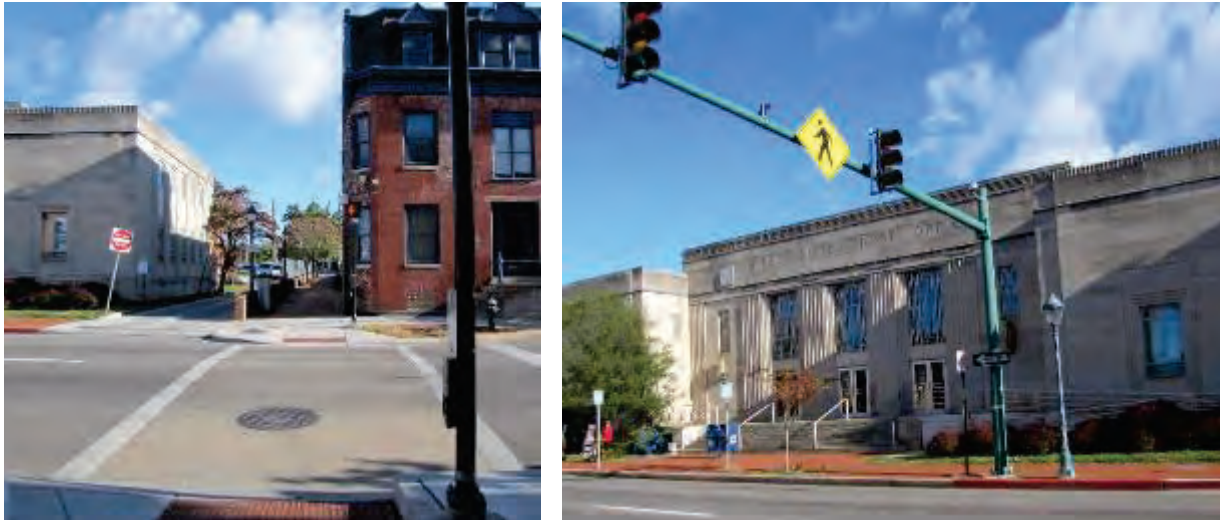
On Franklin Street, there is a signalized mid-block crossing in front of the Post Office (between Jonathon Street and Potomac Street).

There are multiple locations in the Hagerstown BPPA where mid-block crosswalks are signalized, specifically on both Franklin and Washington Streets between Jonathan and Potomac Streets. Signalized midblock crosswalks are generally helpful or essential where there is a high demand for pedestrian travel on high volume roadways, where vehicle gaps are infrequent, in school zones, where older pedestrians travel, and where vehicle speeds are high.

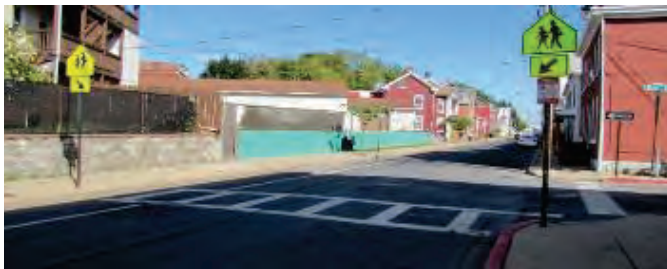
There is an uncontrolled marked crosswalk across Locust Street at Ray Street.

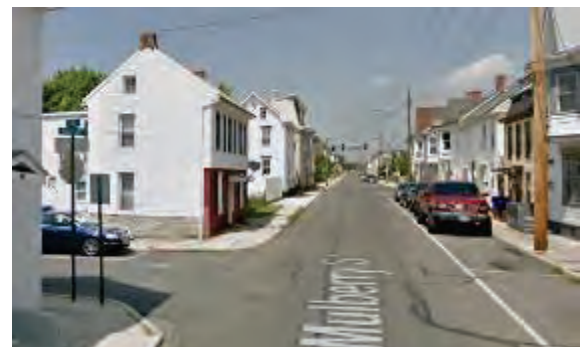
An uncontrolled marked crosswalk could be added across Mulberry Street at John Street.

There may be some locations where uncontrolled marked crosswalks are appropriate (e.g. T intersections where just the minor approach is stop-controlled, e.g. John Street at North Mulberry Street). Overall, uncontrolled pedestrian crossing locations correspond to higher pedestrian crash rates. These treatments should only be considered along low volume, low speed roadways. On roadways with higher volumes, additional treatments may be appropriate, such as crosswalk visibility enhancements, a raised crosswalk, pedestrian refuge island, pedestrian hybrid beacon, or a rectangular rapid flashing beacon

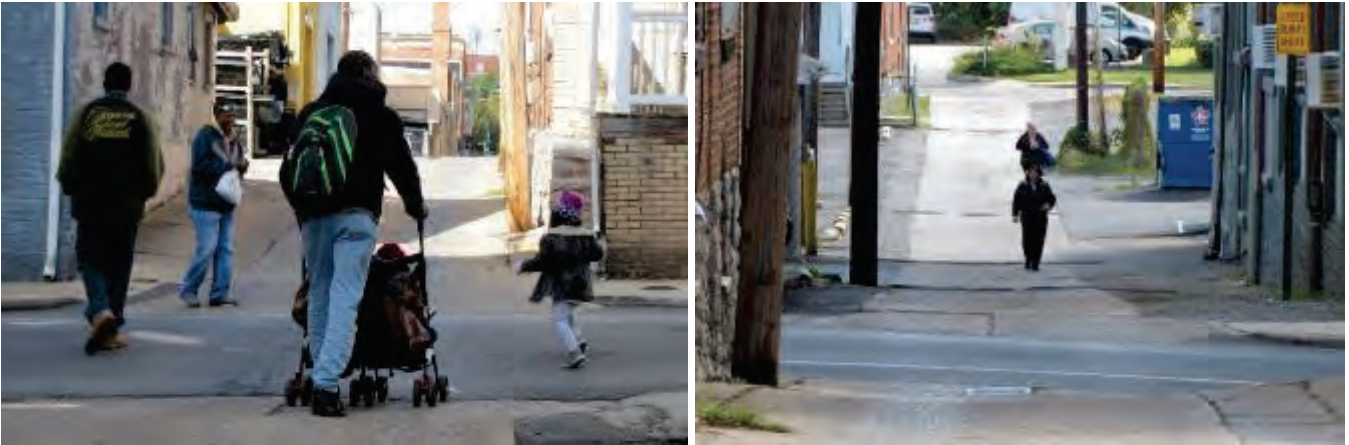
Pedestrians are crossing Mulberry Street to stay on the alley between Franklin Street and Washington Street. The crossing is not marked.
