BICYCLE & PEDESTRIAN
PRIORITY AREA PLAN

City of Hagerstown &
Maryland Department of Transportation State Highway Administration

May 2020

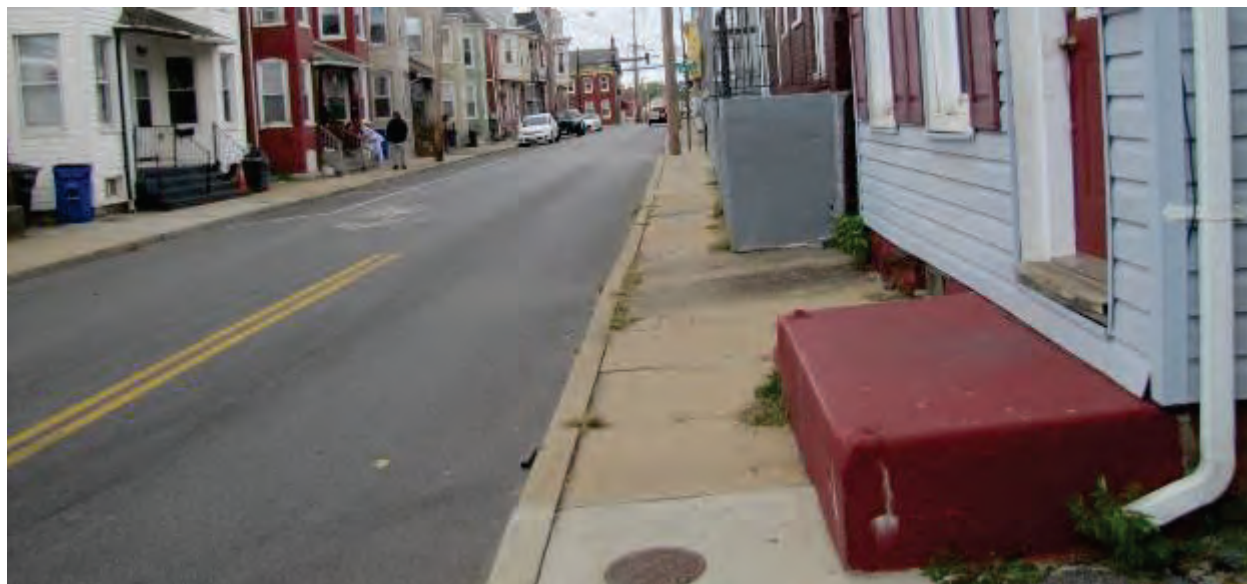
Residential stoops encroach on the sidewalk, narrowing space for pedestrians (Lee Street between Locust Street and Potomac Street).

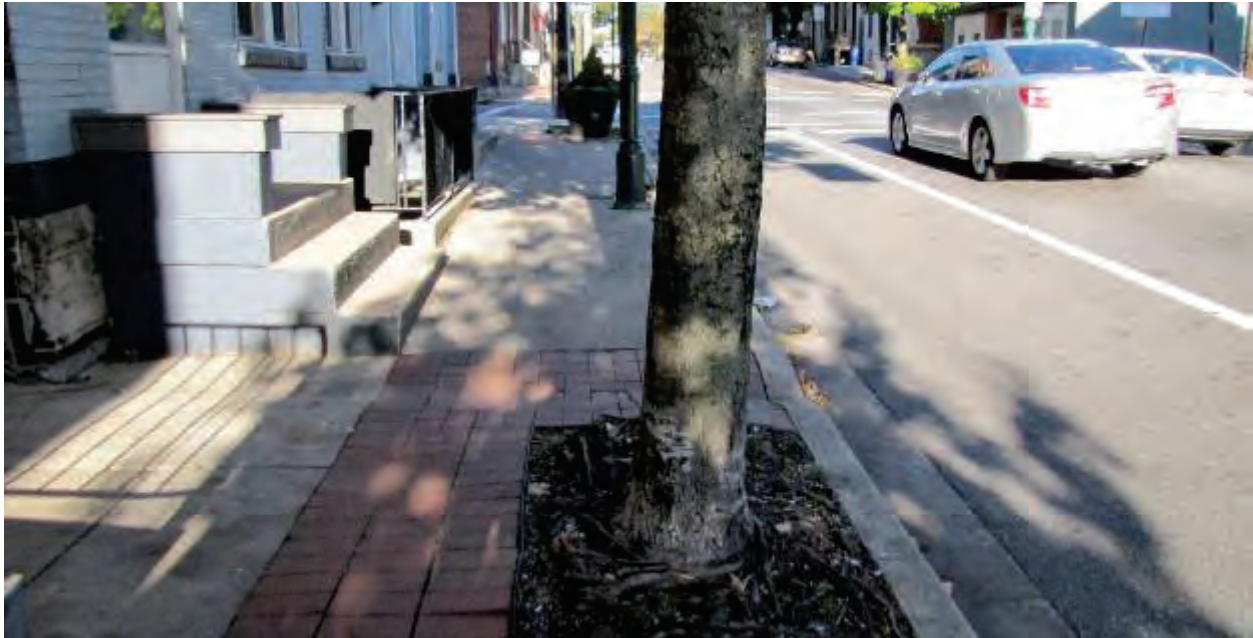
Signs, lamp posts, and trees narrow the throughway for pedestrians (Franklin Street between Mulberry Street and Cannon Avenue).

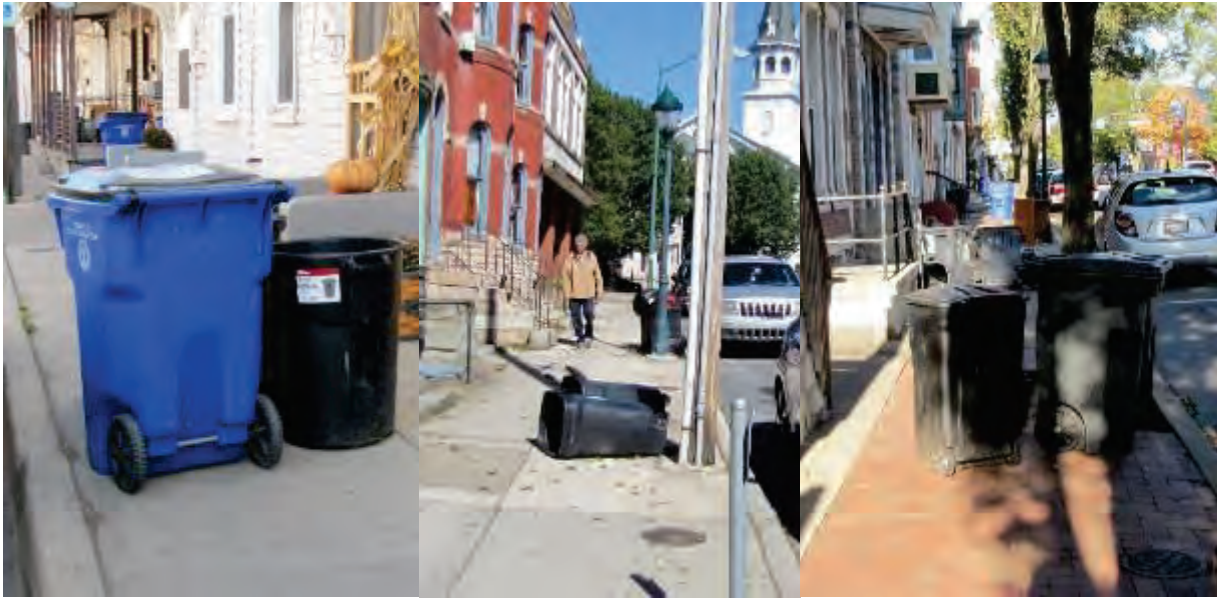
Trash cans block sidewalks on Locust Street (left), Potomac Street (middle), Franklin Street (right) limiting space for pedestrians.

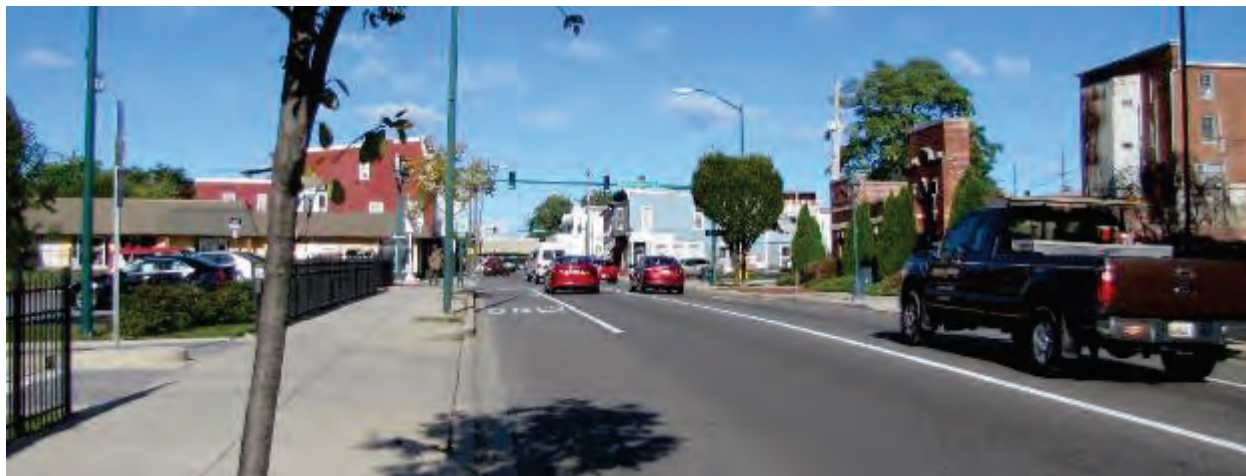
Left-turn lane on Franklin Street between Jonathon Street and North Prospect Street.

Along Franklin Street, which runs one-way westbound through the BPPA, there are left-turn lanes at almost every intersection, and the left-turn lane often extends hundreds of feet back from the intersection. As a one-way street, there is no oncoming traffic preventing left-turn movements during a green phase. In addition, these left-turn lanes are often very narrow and not meeting design standards. During field observations, vehicles were observed only transitioning into the turn lane just before arriving at the intersection as well as not fully merging into the left-turn lane (instead straddling the solid or dashed white line dividing the through lane from the left-turn lane).

It's recommended that Hagerstown review the left-turn lanes along Franklin Street and consider converting these left-turn lanes into on-street parking. On-street parking would slow vehicles on Franklin Street, and it would provide a buffer between pedestrians and vehicles walking along the roadway. This evaluation would include understanding the volumes of the left-turn movements along Franklin Street and the impact to traffic flow of removing left-turn lanes. The City should consider implementing LPIs at these locations as well.

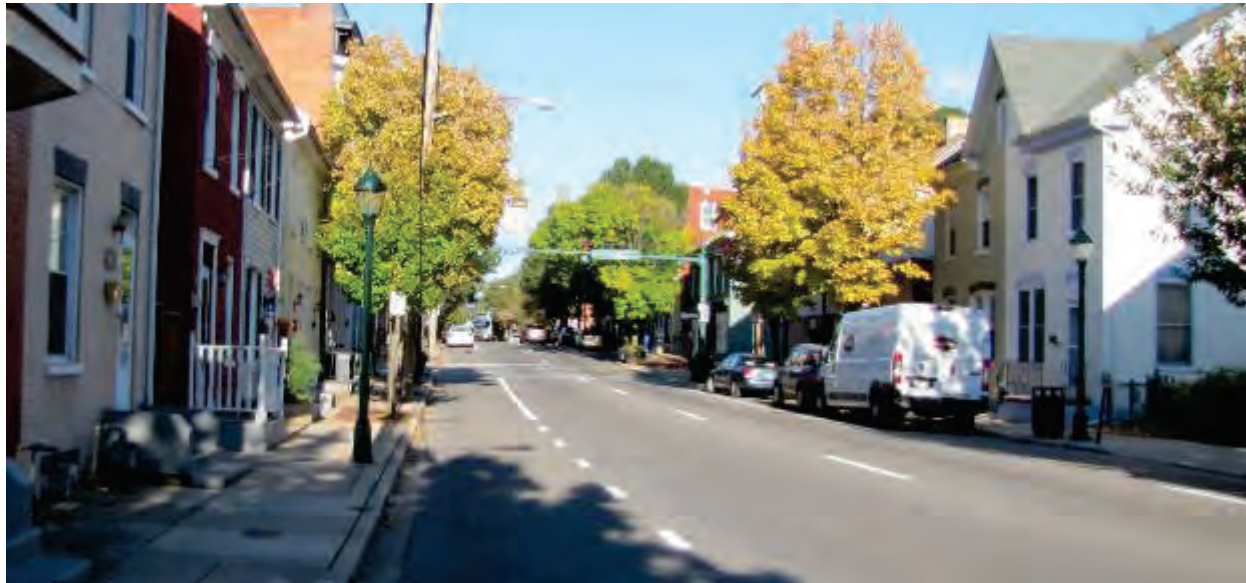
Left-turn lane on Franklin Street between Cannon Street and Mulberry Street.

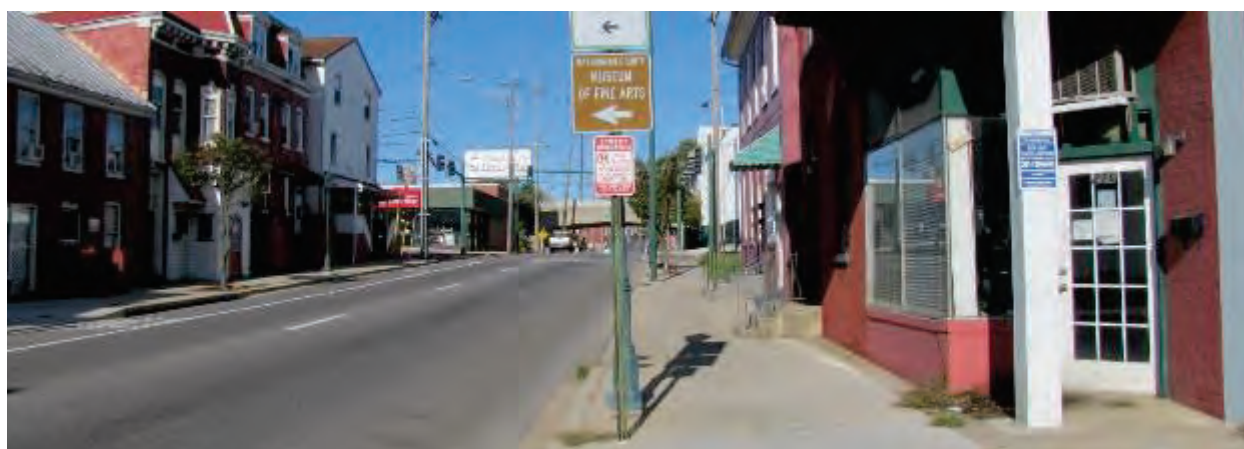
The wide right lane on Franklin Street may be used for on-street parking (between Walnut Street and Prospect Street).

There are some locations throughout the BPPA where on-street parking is marked with a full box, while other locations include "T" markings for the corners of on-street parking spaces. In some locations, on-street parking in the BPPA is permitted, but not marked. Unmarked on-street parking is appropriate on low-volume, low-speed streets, such as Baltimore Street between Prospect Street and Summit Avenue. However, when parking is unmarked on high-volume or high-speed streets, it may be perceived as a wide lane where vehicles can speed up. For example, on-street parking is not marked on Franklin Street between Walnut Street and Prospect Street. It is recommended that on major streets through the BPPA that Hagerstown stripe on-street parking. This will narrow the actual (and perceived) lane of vehicle travel, and in turn, could lower vehicle speeds along the corridor.

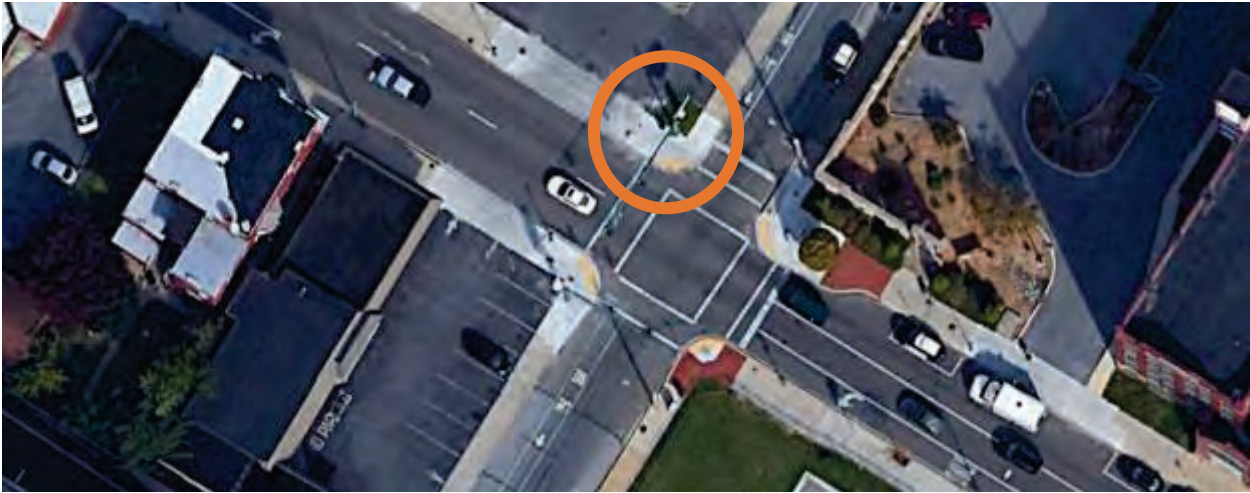
Candidate for bulb out on northwest corner of Prospect Street and Franklin Street.

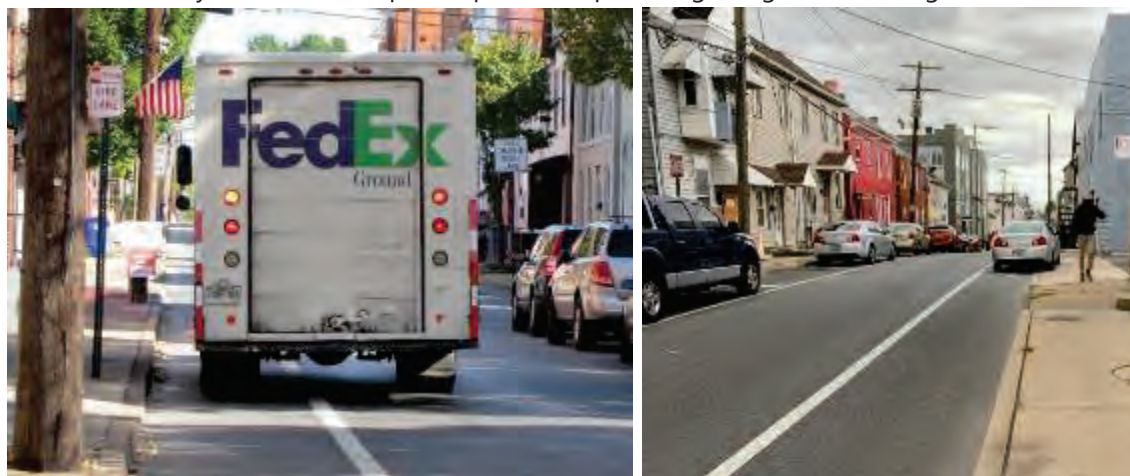
Parking enforcement can reduce parking freight deliveries occurring in the bike lane on Locust Street (left) and Mulberry Street (right).

While installing bicycle facilities is a critical step to improving safety for bicyclists, those safety benefits are only borne out if the bike lanes are unobstructed. During field observations, several vehicles were noted parking or standing in the bike lane. When this occurs, bicyclists must maneuver out of the bike lane into lanes shared with vehicle traffic. Regular enforcement of bicycle lane obstructions could reduce the occurrence of these bicyclist safety challenges. In instances where delivery vehicles are routinely block bike lanes, it may be useful to explore options for providing designated loading zones.

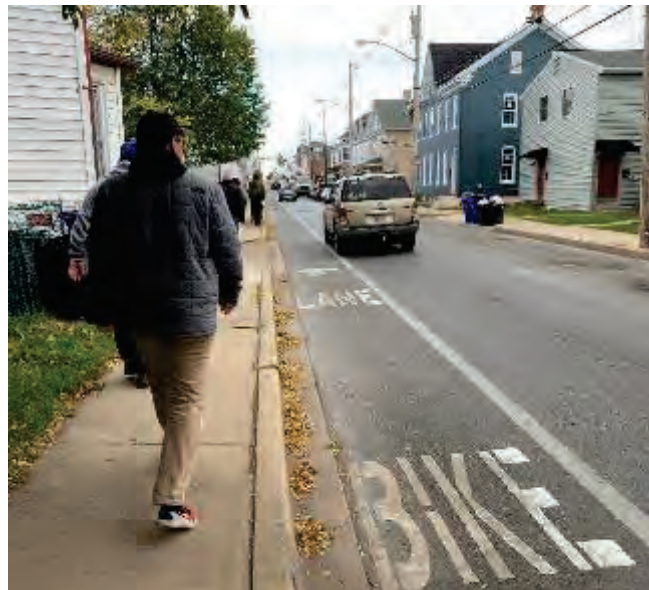
A bike lane runs on the left side of South Locust Street

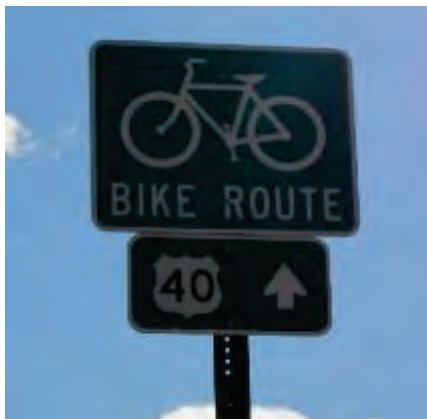
Bike route sign near West Washington Street points at the beginning of the route on US 40.

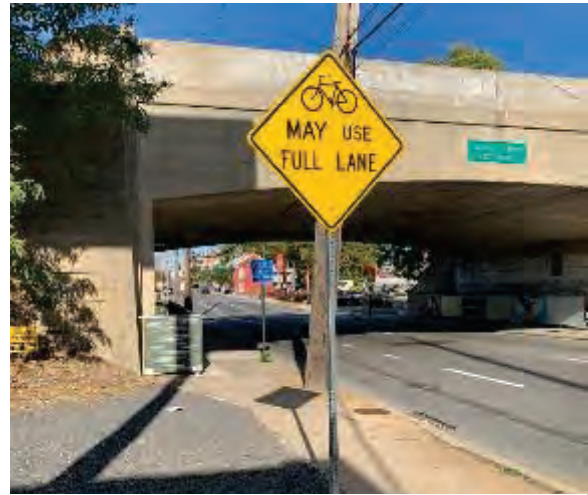
The yellow sign guides drivers to share lanes with bicyclists on the shared lanes.

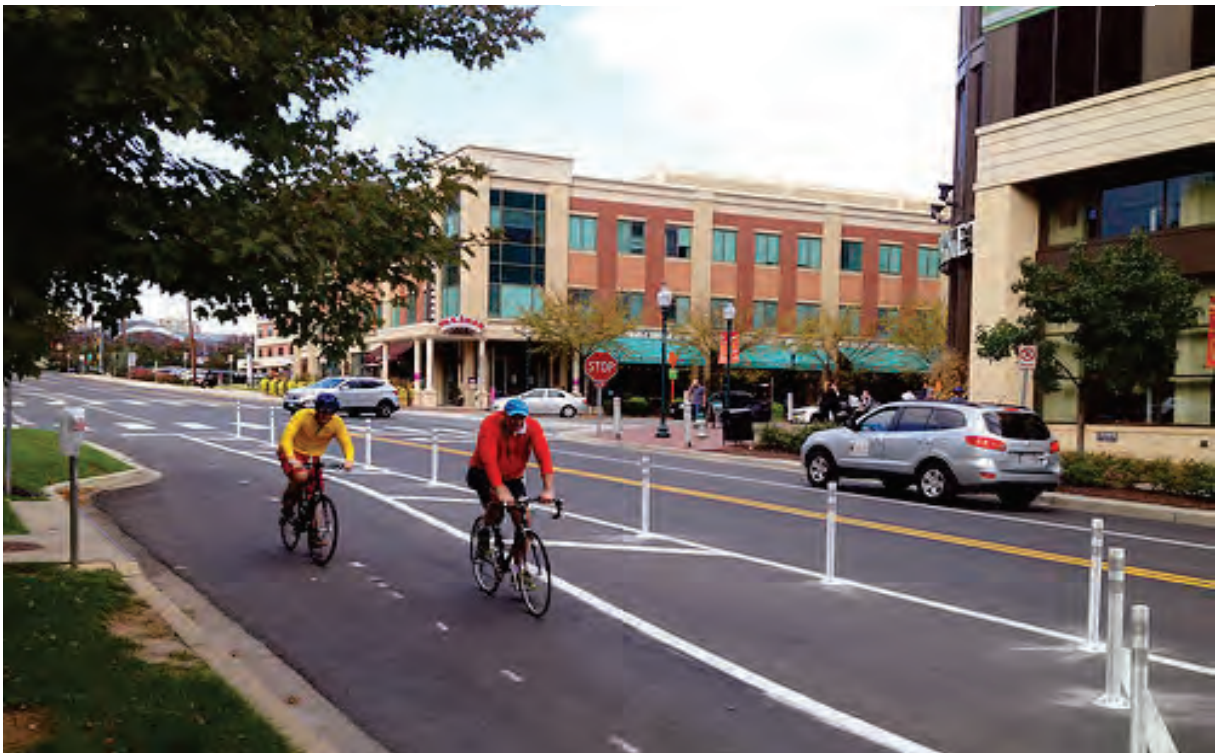
On-way protected cycle track on the left is separated using marking, flexible delineator post at Woodglen Drive cycle track (photo from GGW)

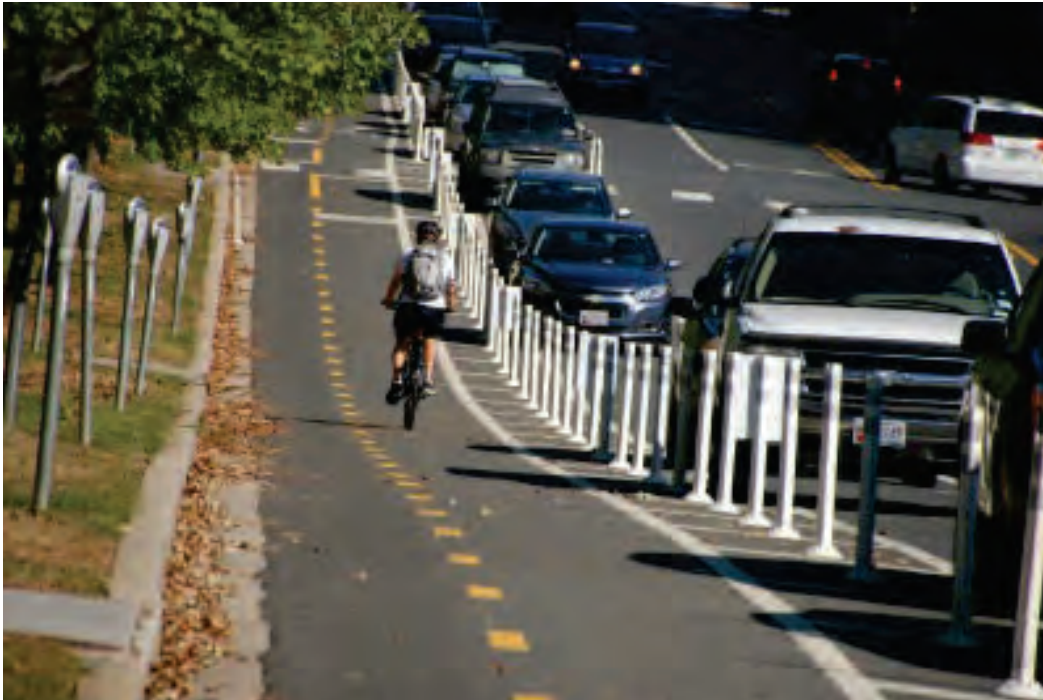
People are biking on buffered bike lanes where a wide marking separates them from the auto lane on Woodglan Drive, Rockville, MD (photo from MCDOT)

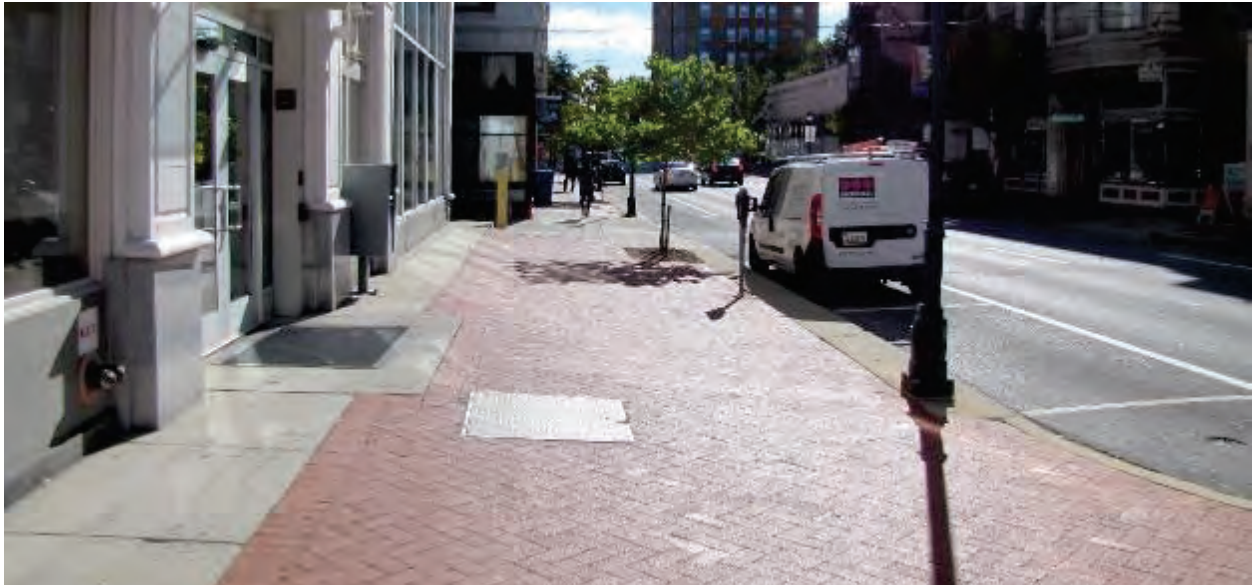
- **Sidewalks** should be accessible continuous routes for all people including those with disabilities, per ADA citation, to access schools, transit stations, and any other destinations.

Sidewalks are wide and perfectly paved on West Washington Street near University System of Maryland at Hagerstown.

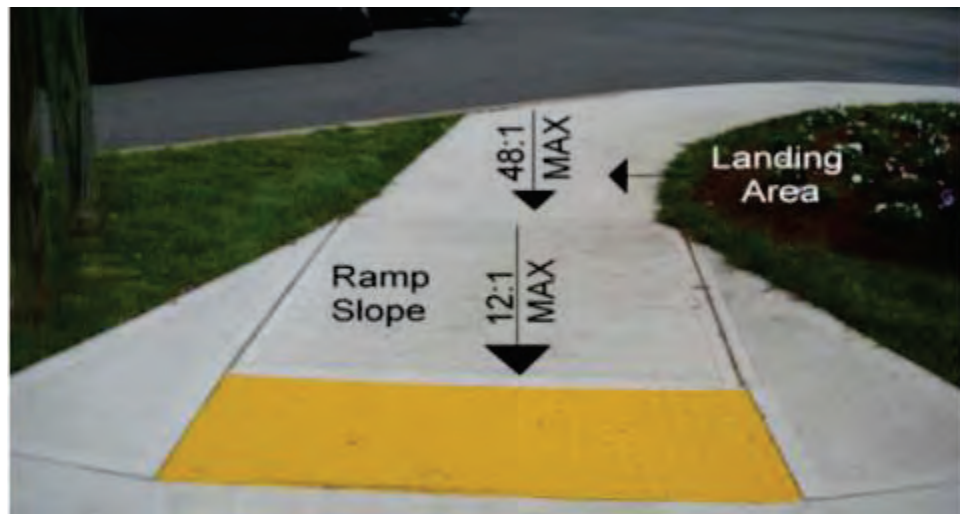
- **Ramps** should provide pedestrians a walkway at intersections with curbs. Maryland has three standard ramp types including paired perpendicular ramps for one corner and two diagonal ramp standards for other skewed intersections.

Maryland standard ramp 655.11 connects a corner of sidewalk to ADA area.

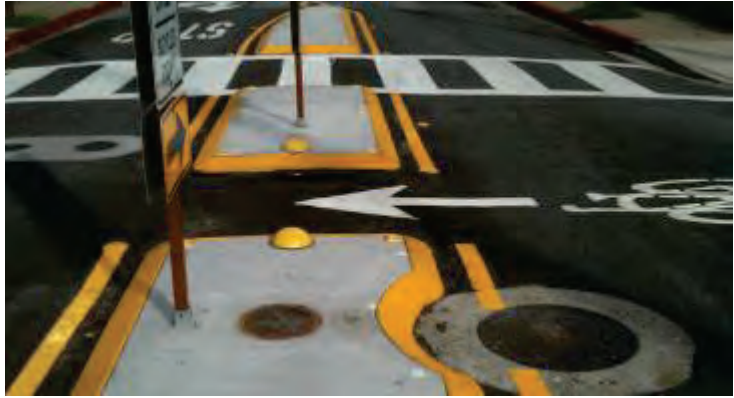
- **Raised medians** are “points of refuge for pedestrians” to reduce the crossing distance access to the opposite side of a road.

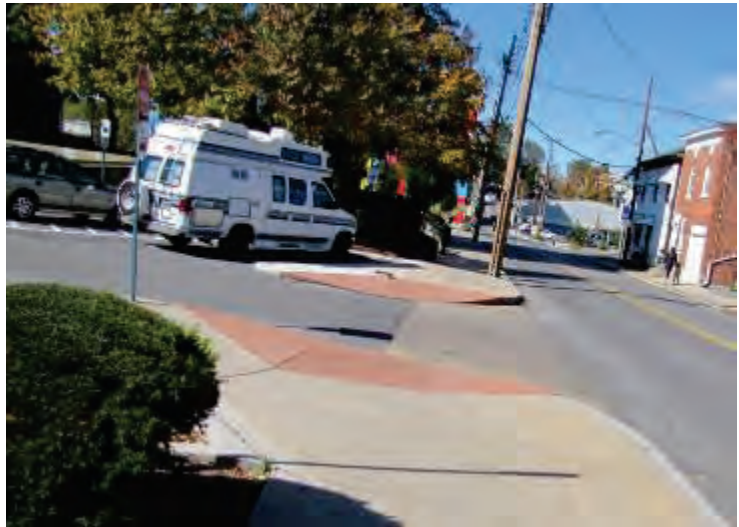
- **Driveway crossings** are where “pedestrian pathway crosses a driveway or entrance.”

A driveway crossings connect sidewalks at a parking lot entrance in Hagerstown.

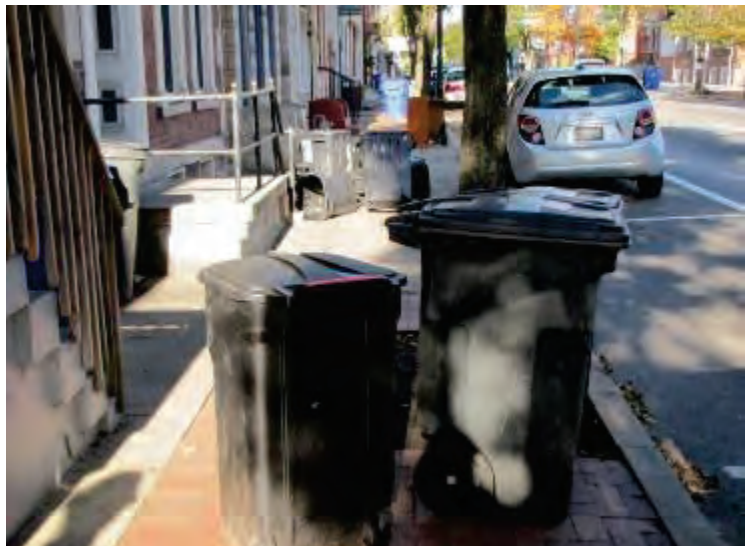
- **Protruding objects** are utility poles, mailboxes, signal poles, signal boxes, signs, and any other objects that “cause challenges to pedestrians specially a person with a disability”.

Trash cans blocking a sidewalk on East Franklin Street.

It is recommended that Hagerstown integrate complaints associated with trash can storage into its existing 311 program. In addition, where possible, Hagerstown could consider removing parking spaces to create “corrals” for trash can storage, similar to a bicycle parking corral. Where no physical change can be made, the City could consider the use of paint within the sidewalk environment to better designate where in-sidewalk trash receptacle should be placed so as not to impede pedestrian travel.

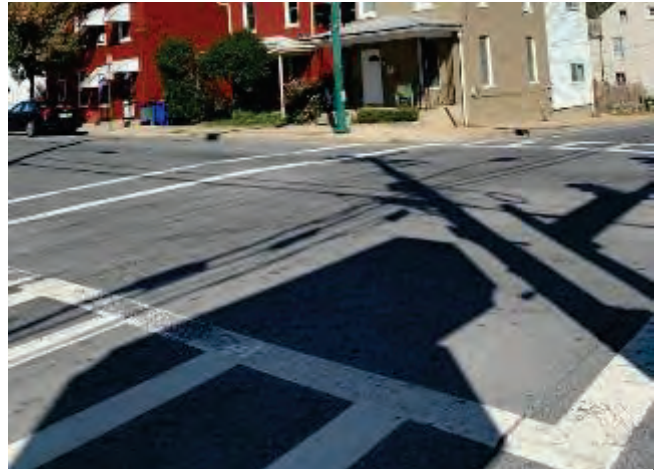
- **Crosswalks** are connections of sidewalks at a junction of two or more roadways with pedestrian markings.

Crosswalks are located on two sides of East Baltimore Street and Locust Street.

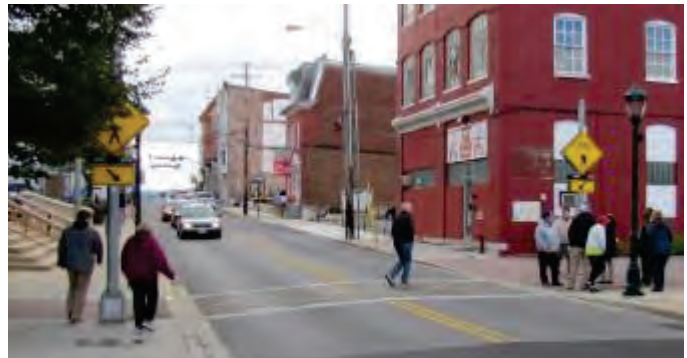
- **Mid-block crossings** are non-intersection pedestrian crossings requiring pedestrians to activate flashing yellow lights.

Mid-block Crossing marking and beacons at Antietam Street is a safe accommodation for pedestrians.

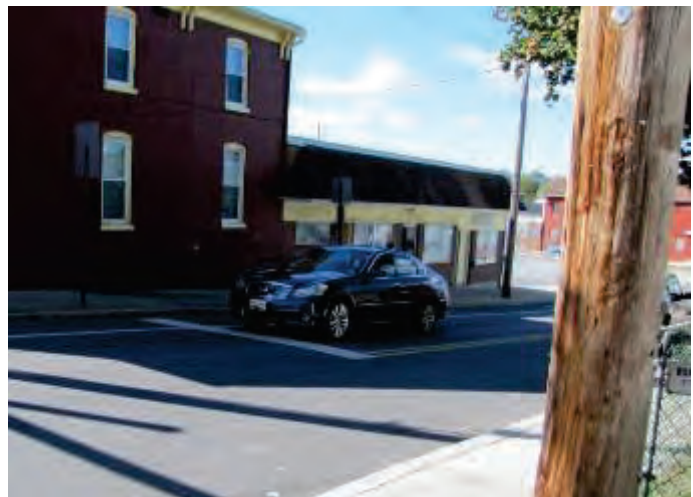
- **Stop lines** are parallel to the crosswalk to ensure visibility for both pedestrians and motorists at intersections.

A car stopped at the stop line ahead of the intersection of East Lee Street and South Potomac Street.

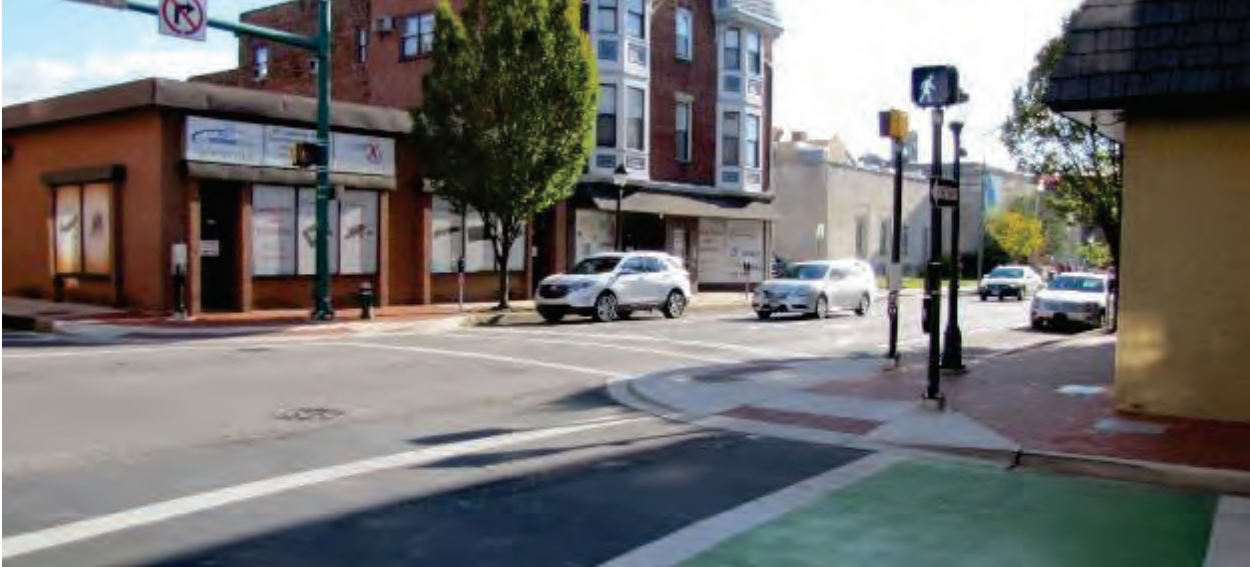
- **Pedestrian signals** are considered at marked crosswalks where “additional passage and/or clearance time is required, where pedestrians must be held to avoid vehicle conflicts, or where pedestrians are given advanced passage time before vehicles being given a green light, and at established school crossings at signalized intersections.”

Pedestrian Signal at West Franklin Street provides pedestrians with crossing time.

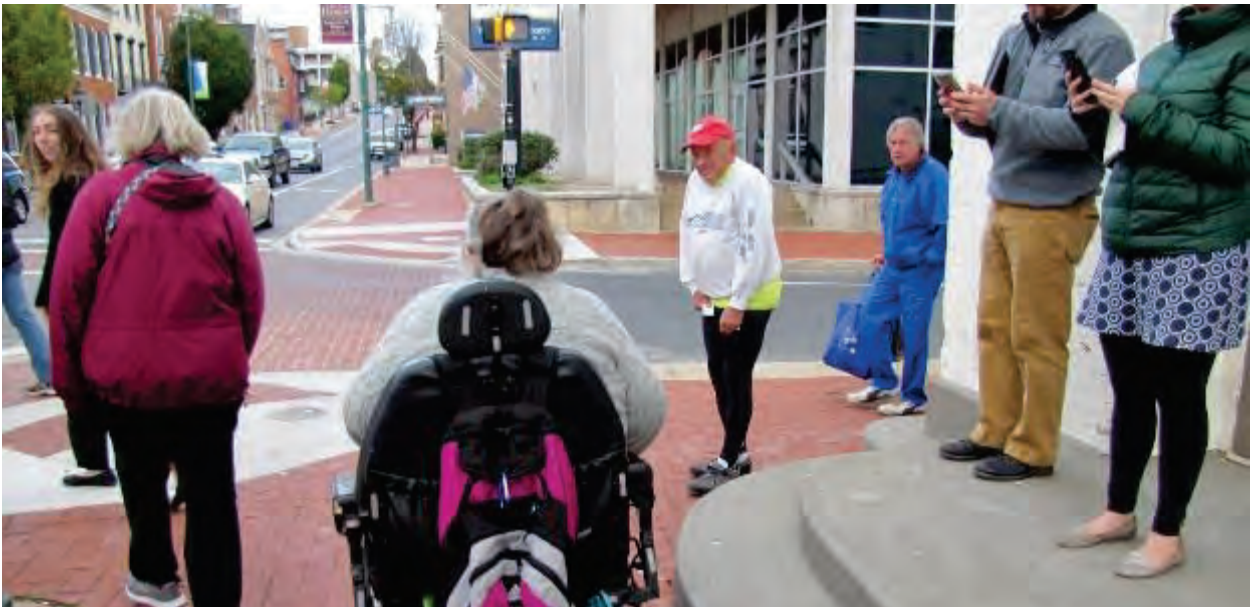
- **Accessible pedestrian signals (APS)** provide equal access for people with disabilities according to the American Disabilities Act with several features such as pushbutton locator tones, tactile arrows, audible and vibrotactile walk indications.

A person with disabilities is waiting for the green signal to cross the street.

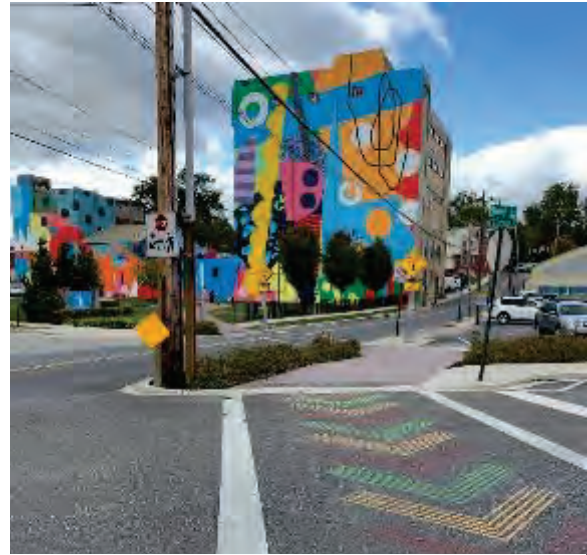
High-visibility crosswalk is painted in different colors at Hood Street and West Baltimore Street.

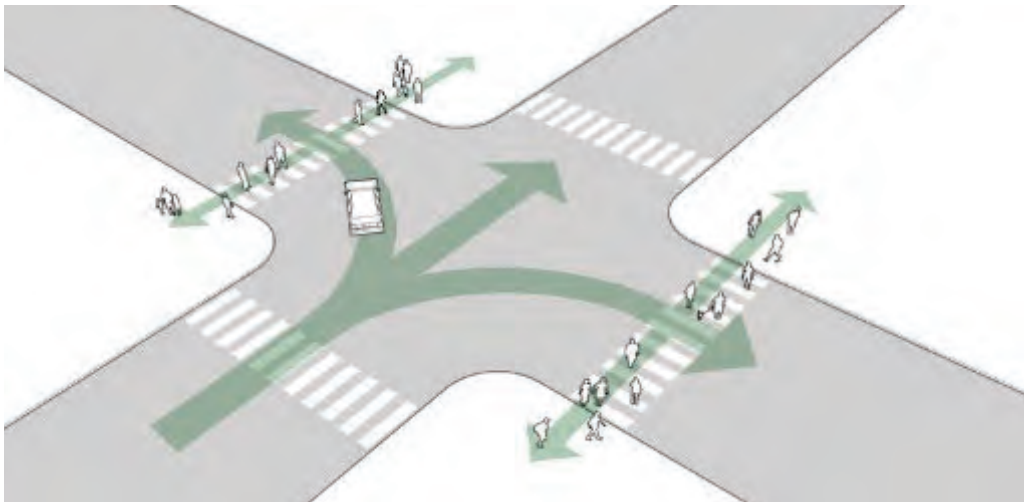
Leading pedestrian interval schematic where turning traffic yields to pedestrians already in the crosswalk (NACTO)

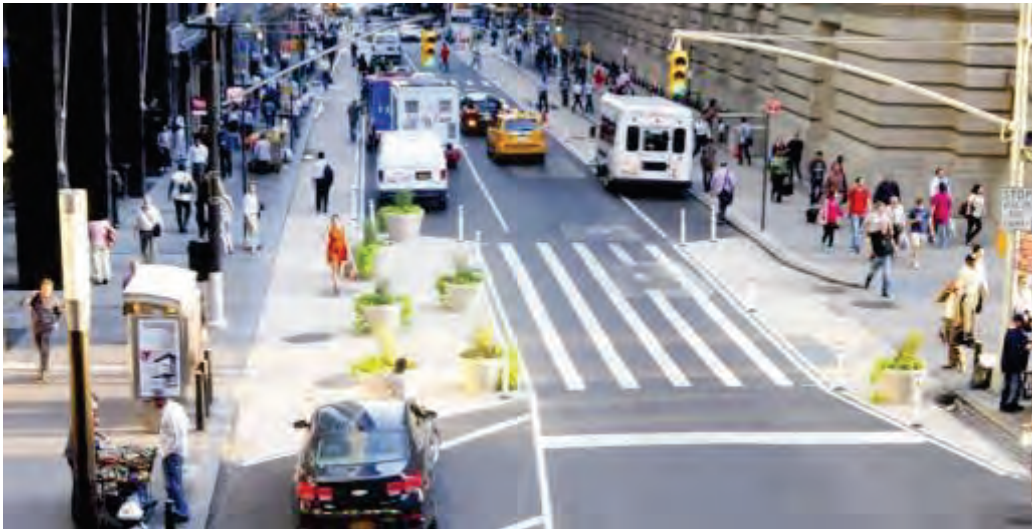
- **Continental Crosswalks** is a pattern of crosswalk striping with large stripes (typically 24" perpendicular to the crosswalk (parallel with the curb)) and is more visible to approaching vehicles than typical crosswalks, which are marked with two 12" stripes parallel to the crosswalk.
- **Curb extensions (bulbouts)** is a general term applied to several treatments. Curb extensions decrease the roadway width to provide a visual cue to drivers. Examples of curb extensions are midblock or choker, gateways, and bus bulbs.⁶

Curb extension at mid-block crossing in New York (Photo: NACTO)

Bulb outs or curb extensions visually and physically narrow the roadway, which creates shorter and safer crossings for pedestrians while increasing the available space for plantings, street trees, and stormwater management. Several intersections throughout the Hagerstown BPPA have curb extensions. Bulb outs are a cost-intensive pedestrian safety measure, and they are not recommended at all intersection corners. However, they may be well-suited to some locations throughout the BPPA. The City might also consider the use of planters and other low cost, quick build installations either as trials or as permanent installations.

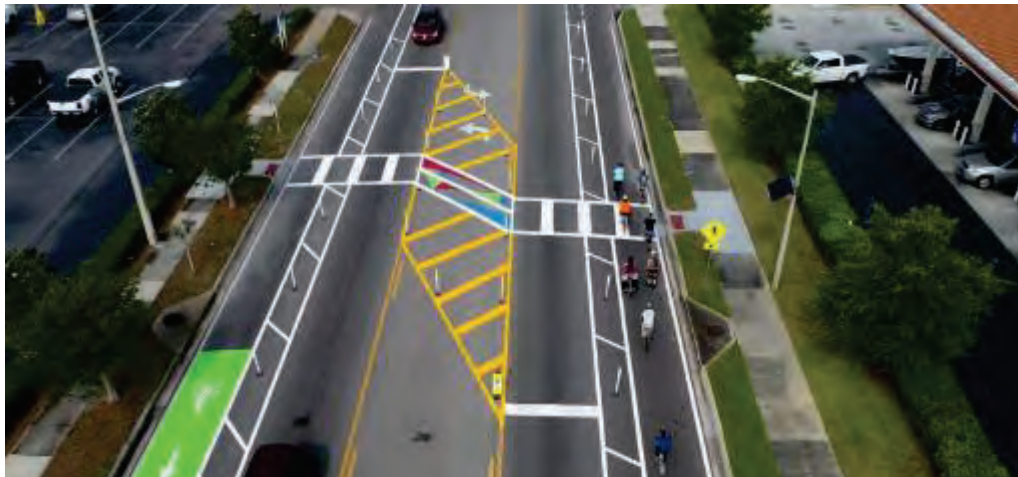
- **Road diet** is a term applied to shrink up streets into leaner ones, more productive and multimodal network. Road diets reduce auto lanes and width to help the safety and efficiency of roads.⁷

Demonstration of Curry Ford Road Diet including protected bike lane at each direction and a crosswalk with high visibility in Orlando, FL (Photo: bungalow.com).

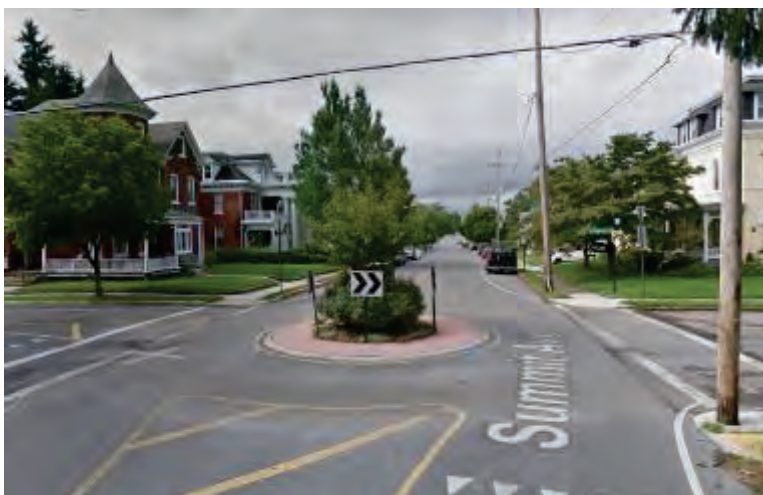
- **Mini-roundabout** is a form of junction control where vehicles can circulate a white central circular island road marking which is slightly raised like a dome.⁸

A mini roundabout is located at Summit Avenue and Reynolds Avenue, Hagerstown.

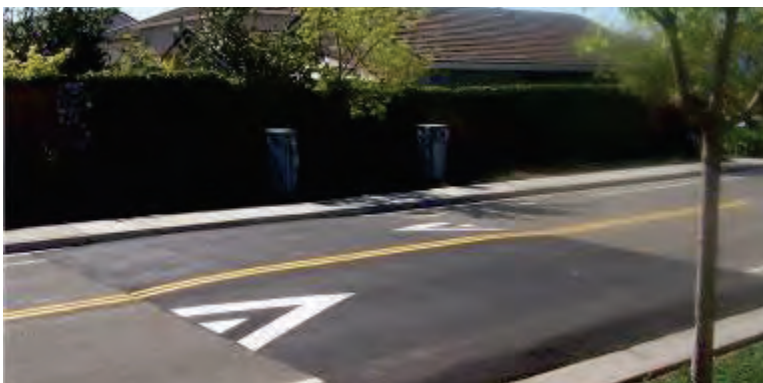
- **Speed hump** is a raised area in the roadway pavement surface to reduce the speed as a traffic calming tool for residential local streets.⁹

Speed hump at a residential street makes drivers to reduce their speed (Photo: NACTO).

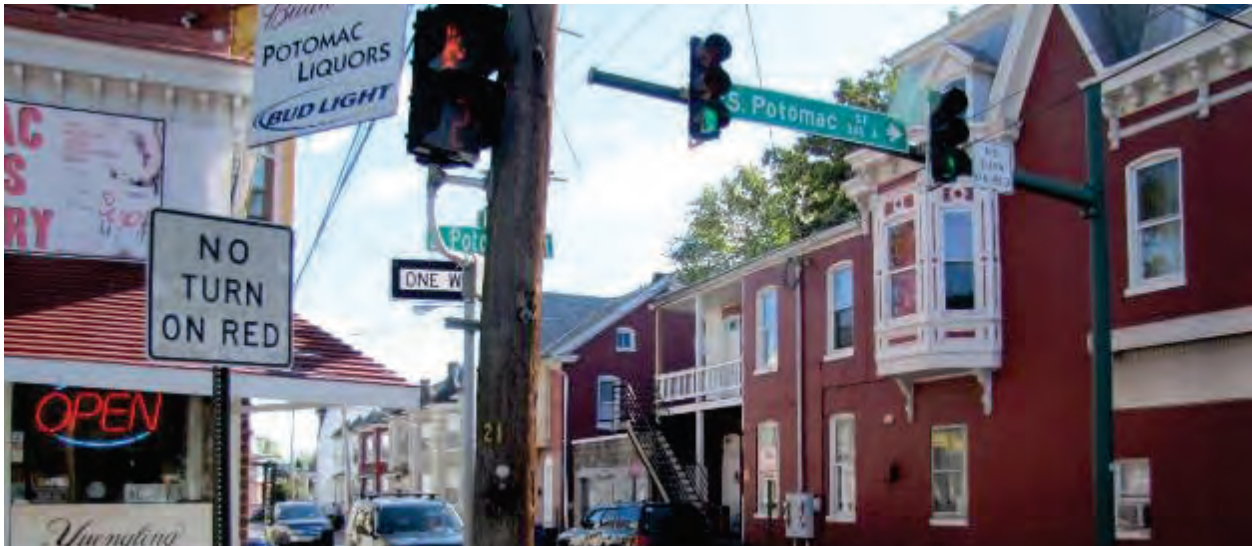
Pedestrian countdown signal at Potomac Street and Lee Street.

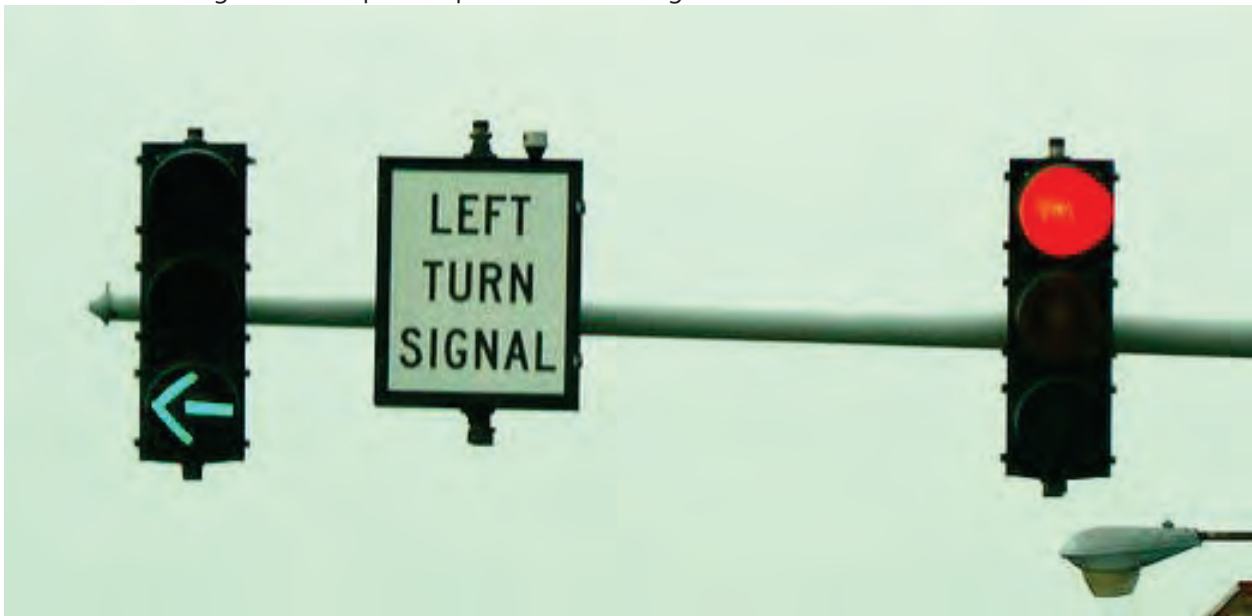
Protected left turn signal enforces protected left turns (Photo from Flickr - Benny Mazur)

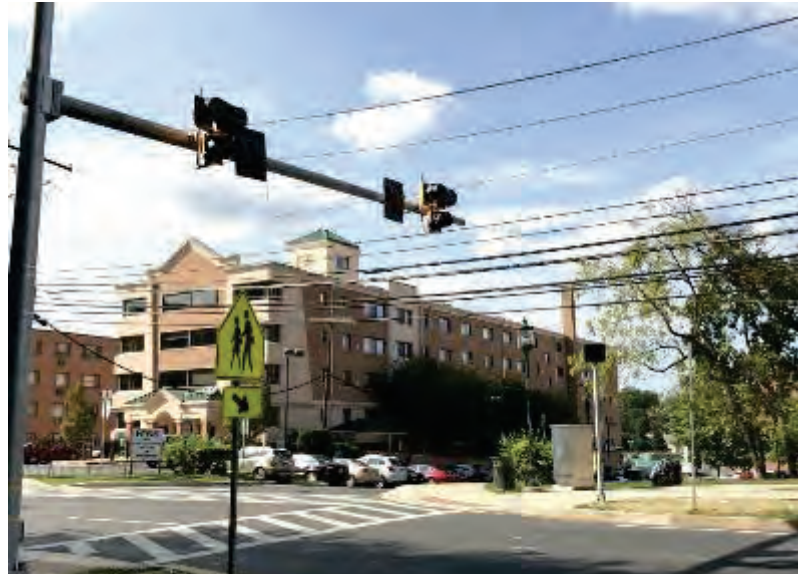
- **Pedestrian hybrid beacon** consists of a signal-head with two red lenses over a single yellow lens on the major street, and pedestrian and/or bicycle signal heads for the minor street.¹²

New pedestrian signal on MD410 at the entrance to Bethesda Chevy Chase High School (Photo: Bethesda Magazine – Andrew Metcalf).

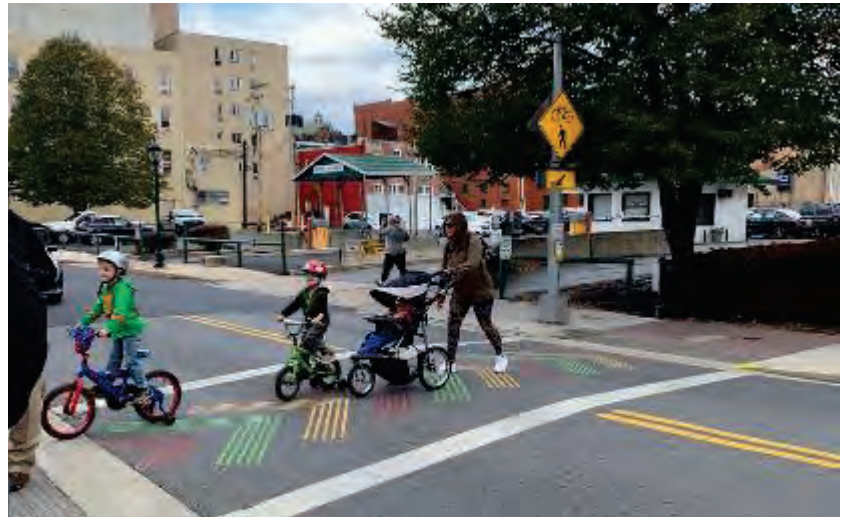
- **Rectangular rapid flashing beacon (RRFB)** is user-actuated amber LEDs that supplement warning signs at unsignalized intersections or mid-block crosswalks. They can be activated by pedestrians manually by a push button or passively by a pedestrian detection system. RRFBs enhance safety by reducing crashes.¹³

A family is crossing a mid-block with RRFB at Antietam Street.
