STUDY AREA

ANALYSIS METHODOLOGY

FIELD OBSERVATIONS - WEST INTERSECTION

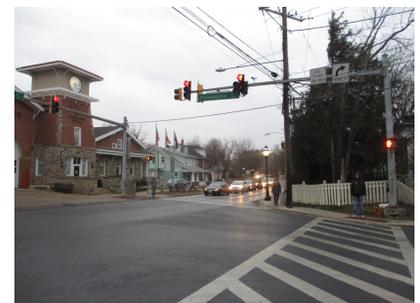
- Pedestrian pushbuttons are used to activate the all-pedestrian phase nearly every signal cycle during both peak periods due to high demand; most pedestrians are compliant and only cross during this phase
- Most pedestrians use the crosswalks, but some cross diagonally
- Bicyclists often travel within the sidewalks as well as the roadways

Pedestrians waiting to cross the intersection

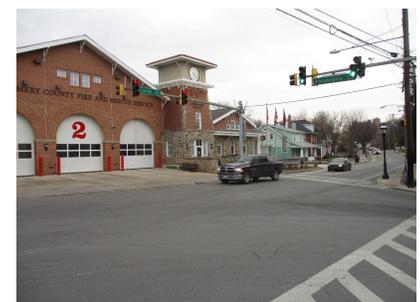
- Westbound right-turning traffic has an overlap phase concurrent with southbound Philadelphia Avenue traffic
- When the fire department signal is activated on the south leg, the other approaches to the intersection experience delays of approximately two minutes
- Once the fire department signal is activated, it can take several signal cycles to clear the resulting queues along the other approaches
- Eastbound through vehicles bypass the left-turning vehicles using the fire station driveway

Fire Station along south leg of intersection

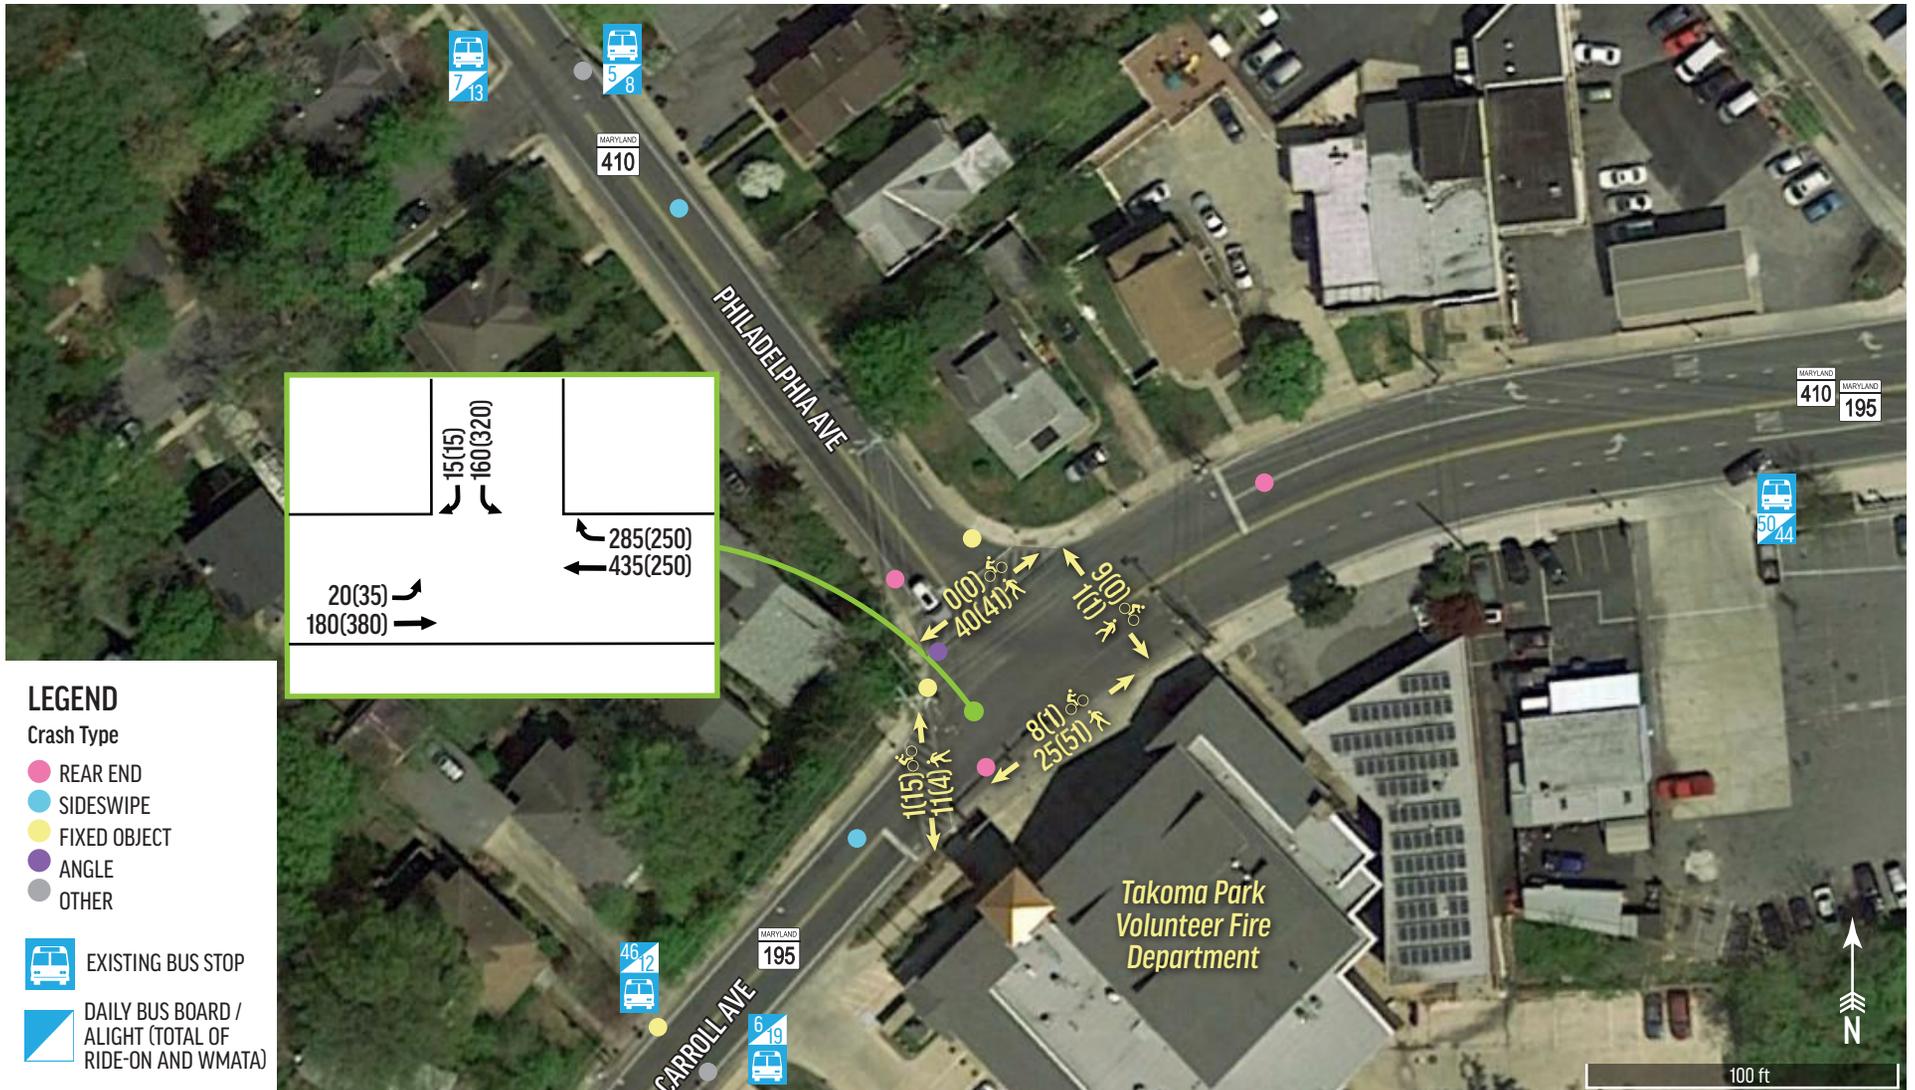
**EXISTING (2019) AM(PM) PEAK HOUR VOLUMES AND
 CRASH HISTORY (2015-2018) - WEST INTERSECTION**

- There were multiple turn-related and fixed object crashes at this intersection
- Only one crash was noted as related to fire station operations; this crash did not involve fire vehicles
- There were no fatal or pedestrian/bicycle crashes during the four-year study period

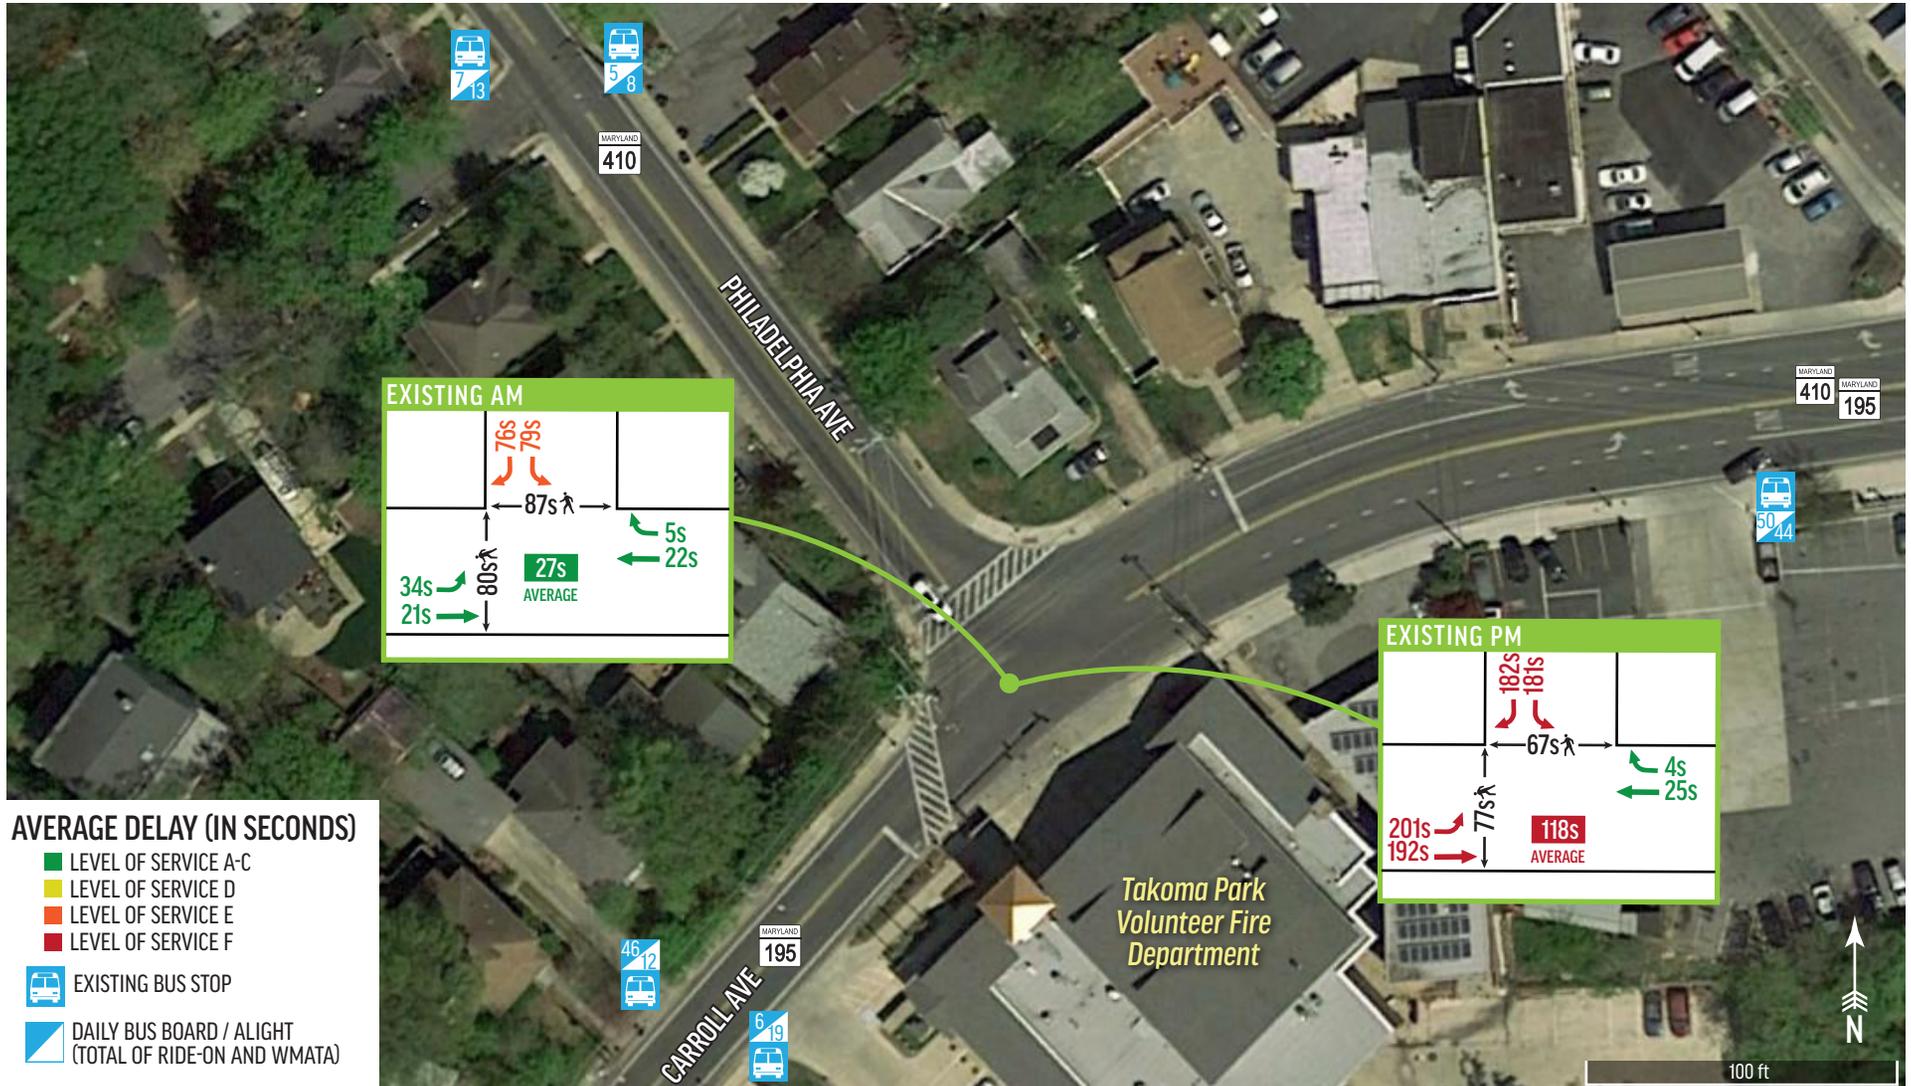
EXISTING DELAYS (SECONDS) AND LEVEL OF SERVICE (LOS) - WEST INTERSECTION

- Westbound queues at Philadelphia Avenue occasionally spillback through the eastern signal at Ethan Allen Avenue during both peak periods
- Eastbound and southbound vehicles are occasionally not able to clear the intersection in one signal cycle; these vehicles must wait through a second cycle during the PM peak period

- Eastbound queues exceeded 40 vehicles and southbound queues reached 33 vehicles during PM peak period field observations
- Eastbound and southbound queues sometimes block side street intersections

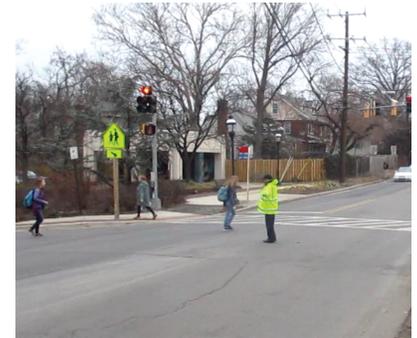
- Pedestrian pushbuttons are used to activate the all-pedestrian phase nearly every signal cycle during both peak periods due to high demand; most pedestrians are compliant and only cross during this phase
- Most pedestrians use the crosswalks, but some cross diagonally; crossing guards assist pedestrians during both peak periods
- Bicyclists often travel within the sidewalks as well as the roadways; eastbound left-turning bicyclists at onto Carroll Avenue use the left-turn lane and ride with vehicular traffic
- On one occasion during the PM peak, a crossing guard directed eastbound left-turning and southbound right-turning traffic to stop during their green phase to allow a pedestrian to cross the north leg

Crossing guard helping students cross the intersection

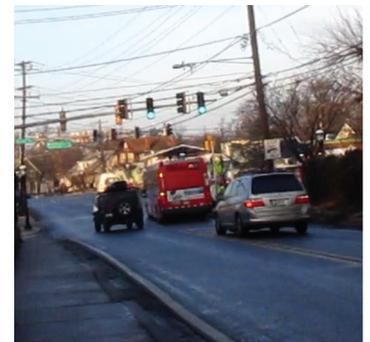
- While a westbound bus was stopped between Sycamore Avenue and Carroll Avenue to board/alight, several vehicles crossed the double-yellow center line to bypass the bus

Vehicle illegally passing a bus stopped west of Sycamore Ave

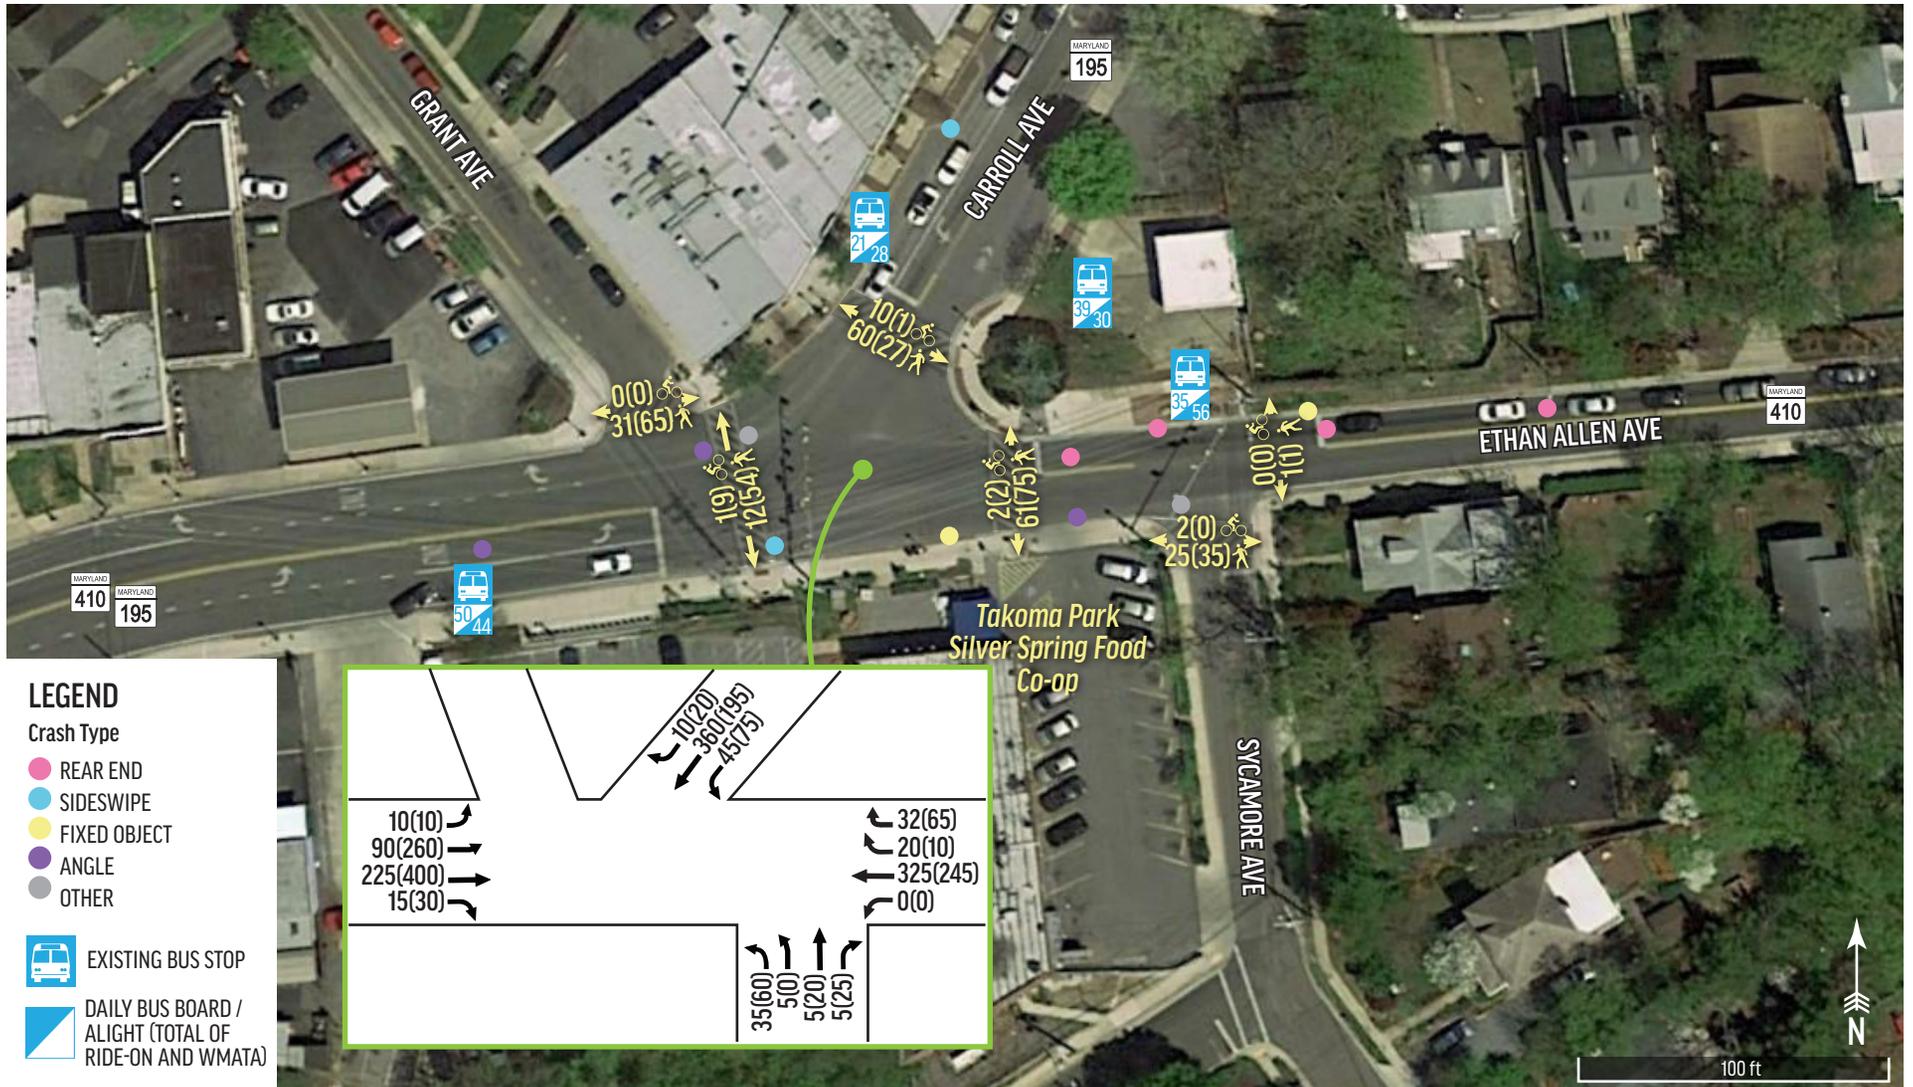
**EXISTING (2019) AM(PM) PEAK HOUR VOLUMES AND
 CRASH HISTORY (2015-2018) - EAST INTERSECTION**

- Rear end and turn-related crashes comprise the majority of crashes on the east and west approaches, respectively
- Multiple crashes involved bus traffic and were typically the fault of the other driver
- There were no fatal or pedestrian/bicycle crashes during the four-year study period

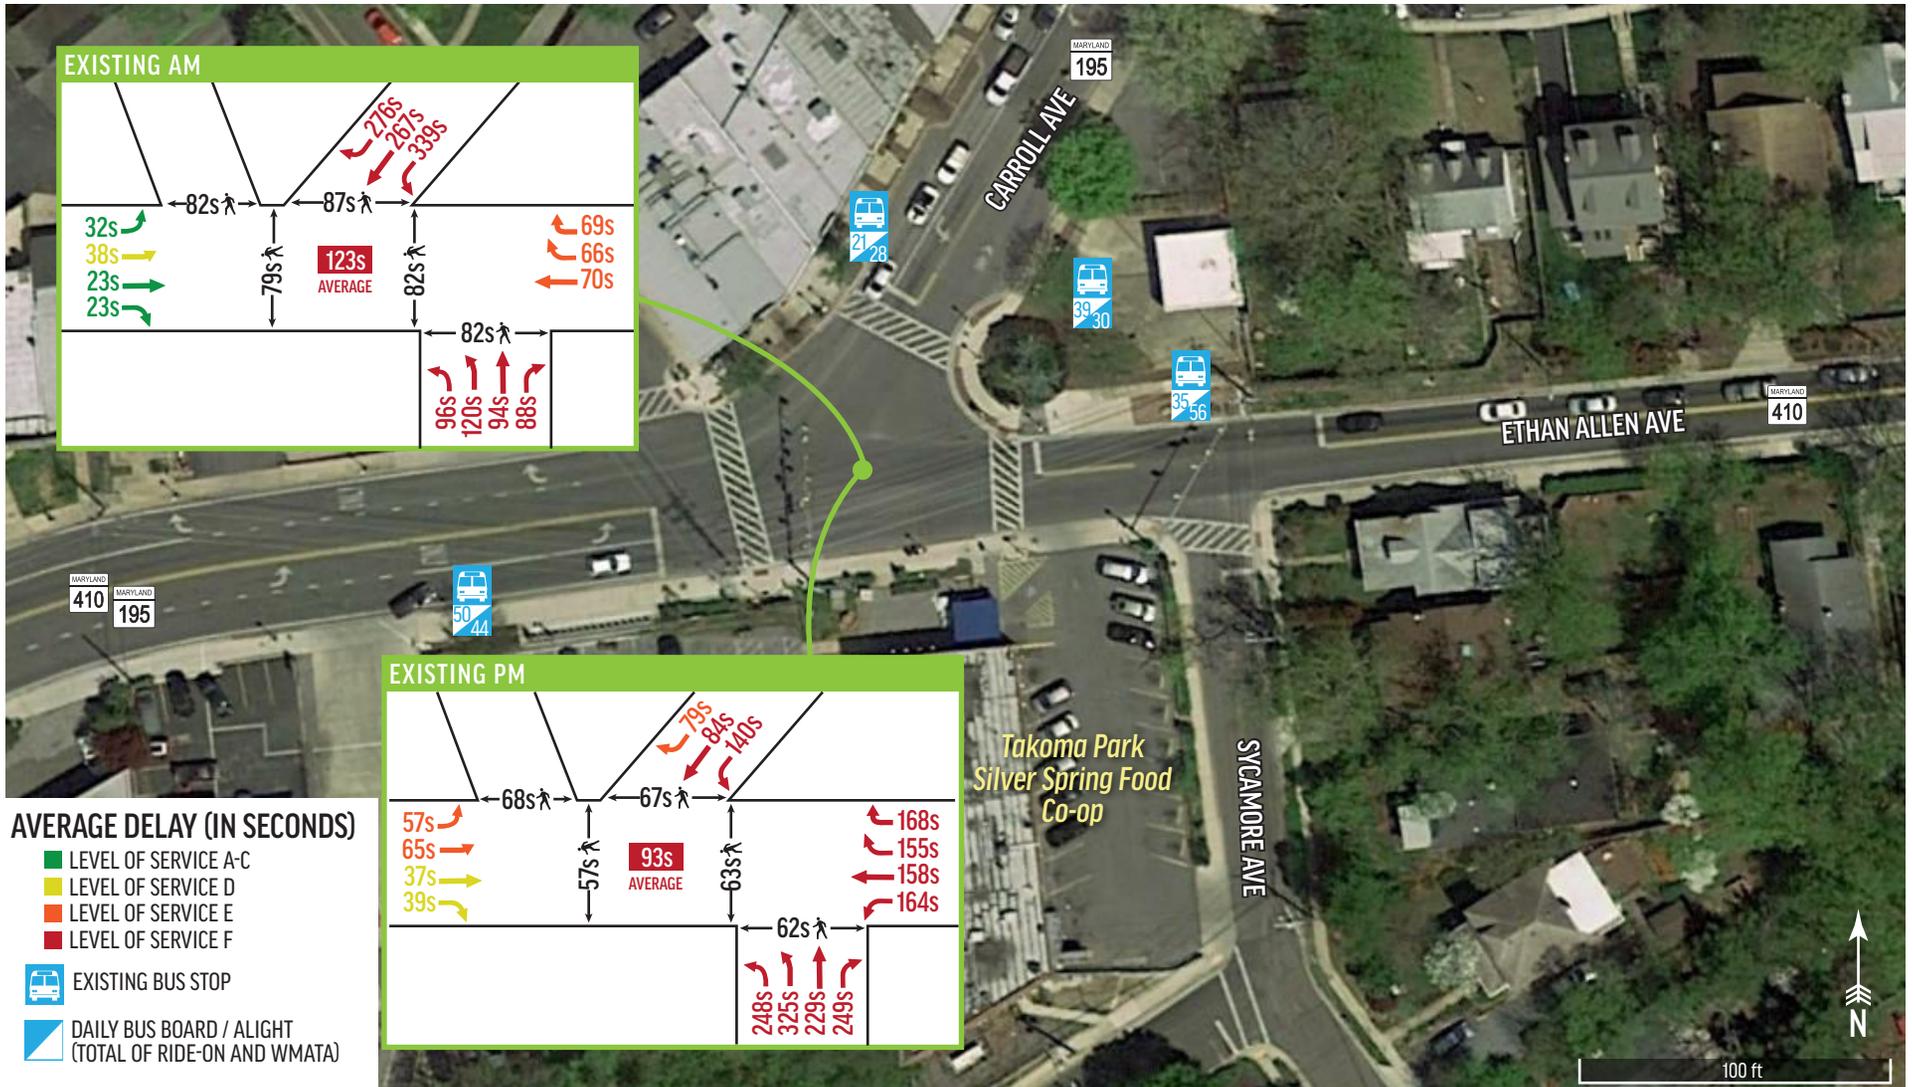
EXISTING DELAYS (SECONDS) AND LEVEL OF SERVICE (LOS) - EAST INTERSECTION

- Eastbound queues at Carroll Avenue occasionally spillback through the upstream signal at Philadelphia Avenue during both peak periods
- Westbound and southbound vehicles are occasionally unable to clear the intersection in one signal cycle and must wait through a second cycle during both peak periods

- Westbound through and southbound right-turn queues exceeded 40 vehicles during AM peak period field observations, which blocks access to other intersections; additionally, westbound through queues exceeded 40 vehicles during the PM peak period
