**MARYLAND DEPARTMENT OF TRANSPORTATION
STATE HIGHWAY ADMINISTRATION**

RESEARCH REPORT

**MASH TEST LEVEL 3 DESIGN, TESTING, AND
EVALUATION OF THE ANCHORED MARYLAND
TEMPORARY PRECAST SINGLE-FACE F-TYPE
CONCRETE BARRIER**

Test Report No. 614271-12

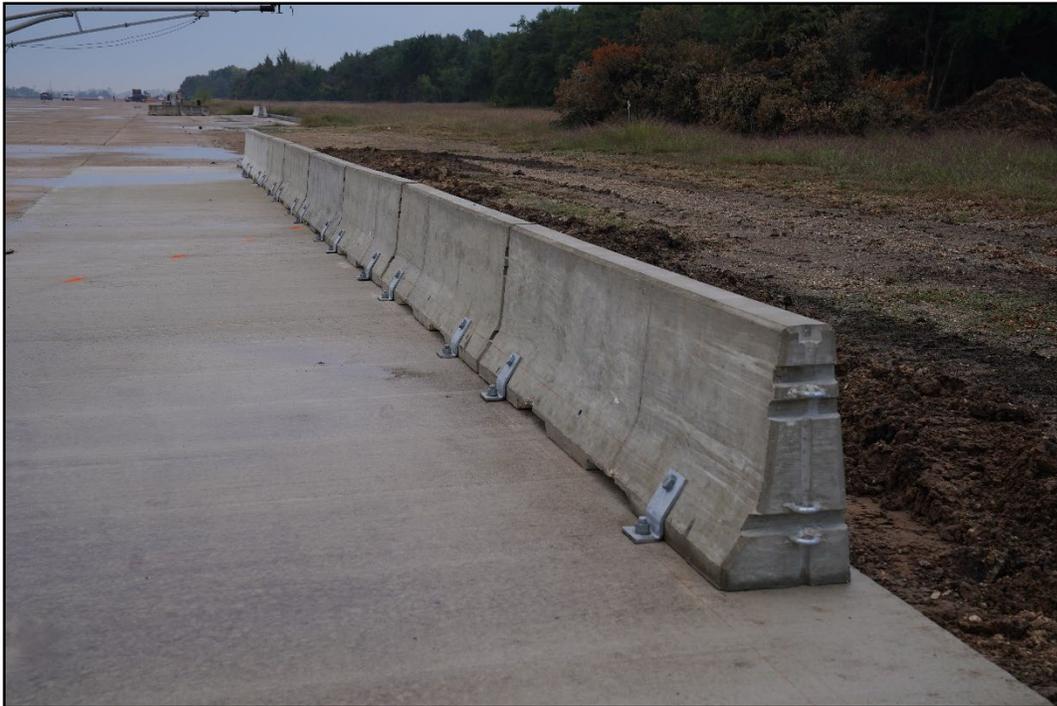
Figure 3.2. Maryland F-Type Temporary Barrier prior to Testing—Front View of the Installation.

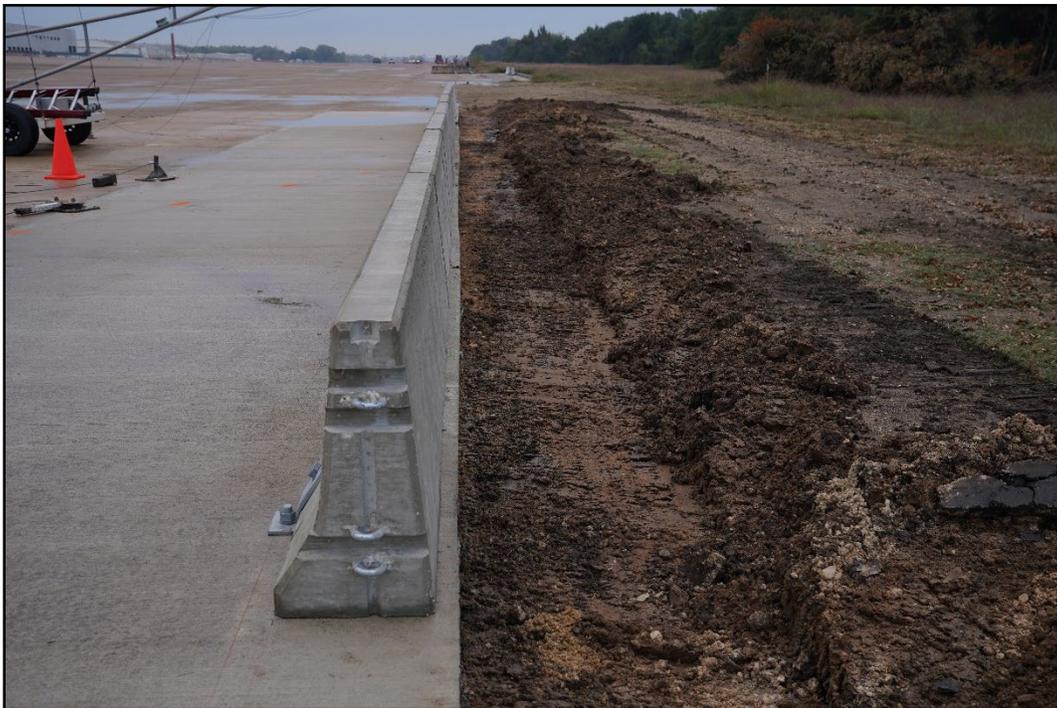
Figure 3.3. Maryland F-Type Temporary Barrier prior to Testing—Back View of the Installation.

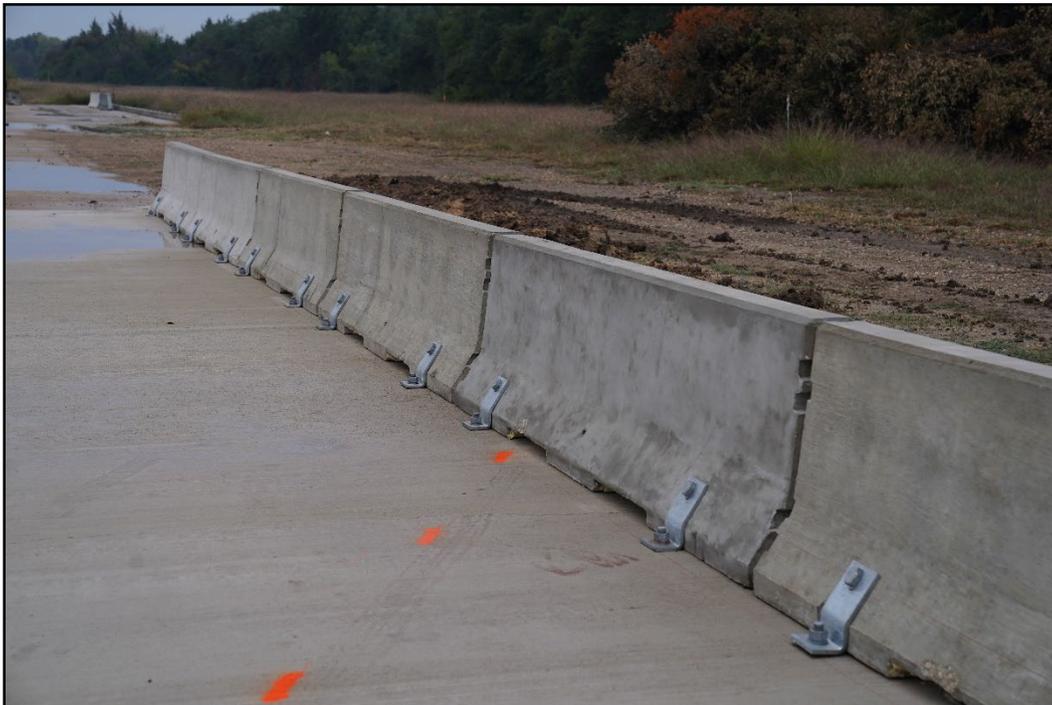
Figure 3.5. Maryland F-Type Temporary Barrier prior to Testing—Vehicle Tire Trajectory (Orange Line) Aimed at Targeted Barrier-Vehicle Impact Location.

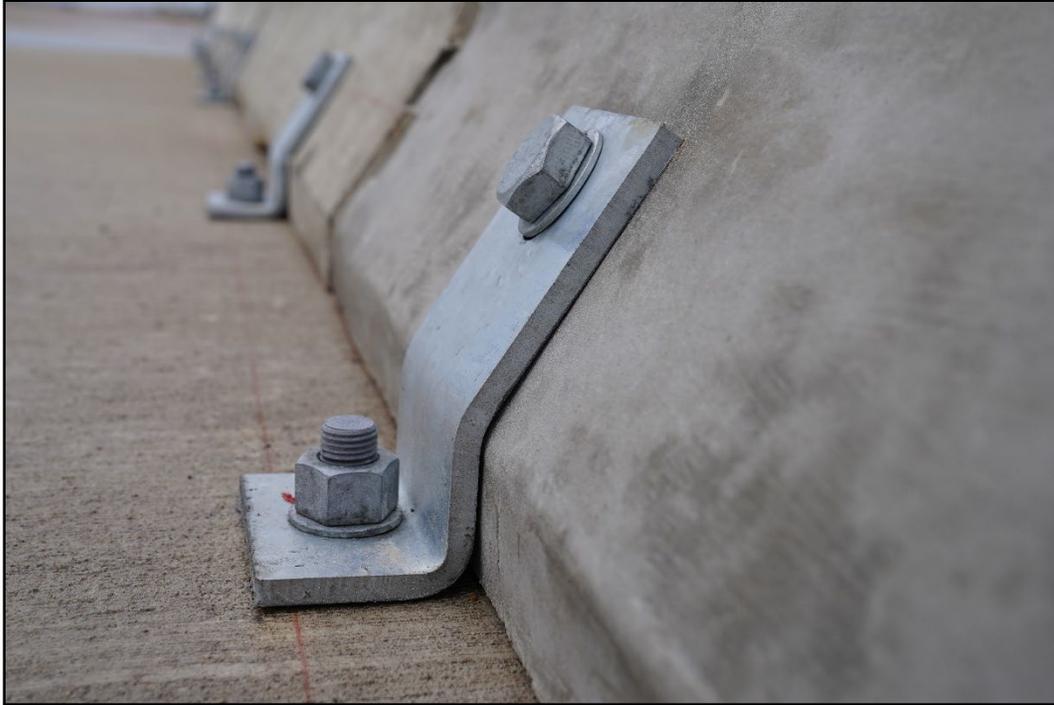
Figure 3.6. Maryland F-Type Temporary Barrier prior to Testing—Ground Connection Details.

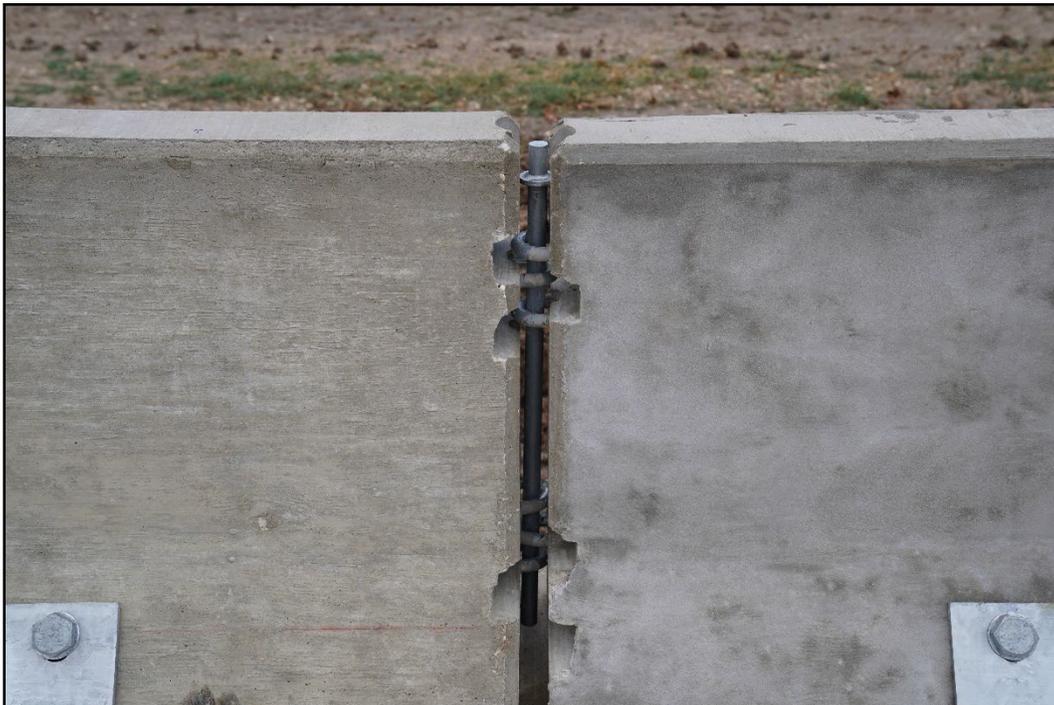
Figure 3.7. Maryland F-Type Temporary Barrier prior to Testing—Segment Connection Details.

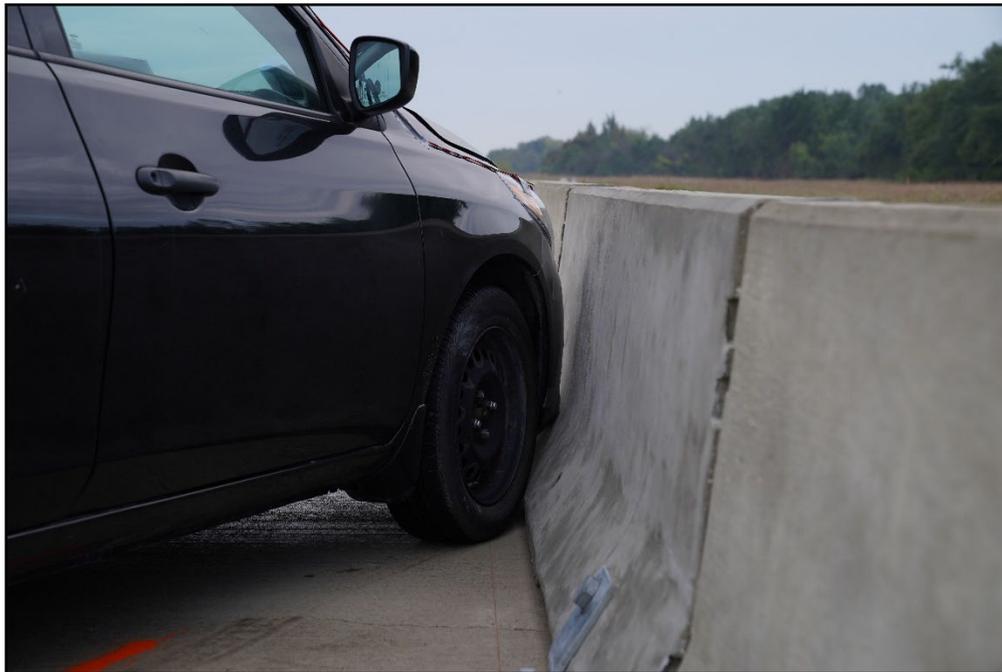
Figure 6.2. Maryland F-Type Temporary Barrier and Test Vehicle Impact Location for Test 614271-12-2.

See Table 6.1 for details on *MASH* impact conditions and Table 6.2 for the exit parameters for Test 614271-12-2. Figure 6.1 and Figure 6.2 depict the target impact setup.

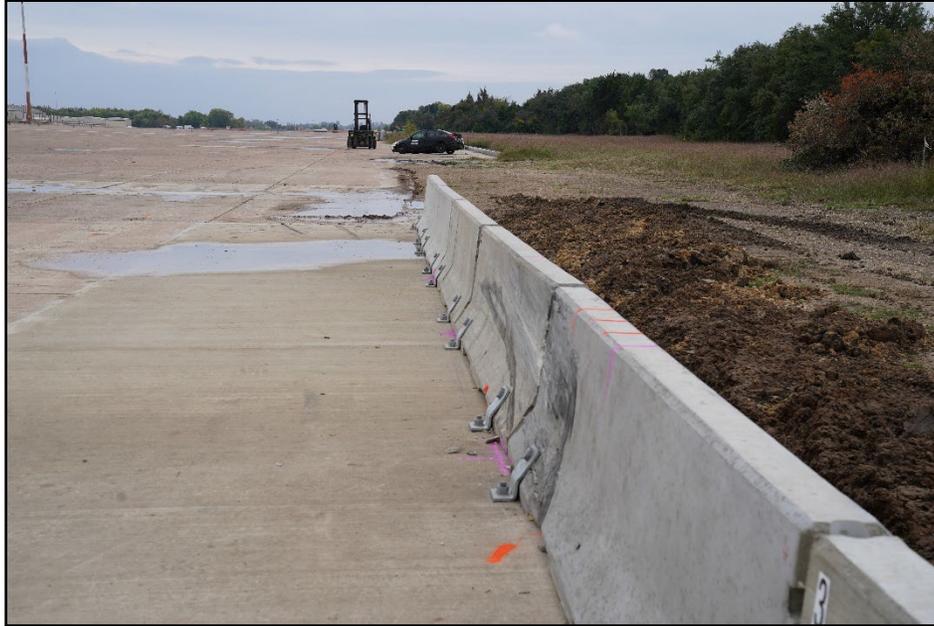
Figure 6.5. Maryland F-Type Temporary Barrier after Test near Impact Location for Test 614271-12-2.

There was damage at each anchor position for barriers 4 and 5, with cracks at the downstream anchor on barrier 4 and the upstream anchor on barrier 5. Barrier 5 also had some spalling on the field side. Table 6.6 describes the damage to the anchored Maryland F-type temporary barrier. Figure 6.5 and Figure 6.6 show the damage to the barrier.

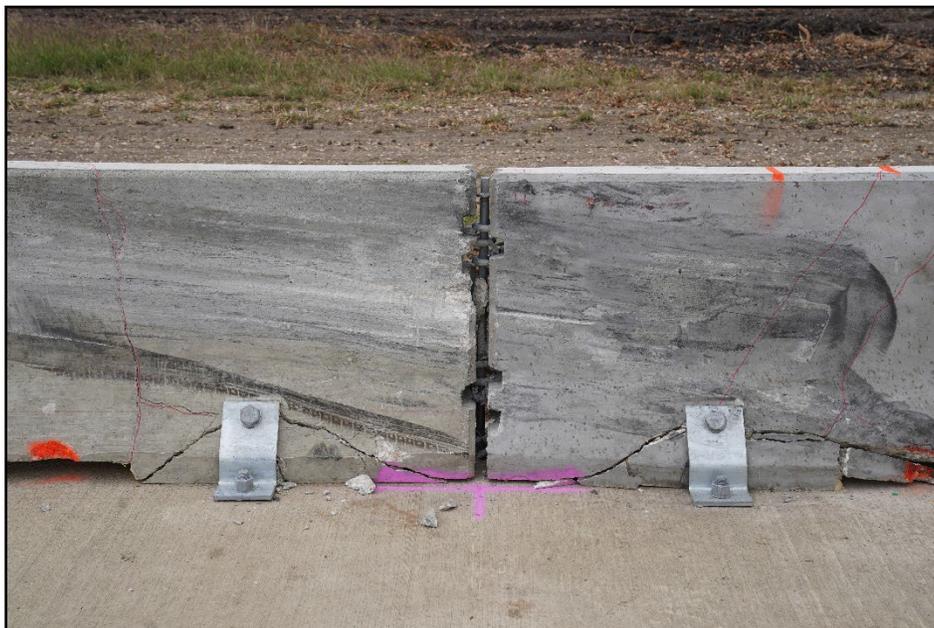
Figure 6.6. Maryland F-Type Temporary Barrier after Test at the Joint of Barriers 4 and 5 for Test 614271-12-2.

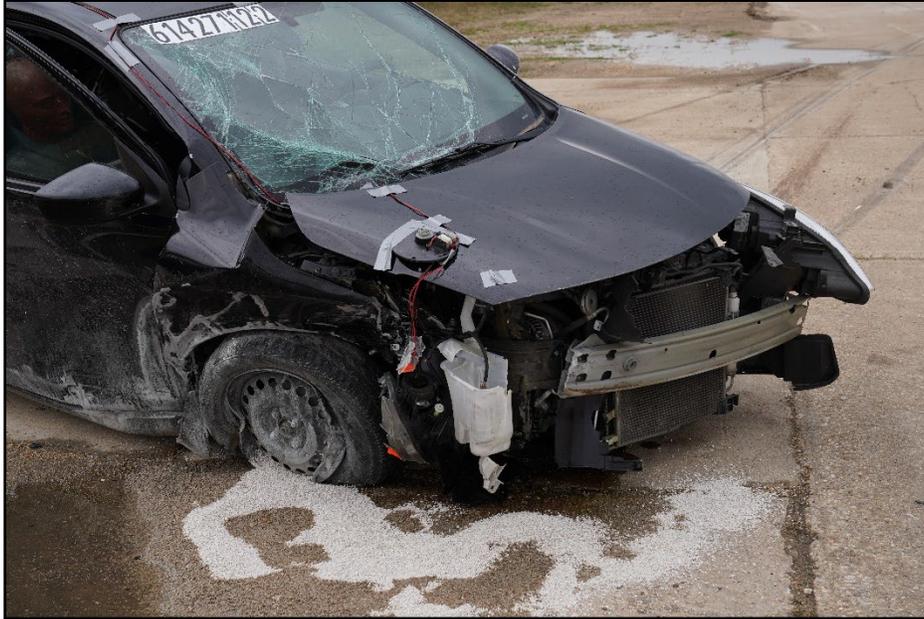
Figure 6.7. Impact Side of Test Vehicle after Test 614271-12-2.

Figure 6.7 and Figure 6.8 show the damage sustained by the vehicle. Figure 6.9 and Figure 6.10 show the interior of the test vehicle. Table 6.7 and Table 6.8 provide details on the occupant compartment deformation and exterior vehicle damage. Figures C.2 and C.3 in Appendix C.1 provide exterior crush and occupant compartment measurements.

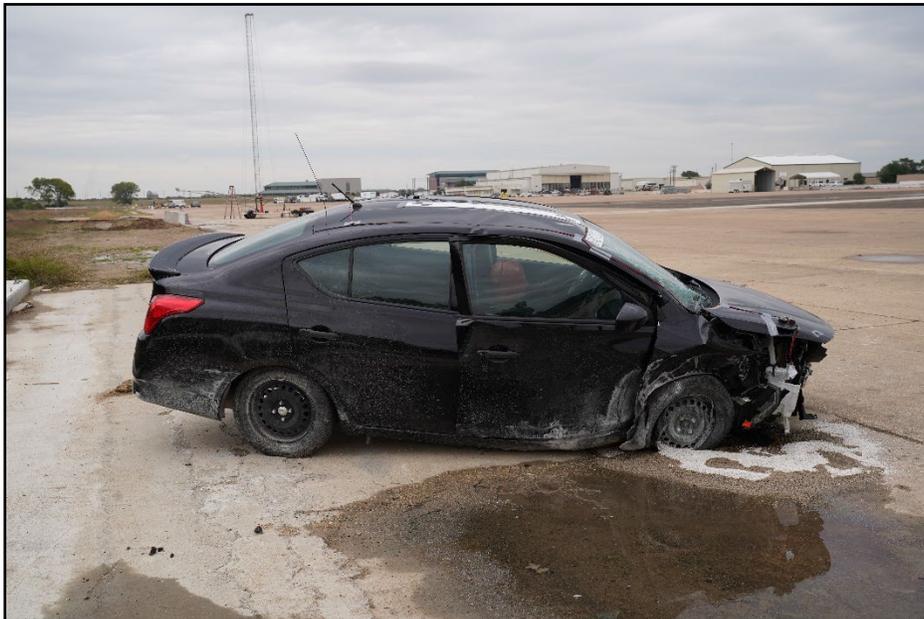
Figure 6.8. Rear Impact Side of Test Vehicle after Test 614271-12-2.

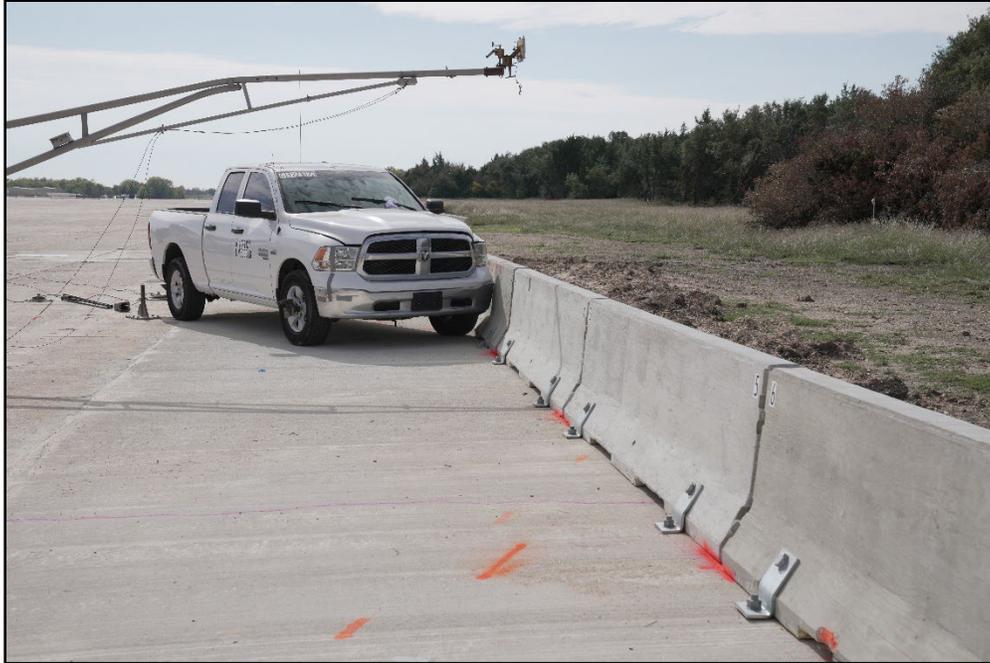
Figure 7.1. Maryland F-Type Temporary Barrier and Test Vehicle Geometries for Test 614271-12-1.

See Table 7.1 for details on *MASH* impact conditions and Table 7.2 for the exit parameters for Test 614271-12-1. Figure 7.1 and Figure 7.2 depict the target impact setup.

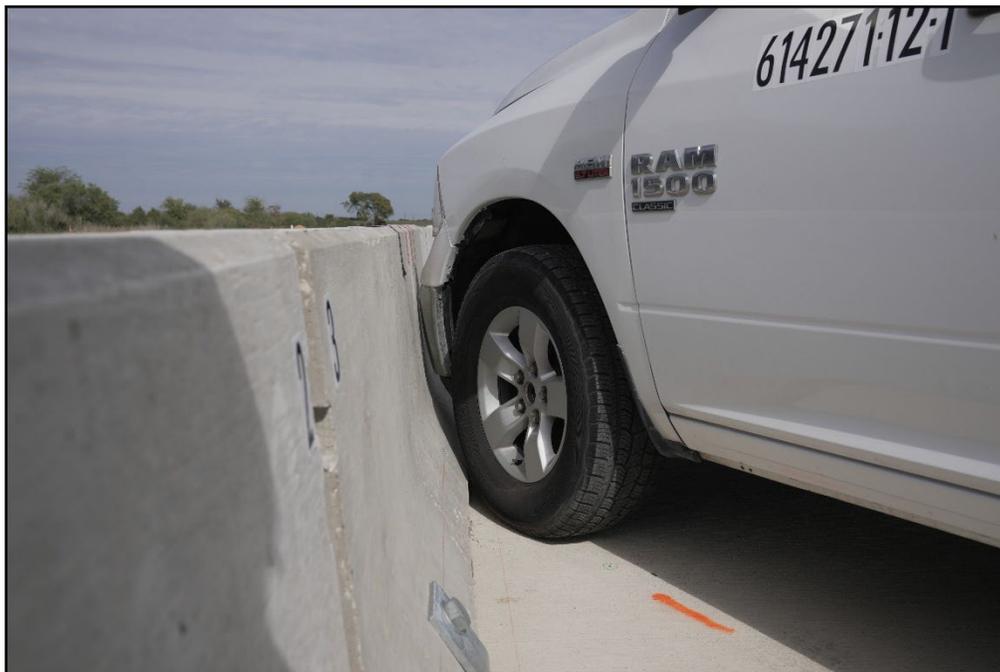
Figure 7.2. Maryland F-Type Temporary Barrier and Test Vehicle Impact Location for Test 614271-12-1.

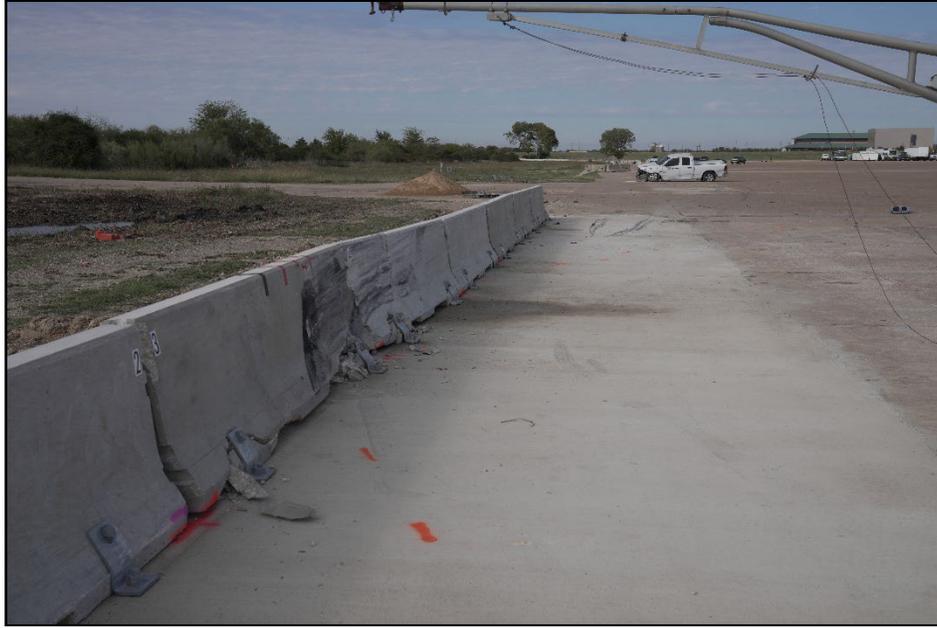
Figure 7.5. Maryland F-Type Temporary Barrier after Test at Impact Location for Test 614271-12-1.

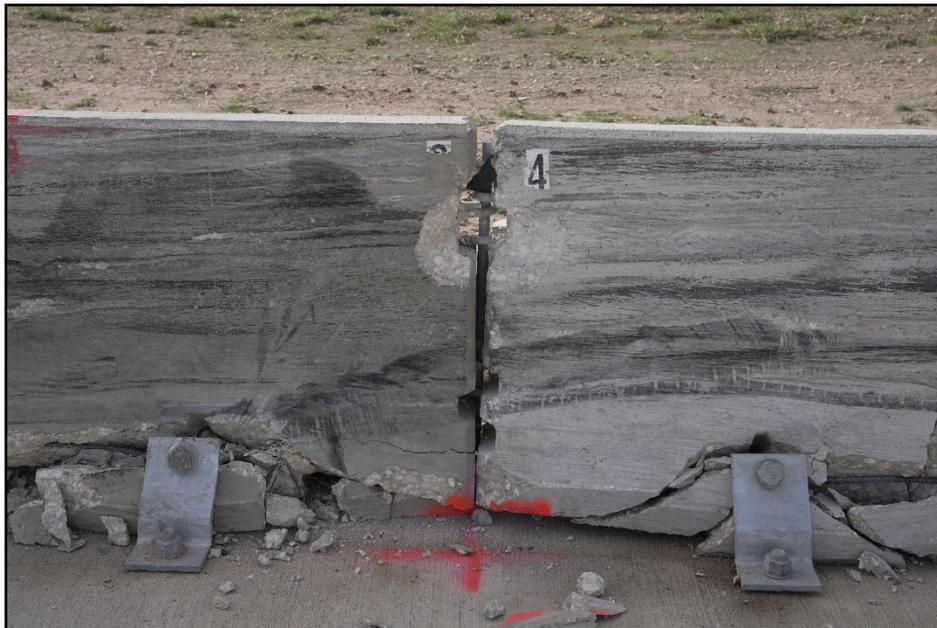
Figure 7.6. Maryland F-Type Temporary Barrier after Test at the Joint of Barriers 3 and 4 for Test 614271-12-1.

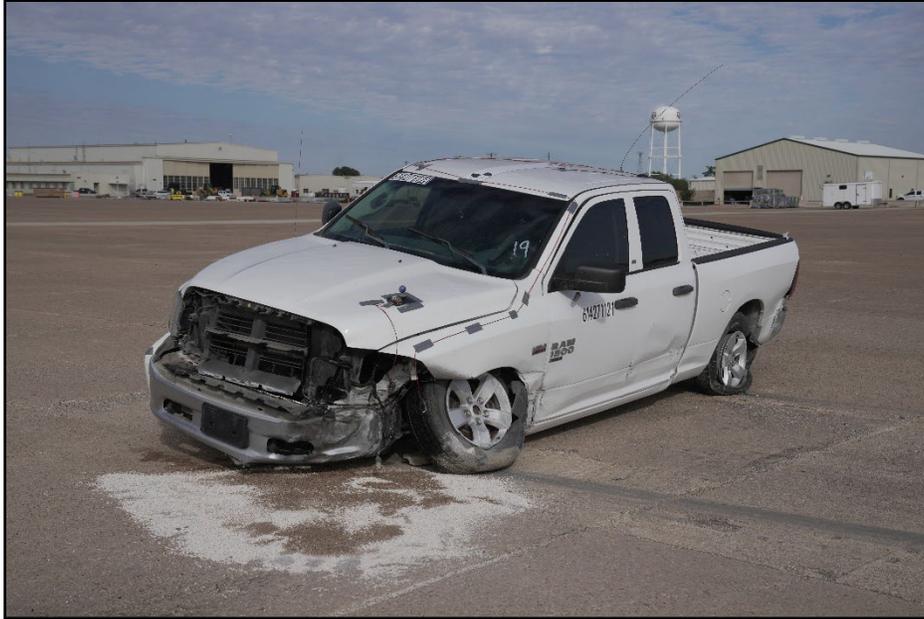
Figure 7.7. Impact Side of Test Vehicle after Test 614271-12-1.

Figure 7.7 and Figure 7.8 show the damage sustained by the vehicle. Figure 7.9 and Figure 7.10 show the interior of the test vehicle. Table 7.7 and Table 7.8 provide details on the occupant compartment deformation and exterior vehicle damage. Figures D.2 and D.3 in Appendix D.1 provide exterior crush and occupant compartment measurements.

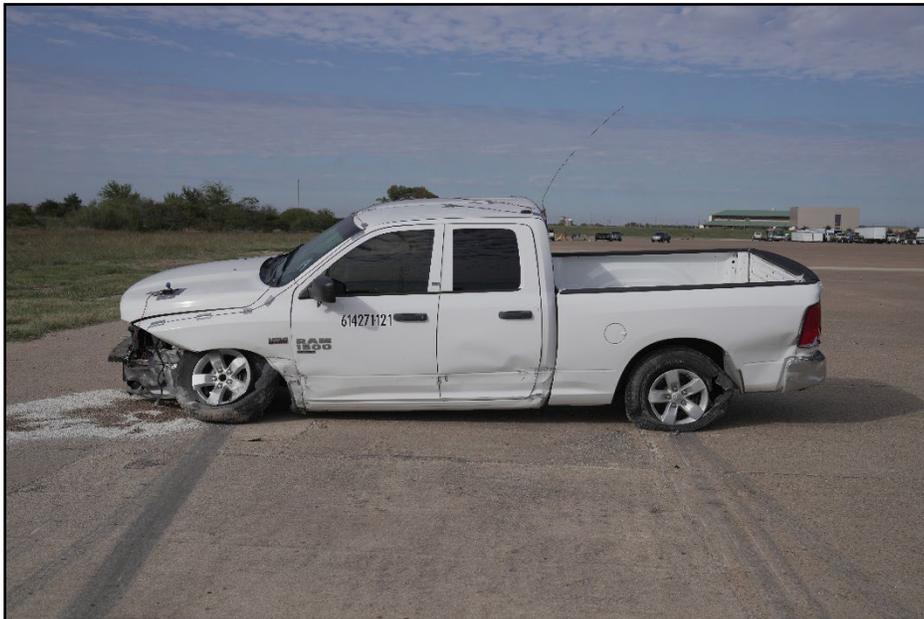
Figure 7.8. Rear Impact Side of Test Vehicle after Test 614271-12-1.

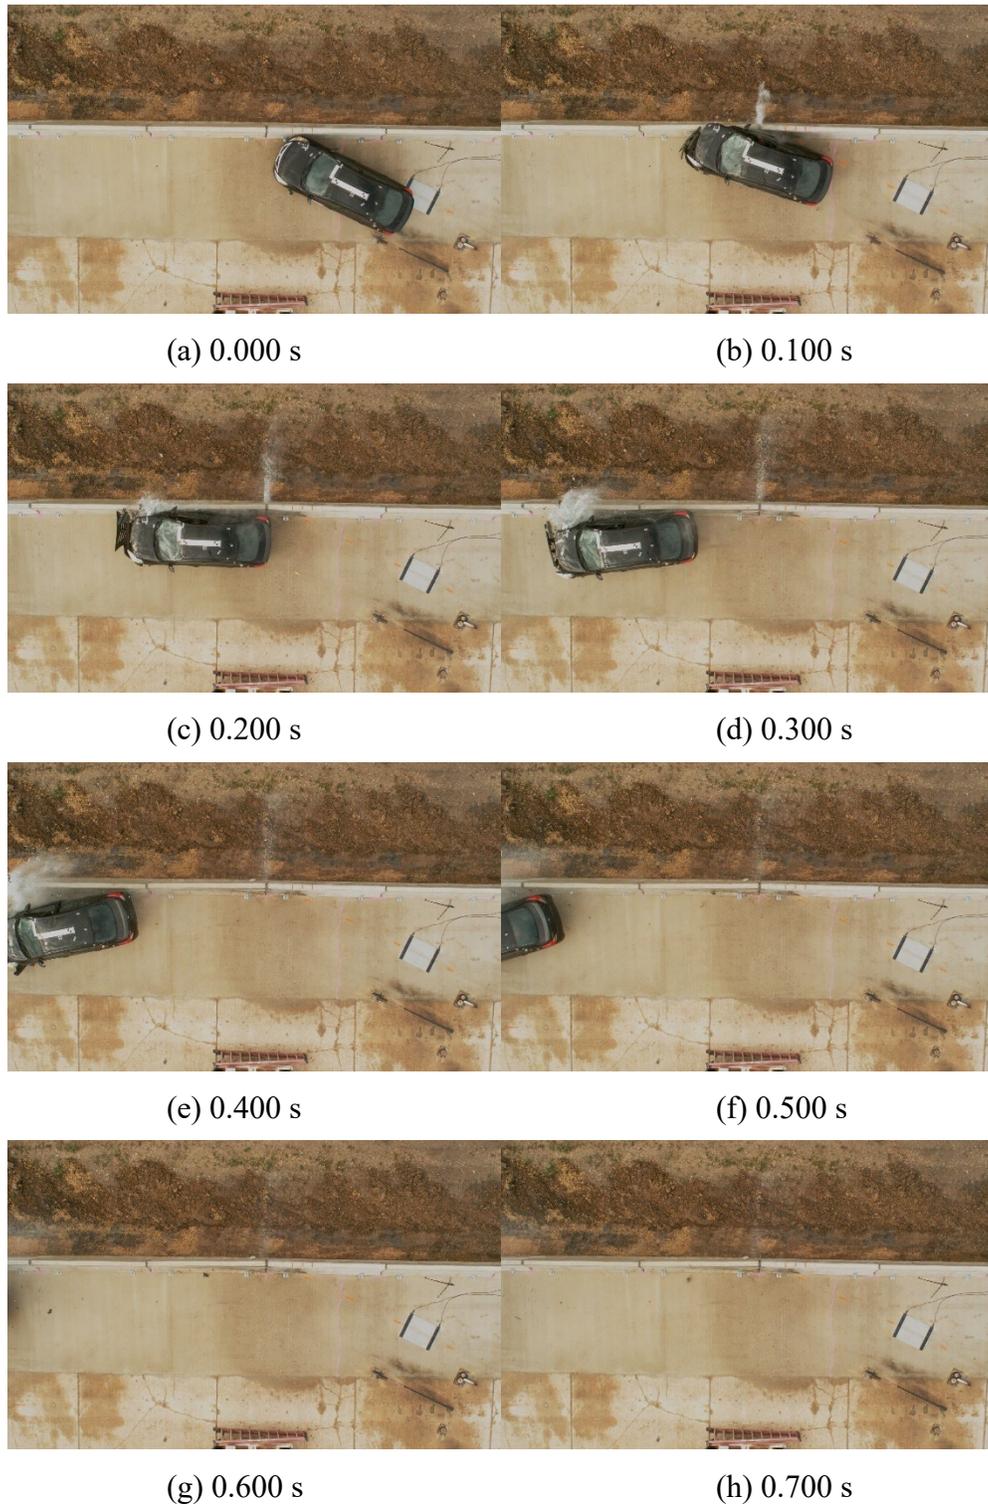
Figure C.4. Sequential Photographs for Test No. 614271-12-2 (Overhead Views).
