MANAGEMENT PLAN
for
HISTORIC HIGHWAY BRIDGES

April 2012

Management Plan for Historic Highway Bridges
SHA Contract No. BCS 2010-02B
Project No. SP312C44

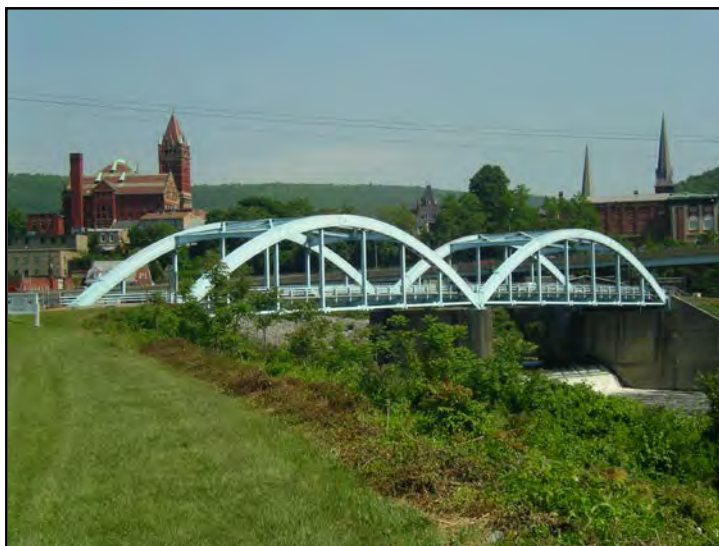
NRHP Eligibility: Criterion C, as a rare example of steel tied-arch construction in Maryland.

Primary CDEs: Steel arches, suspenders, and ties, and concrete pier and abutments.

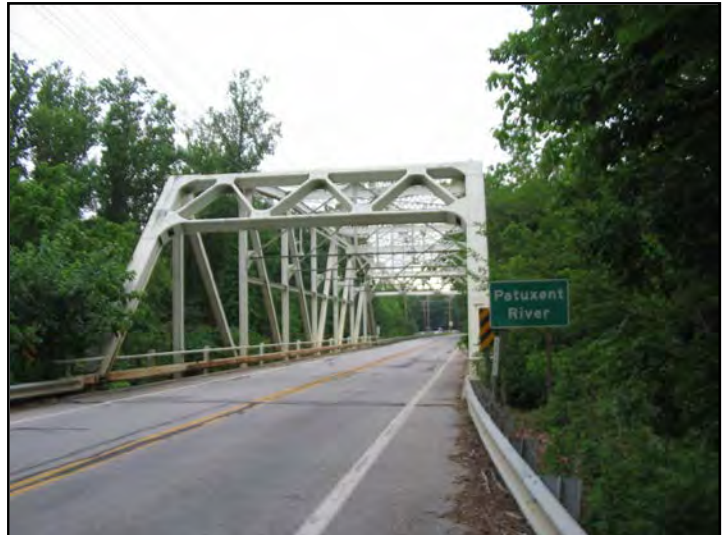
NRHP Eligibility: Criterion A for its association with continuing advances in metal truss technology and fabrication in the early 20th century, and Criterion C as a good example of a Parker through truss.

Primary CDEs: Steel trusses, sway-bracing portals, floorbeams, and concrete abutments and wingwalls.

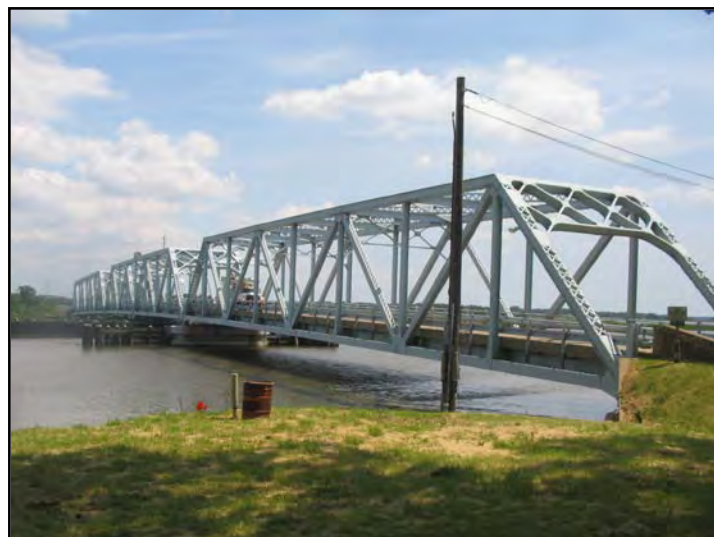
**SHA Bridge No. 2002300
MD 331 over Choptank River
“Dover Drawbridge”**

Bridge Type: Steel Sub-Divided Warren Through Truss, with a Center Swing Span, and Reinforced Concrete Slab Approach Spans

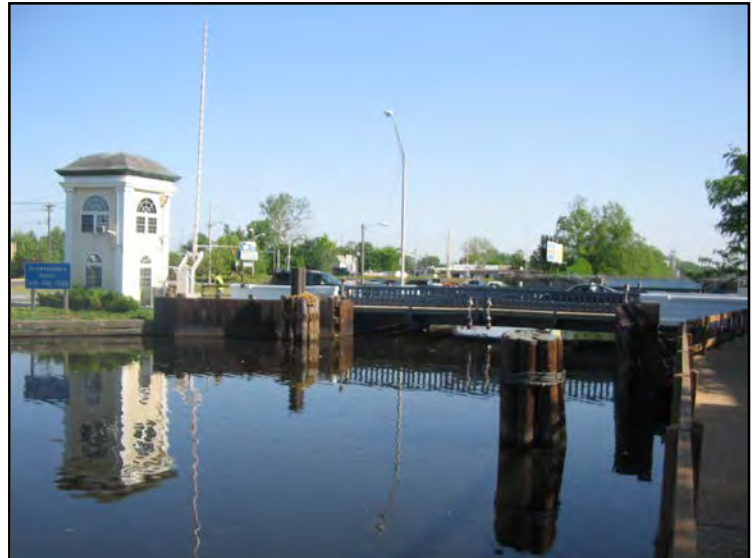
Eligibility: Criterion A for its association with the development of vehicular traffic, which began to take over as the primary means of transport on the Eastern Shore, and Criterion C as a significant example of a Chicago trunnion-style bascule bridge and for the architectural aspects of the tender's tower.

Primary CDEs: Bascule girders, trunnions, counterweights, drive machinery, tender's tower, and bascule piers.

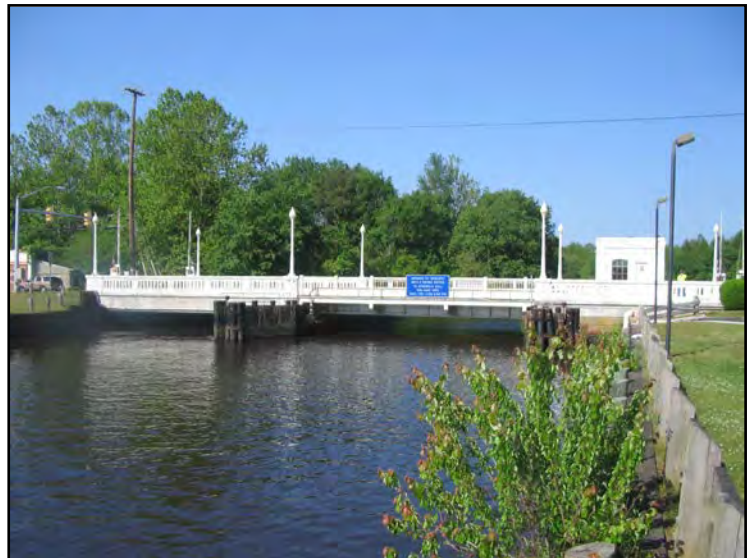
**SHA Bridge No. 2300200
MD 12 over Pocomoke River
“Snow Hill Drawbridge”**

Bridge Type: Steel Single-Leaf Trunnion
Bascule

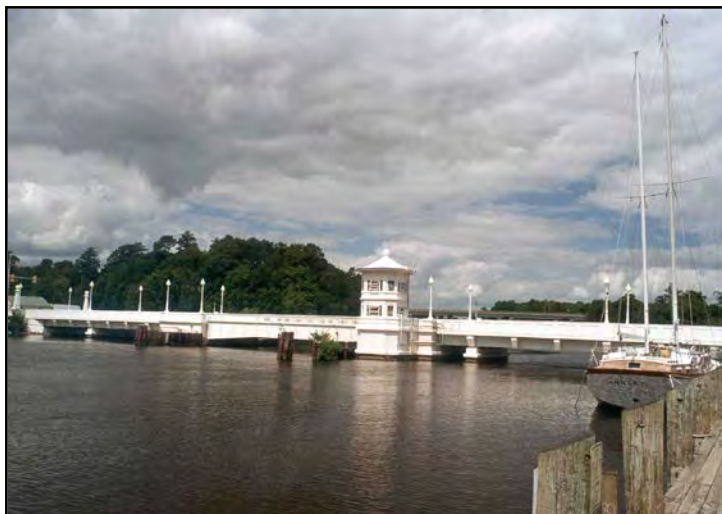
SHA Bridge No. 2300400
US 13 Business over
Pocomoke River
“Pocomoke Drawbridge”

Bridge Type: Steel Double-Leaf Trunnion
Bascule, with Steel Beam
Approach Spans

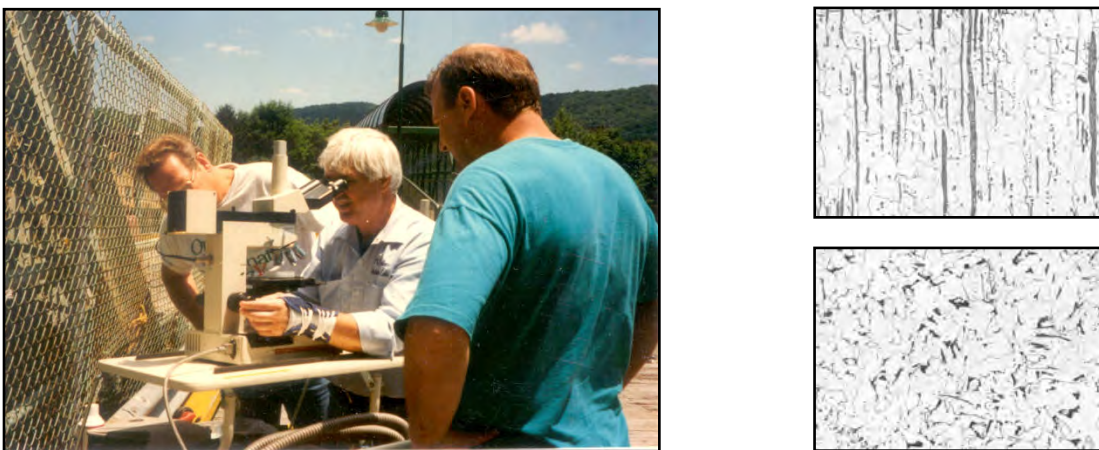
Figure 1. Non-destructive metallographic examination (left) can be used to identify the microstructure of wrought iron (top right) versus steel (bottom right). Note the distinctive elongated slag fibres in the wrought iron.

Most post-1895 truss bridges are steel, but the transition from wrought iron to steel in the middle to late 1890s was gradual. There are two low-cost, non-destructive tests that can be performed to characterize ferrous material as to whether it is wrought iron, mild steel, or steel. These include the spark test and field metallography where the metal is polished, etched and then its microstructure is replicated for examination in the laboratory. Iron and steel each have a distinctive microstructure that reveals which material it is (Figure 1).

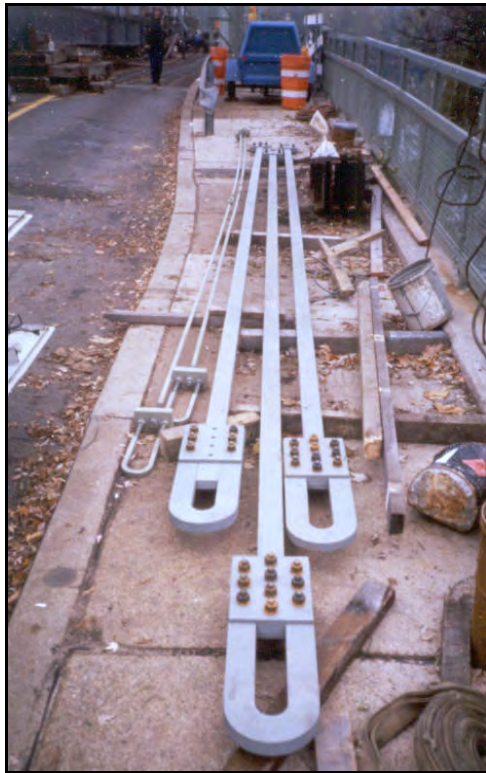
Figure 2 (below). Use of high-strength bolts to replace rivets. It is best to specify to which side to place the heads and the shanks to ensure a consistent appearance. In this example, some shanks are on the wrong side.

transferred at panel-point connections on a truss bridge, must be maintained since pinned and rigid connection designs handle stresses differently. Replacing a failed eye bar on a pin-connected bridge with a modern steel rod with end eyes that fit around the original pin is proper. While the appearance is different, the detail permits the bridge to continue to accommodate stresses as it was originally designed (Figure 2).

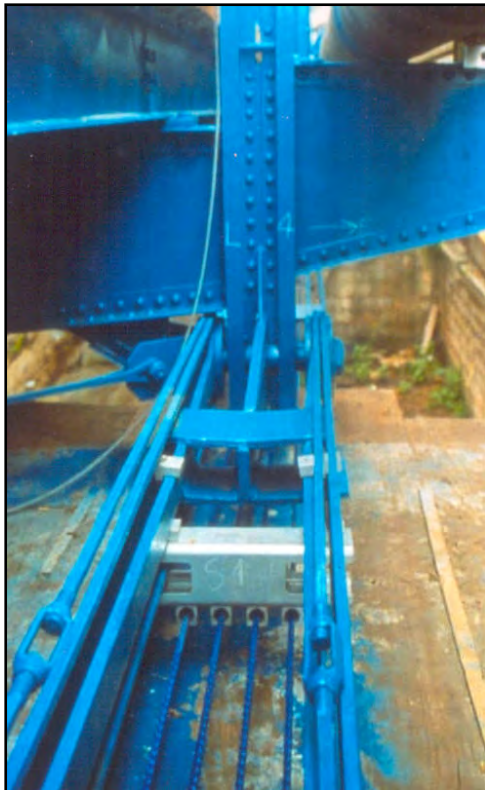
Figure 4 (left). Post-tensioned lower chord of pin-connected thru truss bridge. Note new members and guide placed between the eyebar packs.

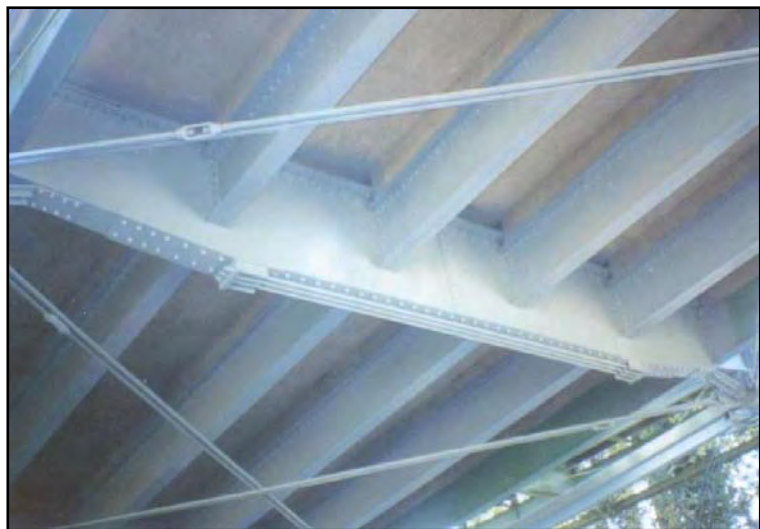
Figure 5 (below). Post-tensioned floorbeam using standard high-strength rods. This increases the capacity of the floorbeam.

When analysis reveals that truss bridge tension members, longitudinal beams or floorbeams require strengthening consideration should be given to adding new members to take part of the load. Post-tensioning consists of installing a post-tension cable or high-strength rod to reduce some of the dead load stress and transfer it to the post-tensioning system. It has proven to be a cost-effective means to increase load carrying capacity for undersized members or where redundancy is desired. This treatment is most appropriate for larger and heavier truss bridges (Figures 4, 5).

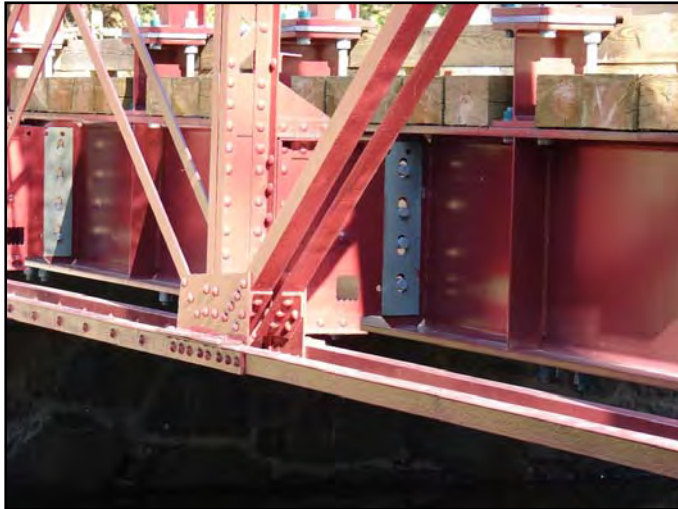
Figure 6. When attaching historic truss lines to a new superstructure make sure to retain a sufficient length of the floorbeams to facilitate attachment to the beams. The truss lines support themselves.

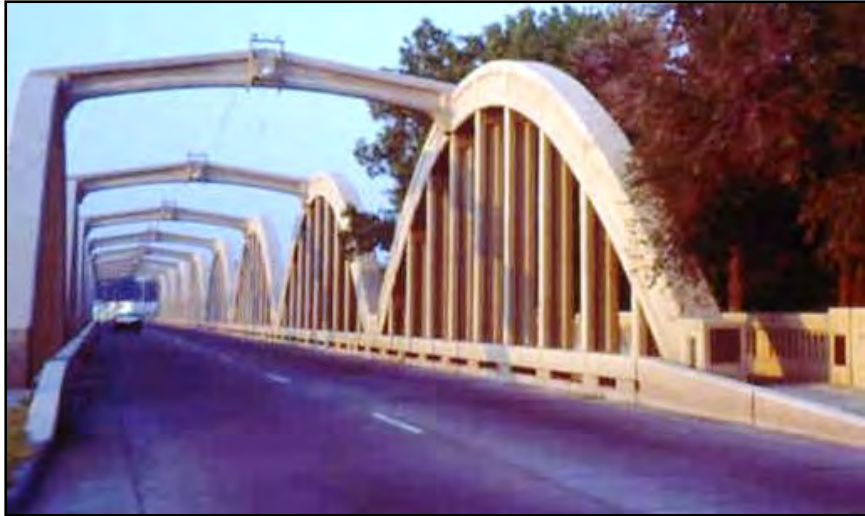
Figure 7. A crash tested traffic railing that blends well with many historic bridges is the Kansas coral railing, used here on the John Mack Bridge at Wichita, KS. Adding it to the historic bridge was no adverse effect.

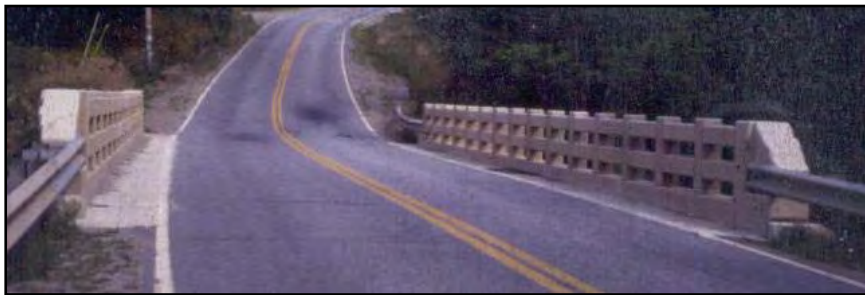
Figure 8. Partridge Bridge, Maine, an example of new railings, inspired by, but not exact replicas of, the original. Note the detail for the acceptable attachment for the approach guide rails.

In many instances, there is no alternative but to attach the end of an approach guide rail system to the end posts of the old railings. Such attachments should be done in the least intrusive manner possible. Any plaques that are in the location of the attachment should be relocated to ensure their preservation and conservation (Figure 8).

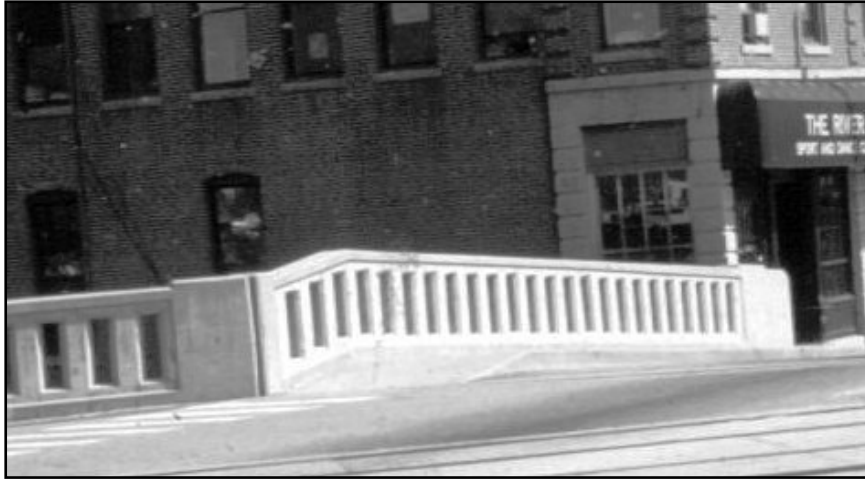
Figure 9. This is an appropriate, urban use of the crash-tested Texas Railing. It has proven to be a good replacement design for open balustrade railings used by many departments of transportation through the 1950s. This railing would not be appropriate for a rural setting because historically it was rarely used for non-urban bridges.

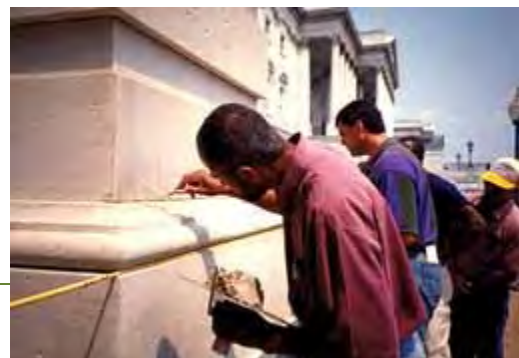
Masons practice using lime putty mortar to repair historic marble. Photo: NPS files.

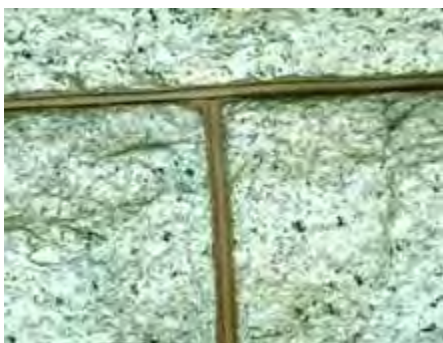
This late 19th century granite has recently been repointed with the joint profile and mortar color carefully matched to the original. Photo: NPS files.

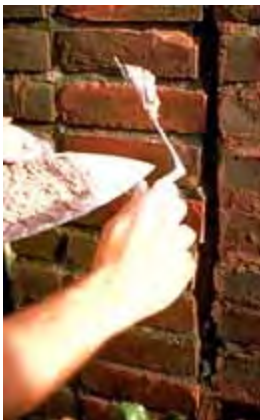
This mortar is the proper consistency for repointing historic brick. Photo: John P. Speweik.

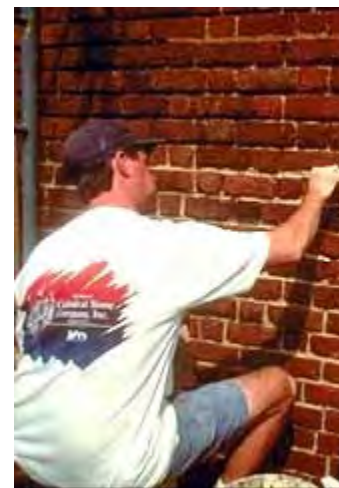
This early 19th century building is being repointed with lime mortar. Photo: Travis McDonald.

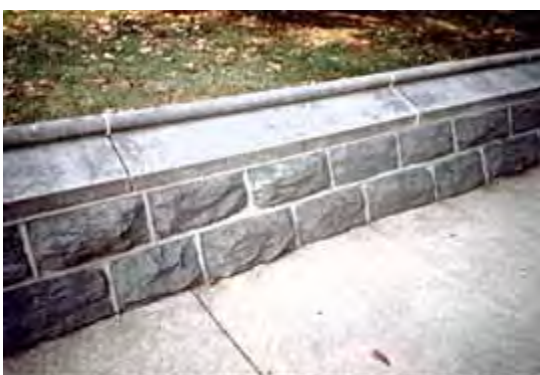
Caulking was inappropriately used here in place of mortar on the top of the wall. As a result, it has not been durable. Photo: NPS files.

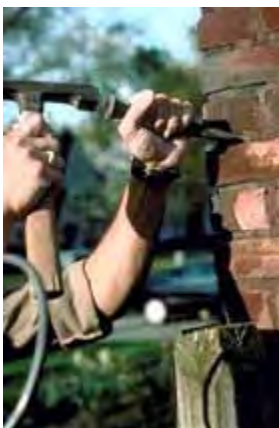
Here, a hammer and chisel are being correctly

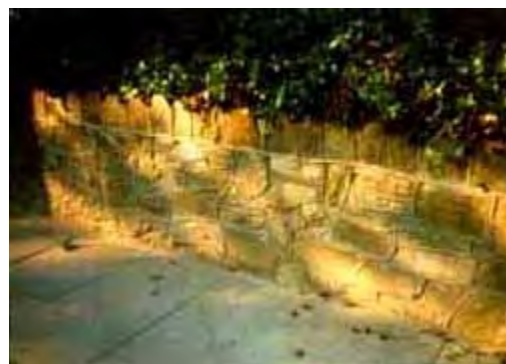
When repairing this stone wall, the mason matched the raised profile of the original tuckpointing. Photo: NPS files.

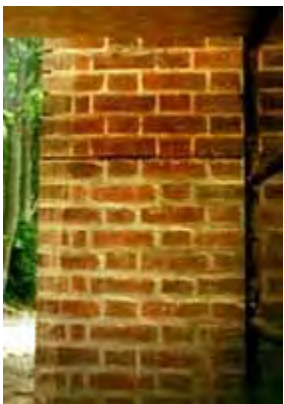
A mechanical grinder improperly used to cut out the horizontal joint and incompatible repointing have seriously damaged the 19th century brick. Photo: NPS files.

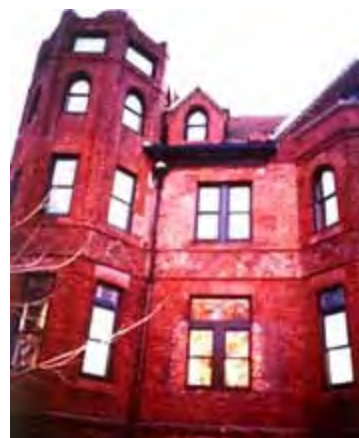
Unskilled repointing has negatively impacted the character of this late-19th century building. Photo: NPS files.

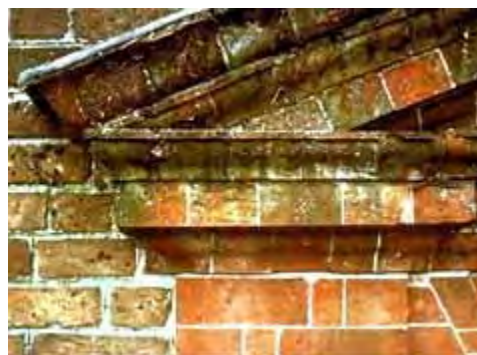
This 18th century pediment and surrounding wall exhibit distinctively different mortar joints. Photo: NPS files.

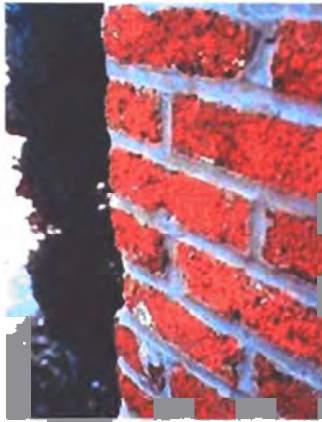
Abrasive cleaning can cause permanent damage to historic fabric, such as this brick wall. Photo: NPS files.

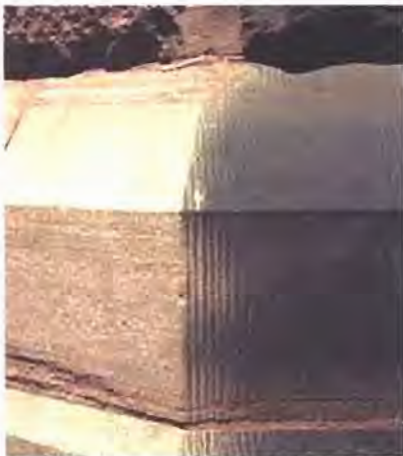
On the left, grit blasting has obliterated the vertical tooling marks from granite, a very dense stone. Photo: NPS files.

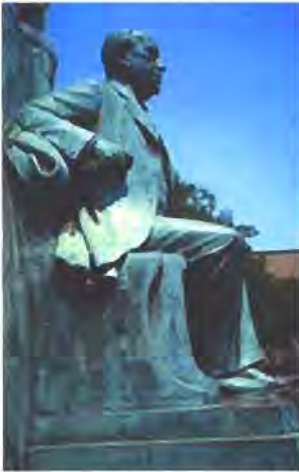
Bronze statuary may be cleaned gently using crushed walnut shells.
Photo: NPS files.

Sometimes a very fine smooth sand is used at a low pressure to clean or remove paint and corrosion from copper flashing and other metal building components. Restoration architects recently found that a mixture of crushed walnut shells and copper slag at a pressure of approximately 200 psi was the only way to remove corrosion successfully from a mid-19th century terne-coated iron roof. Metal cleaned in this manner must be painted immediately to prevent rapid recurrence of corrosion. It is thought that these methods "work harden" the surface by compressing the outer layer, and actually may be good for the surface of the metal. But the extremely complex nature and the time required by such processes make it very expensive and impractical for large-scale use at this time.

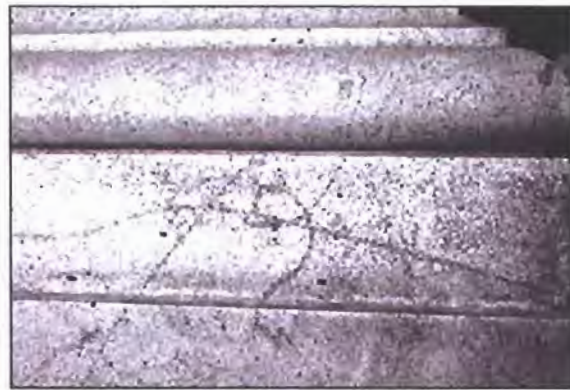
Very high-pressure water has scarred this granite. Photo: NPS files.

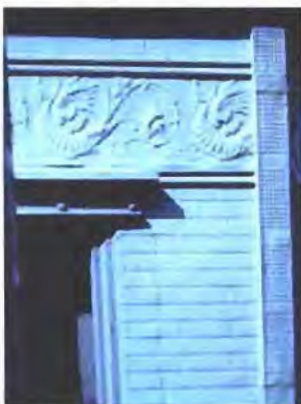
Decorative pressed metal interior or exterior features should not be cleaned abrasively. Photo: NPS files.

Much applied architectural metal work used on historic buildings--tin, zinc, lead and copper--is often quite thin and soft, and therefore susceptible to denting and pitting. Galvanized sheet metal is especially vulnerable, as abrasive treatment would wear away the protective galvanized layer.

In the late 19th and early 20th centuries, these metals were often cut, pressed or otherwise shaped from sheets of metal into a wide variety of practical uses such as roofs, gutters and flashing, and facade ornamentation such as cornices, friezes, dormers, panels, cupolas, oriel windows, etc. The architecture of the 1920s and 1930s made use of metals such as chrome, nickel alloys, aluminum and stainless steel in decorative exterior panels, window frames, and doorways. Harsh abrasive blasting would destroy the original surface finish of most of these metals, and would increase the possibility of corrosion.

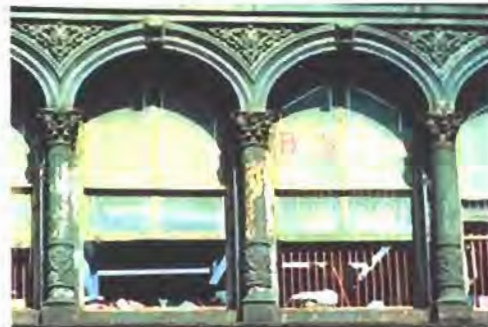
Cast iron may be abrasively cleaned, but must be painted immediately to prevent rust. Photo: NPS files.

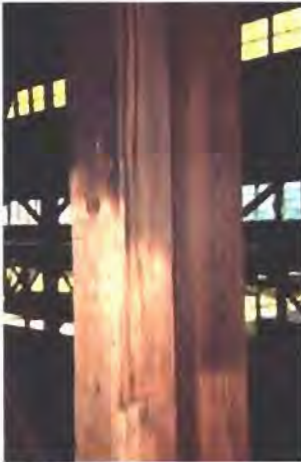
Industrial interiors that are not finely milled may be abrasively cleaned, in some instances. Photo: NPS files.

Interior spaces of factories or warehouse structures in which the masonry or plaster surfaces do not have significant design, detailing, tooling or finish, and in which wooden architectural features are not finished, molded, beaded or worked by hand, may be cleaned abrasively in order to remove layers of paint and industrial discolorations such as smoke, soot, etc. It is expected after such treatment that brick surfaces will be rough and pitted, and wood will be somewhat frayed or "fuzzy" with raised wood grain. These nonsignificant surfaces will be damaged and have a roughened texture, but because they are interior elements, they will not be subject to further deterioration caused by weathering.

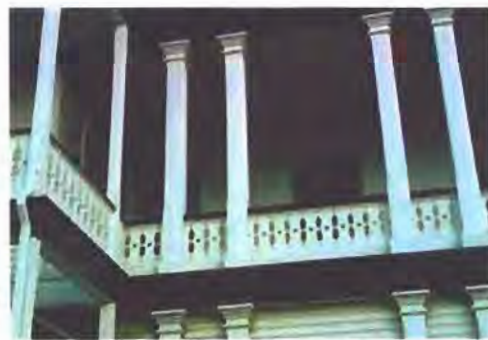
Decorative wood exterior or interior features should not be cleaned abrasively. Photo: NPS files.

Thus, it is not acceptable to clean abrasively interiors of historic residential and commercial properties which have *finished* interior spaces featuring milled woodwork such as doors, window and door moldings, wainscoting, stair balustrades and mantelpieces. Even the most modest historic house interior, although it may not feature elaborate detailing, contains plaster and woodwork that is architecturally significant to the original design and function of the house. Abrasive cleaning of such an interior would be destructive to the historic integrity of the building.

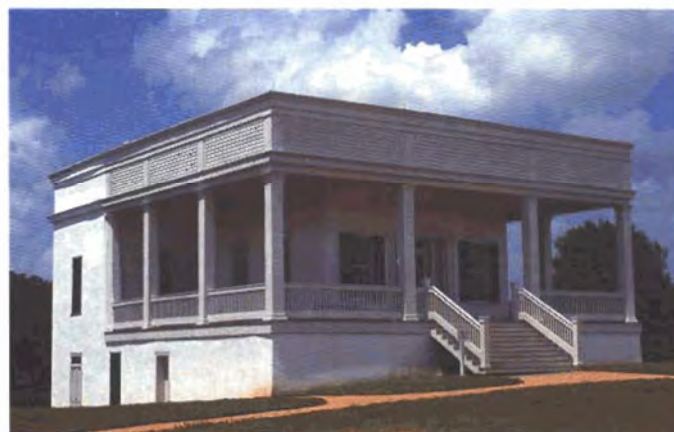
Figure 1. The Sebastopol House in Seguin, Texas, is an 1856 Greek Revival-style house constructed of lime concrete. Lime concrete or "limecrete" was a popular construction material, as it could be made inexpensively from local materials. By 1900, the town had approximately ninety limecrete structures, twenty of which remain. Photo: Texas Parks and Wildlife Department.

publicized in the second edition of Orson S. Fowler's *A Home for All* (1853) which described the advantages of "gravel wall" construction to a wide audience. The town of Seguin, Texas, thirty-five miles east of San Antonio, already had a number of concrete buildings by the 1850s and came to be called "The Mother of Concrete Cities," with approximately ninety concrete buildings made from local "lime water" and gravel (Fig. 1).

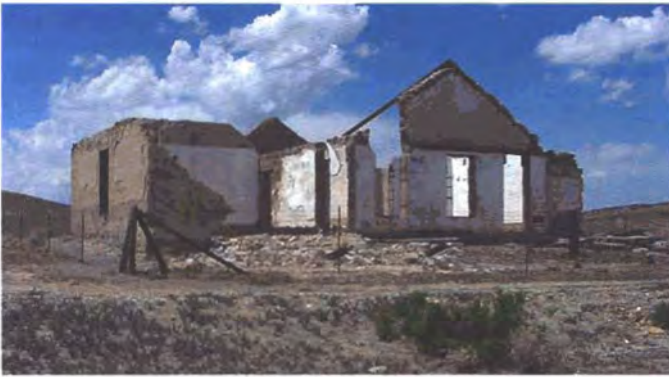
Figure 2. *Chatterton House* was the home of the post trader at Fort Fred Steel in Wyoming, one of several forts established in the 1860s to protect the Union Pacific Railroad. The walls of the post trader's house were built using stone aggregate and lime, without cement. The use of this material presents special preservation challenges.

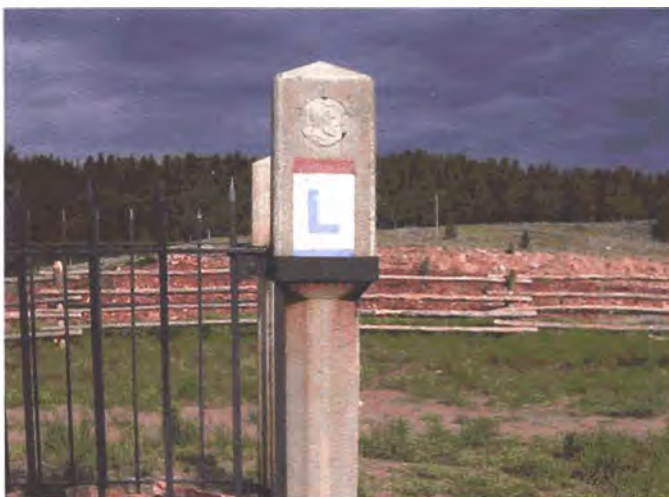
Figure 3. The Lincoln Highway Association promoted construction of a high quality continuous hard surface roadway across the country. The Boys Scouts of America installed concrete road markers along the Lincoln Highway in 1928.

Highway as an example. Concrete “seedling miles” were constructed in remote areas to emphasize the superiority of concrete over unimproved dirt. The Association believed that as people learned about concrete, they would press the government to construct good roads throughout their states. Americans’ enthusiasm for good roads led to the involvement of the federal government in road-building and the creation of numbered U.S. routes in the 1920s (Fig. 3).

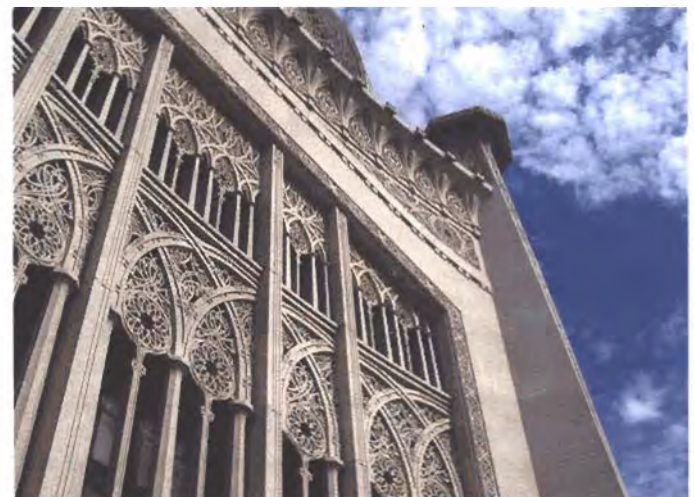
Figure 4. The highly ornamental concrete panels on the exterior facade of the Baha'i House of Worship in Wilmette, Illinois, illustrate the work of fabricator John J. Earley, known as "the man who made concrete beautiful."

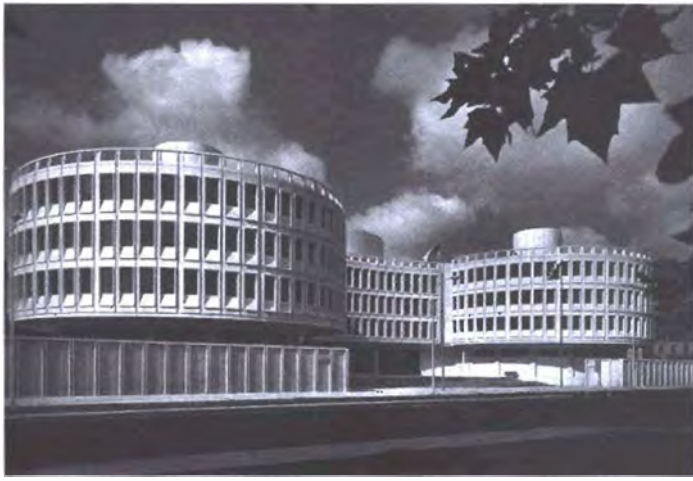
Figure 5. Following World War II, architects and engineers took advantage of improvements in concrete production, quality control, and advances in precast concrete to design structures such as the Police Headquarters building in Philadelphia, Pennsylvania, constructed in 1961. Photo: Courtesy of the Philadelphia Police Department.

During the early twentieth century, Ernest Ransome in Beverly, Massachusetts, Albert Kahn in Detroit, and Richard E. Schmidt in Chicago, promoted concrete for use in “Factory Style” utilitarian buildings with an exposed concrete frame infilled with expanses of glass. Thomas Edison’s cast-in-place reinforced concrete homes in Union Township, New Jersey (1908), proclaimed a similarly functional emphasis in residential construction. From the 1920s onward, concrete began to be used with spectacular design results: examples include John J. Earley’s Meridian Hill Park in Washington, D.C.; Louis Bourgeois’ exuberant, graceful Baha’i Temple in Wilmette, Illinois (1920–1953), for which Earley fabricated the concrete (Fig. 4); and Frank Lloyd Wright’s Fallingwater near Bear Run, Pennsylvania (1934). Continuing improvements in quality control and development of innovative fabrication processes, such as the Shockbeton method for precast concrete, provided increasing opportunities for architects and engineers. Wright’s Guggenheim Museum in New York City (1959); Geddes Brecher Qualls & Cunningham’s Police Headquarters building in Philadelphia, Pennsylvania (1961); and Eero Saarinen’s soaring terminal building at Dulles International Airport outside Washington, D.C., and the TWA terminal at Kennedy Airport in New York (1962), exemplify the masterful use of concrete achieved in the modern era (Fig. 5).

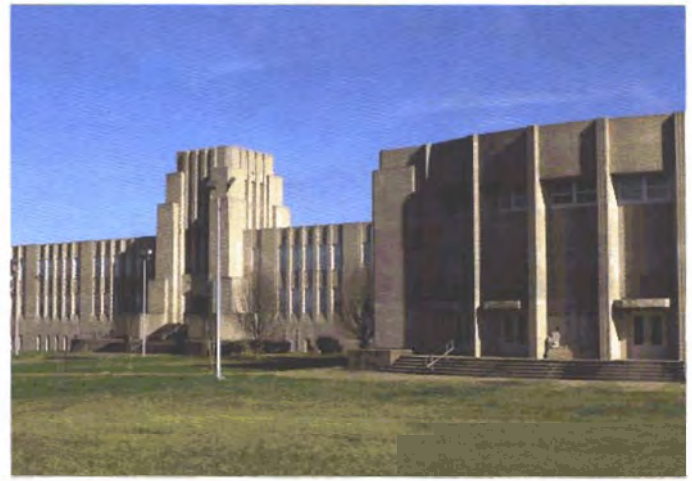
Figure 6. The Bailey Magnet School in Jackson, Mississippi, was designed as the Jackson Junior High School by the firm of N.W. Overstreet & Town in 1936. The streamlined building exemplifies the applicability of concrete to creating a modern architectural aesthetic. Photo: Bill Burriss, Burriss/Wagnon Architects, P.A.

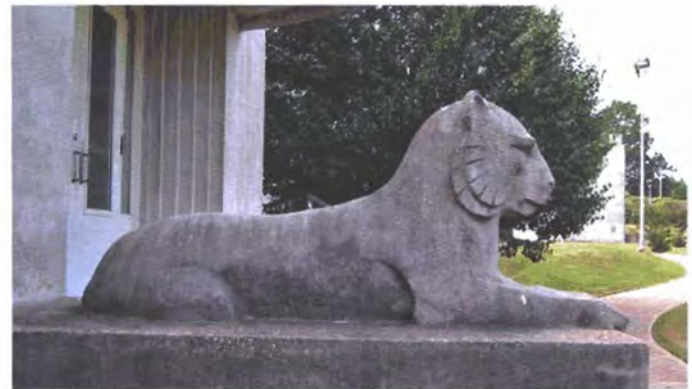
Figure 7. Detailed bas reliefs as well as sculptures, such as this lion at the Bailey Magnet School, could be used as ornamentation on concrete buildings. Sculptural concrete elements were typically cast in molds.

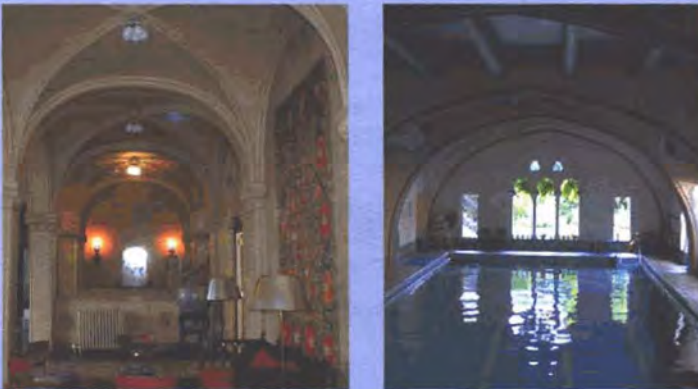
Figure 10. The Berkeley City Club has significant interior spaces and features of concrete construction, including the lobby and pool. Photos: Una Gilmartin (left) and Brian Kehoe (right), Wiss, Janney, Elstner Associates, Inc.

The expanded use of concrete provided new opportunities to create dramatic spaces and ornate architectural detail on the interiors of buildings, at a significant cost savings over traditional construction practices. The architectural design of the Berkeley City Club in Berkeley, California, expressed Moorish and Gothic elements in concrete on the interior of the building (Fig. 10). Used as a woman's social club, the building was designed by noted California architect Julia Morgan and constructed in 1929. The vaulted ceilings, columns, and ornamental capitals of the lobby and the ornamental arches and beamed ceiling of the "plunge" are all constructed of concrete.

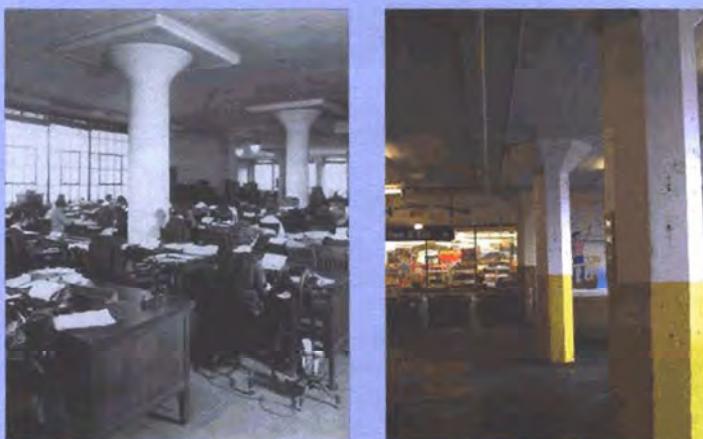
Figure 11. Whether in a circa 1925 office (left) or in a parking garage and retail facility (right), exposed concrete structures help characterize these building interiors. Photo: Minnesota Historical Society (left).

The historic character of a building's interior can also be conveyed in a more utilitarian manner in terms of concrete features and finishes (Fig. 11). The exposed concrete structure—columns, capitals, and drop panels—is an integral part of the character of this old commercial building in Minneapolis. In concrete warehouse and factory buildings of the early twentieth century, exposed concrete columns and formboard finish concrete slab ceilings are common features as seen in this warehouse, now converted for use as a parking garage and shops.

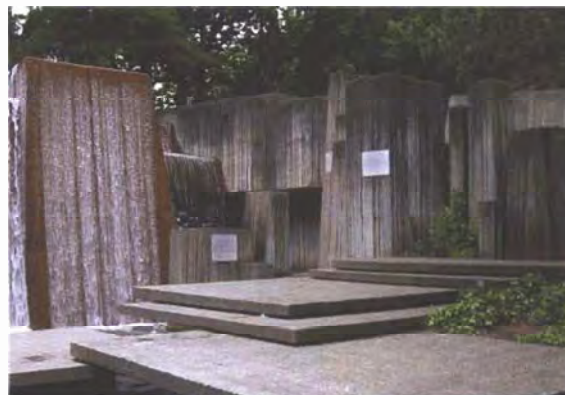
Figure 9. The Ira C. Keller Fountain in Portland, Oregon, was designed by Lawrence Halprin and constructed in 1969. The fountain is constructed primarily of concrete pillars with formboard textures and surrounding elements, patterned with geometric lines, which facilitate the path of water. Photo: Anita Washko, Wiss, Janney, Elstner Associates, Inc.

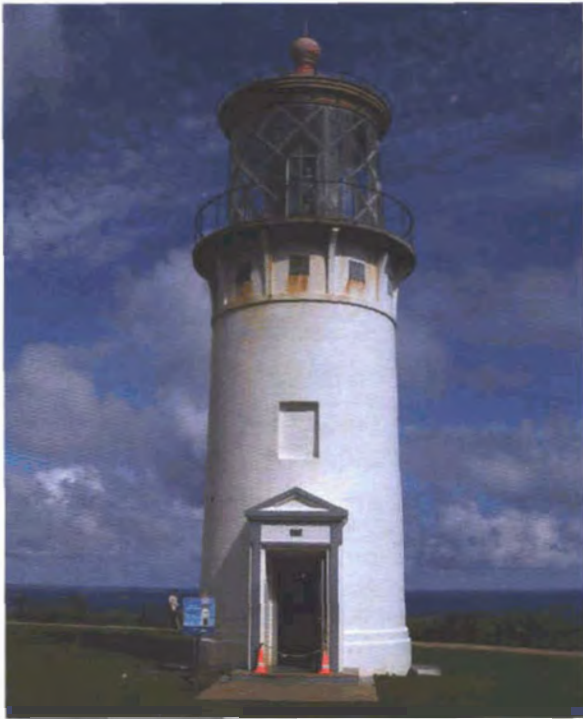
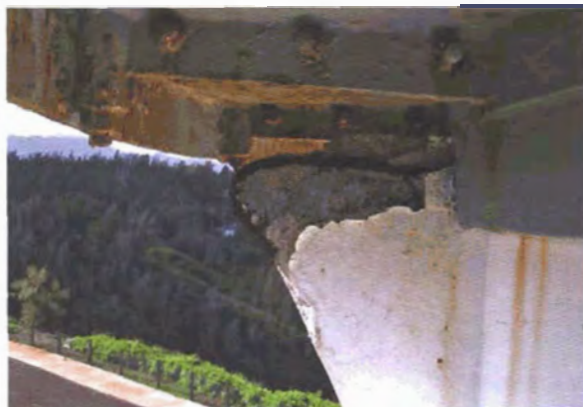
Figure 12. The concrete lighthouse at the Kilauea Point Light Station, Kilauea, Kauai, Hawaii, was constructed circa 1913. The concrete, which was a good quality, high strength mix for its day, is in good condition after almost one hundred years in service. Deterioration in the form of spalling related to corrosion of embedded reinforcing steel has occurred primarily in areas of higher ornamentation such as projecting bands and brackets (see close-up photo).

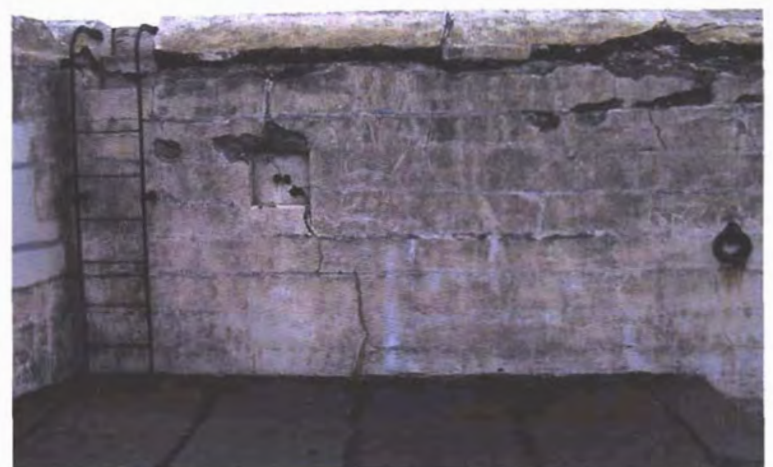
Figure 13. Fort Casey on Admiralty Head, Fort Casey, Washington, was constructed in 1898. The lift lines from placement of concrete are clearly visible on the exterior walls and characterize the finished appearance.

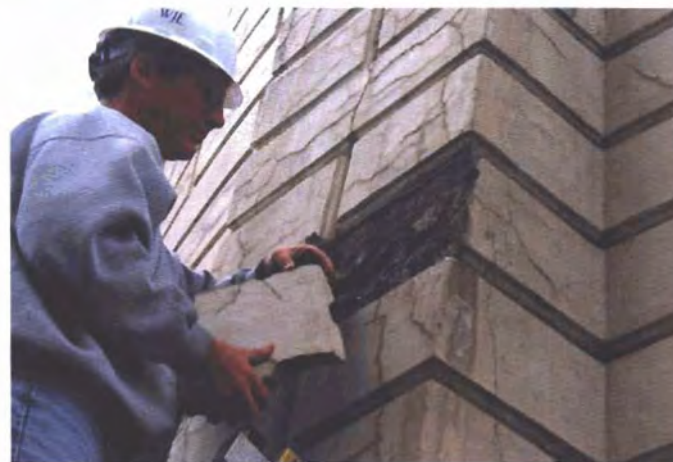
Figures 14. Layers of architectural concrete that have debonded (spalled) from the surface were removed from a historic water tank during the investigation performed to assess existing conditions. Photos: Anita Washko, Wiss, Janney, Elstner Associates, Inc.

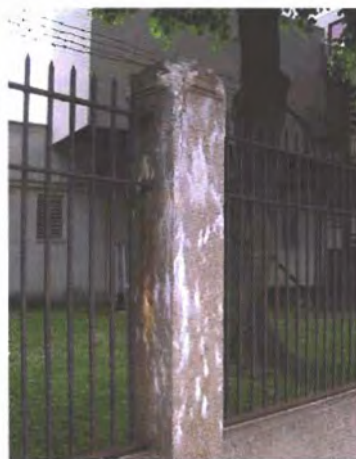
Figure 15. Evidence of moisture movement through concrete is apparent in the form of mineral deposits on the concrete surface. Cyclic freezing and thawing of entrapped moisture, and corrosion of embedded reinforcement, have also contributed to deterioration of the concrete column on this fence at Crocker Field in Fitchburg, Massachusetts, designed by the Olmsted Brothers.

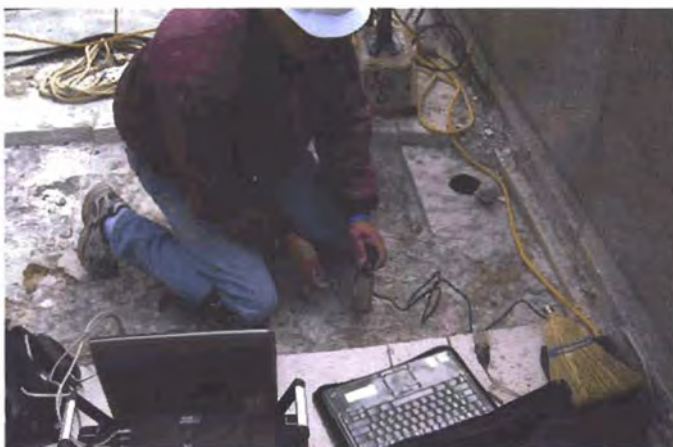
Figure 16. Impact echo testing is performed on a concrete structural slab to help determine depth of deterioration. In this method, a short pulse of energy is introduced into the structure and a transducer mounted on the impacted surface of the structure receives the reflected input waves or echoes. These waves are analyzed to help identify flaws and deterioration within the concrete.

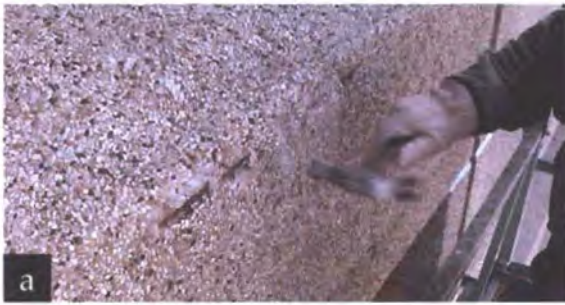
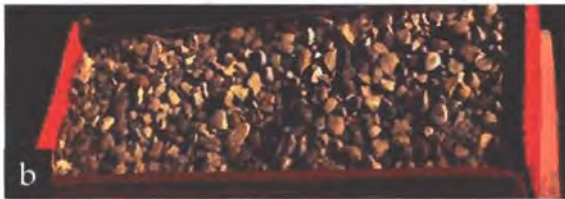
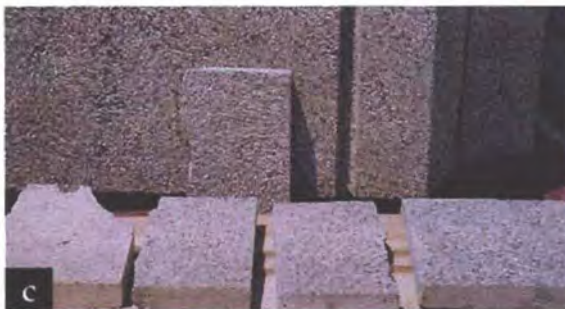
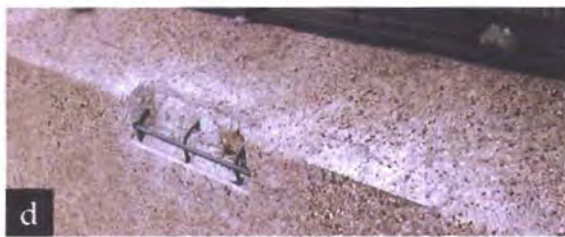
Figure 18. (a) Exposed aggregate precast concrete is sounded with a hammer to detect areas of deterioration. Corrosion of the exposed reinforcing steel bar has led to spalling of the adjacent concrete. (b) Samples of aggregate considered for use in repair concrete are compared to the original concrete materials in terms of size, color, texture, and reflectance. (c) Various sample panels are made using the selected concrete repair mix design for comparison to the original concrete on the building, and the mix design is adjusted based on review of the samples. (d) After removal of the spall, the concrete surface is prepared for installation of a formed patch. (e) Prior to placement of the concrete, a retarding agent is brush-applied to the inside face of the formwork to slow curing at the surface. After the concrete is partially cured, the forms are removed and the surface of the concrete is rubbed to remove some of the paste and expose the aggregate to match the original concrete.

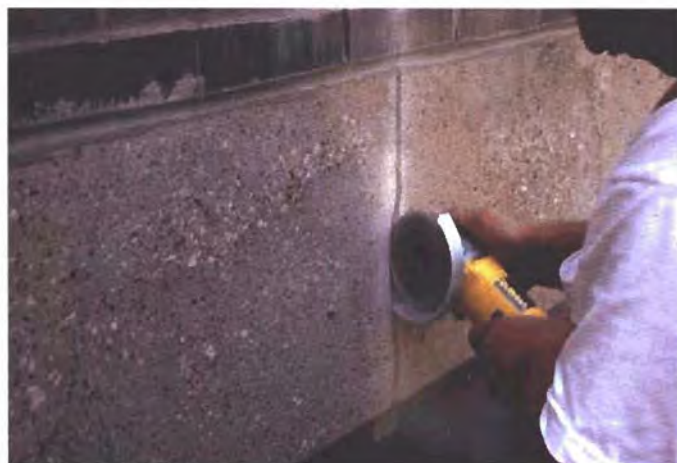
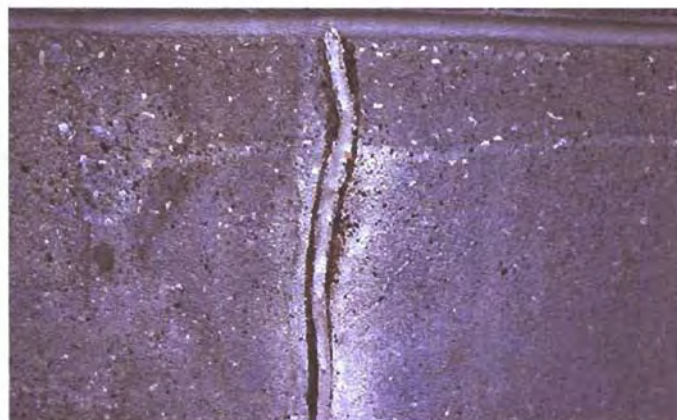
Figure 19. A high-speed grinder is used to widen a crack in preparation for installation of a sealant. This process is called "routing." After the crack is prepared, the sealant is installed to prevent moisture infiltration through the crack. Although sealant repairs can provide a durable, watertight repair for moving cracks, they tend to be very visible.

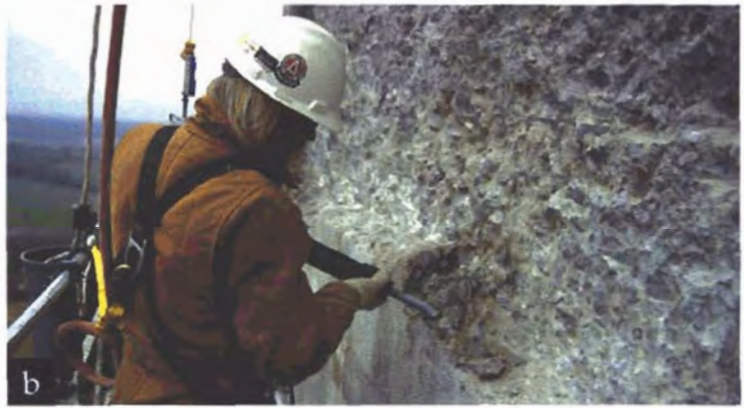
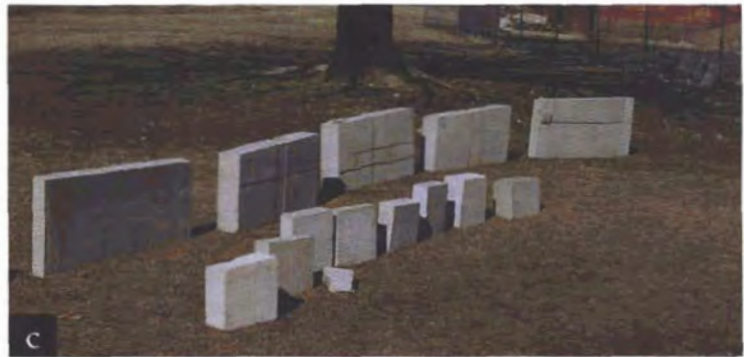
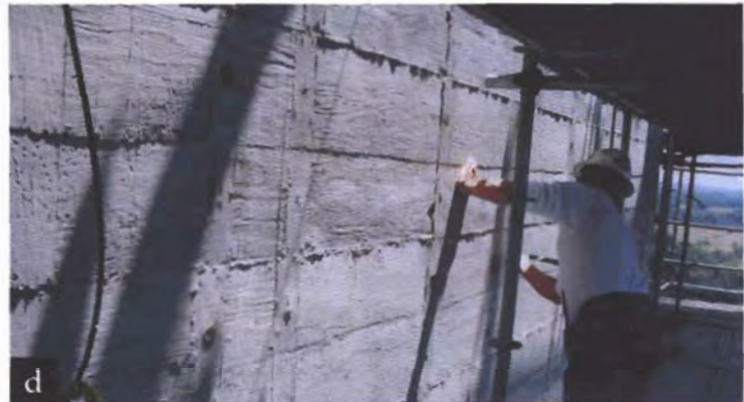
Figure 20. (a) The Jefferson Davis Memorial in Fairview, Kentucky, constructed from 1917–1924, is 351 feet tall and constructed of unreinforced concrete. The walls of the memorial are 8 feet thick at the base and 2 feet thick at the top of the wall. Access to the monument for investigation was provided by rappelling techniques, while ground supported and suspended scaffolding was used to access the exterior during repairs. (b) The concrete was severely deteriorated at isolated locations, with spalling and damage from cyclic freezing and thawing of entrapped water. In addition, previous repairs were at the end of their service life and removal of deteriorated concrete and failed previous repairs was required. Light duty chipping hammers were used to avoid damage to adjacent material when removing deteriorated concrete to the level of sound concrete. (c) Field samples were performed to match the color, finish, and texture of the original concrete. A challenge in matching of historic concrete is achieving variability of appearance. (d) The completed surface after repairs exhibits intentional variability of the concrete surface to match the appearance of the original concrete. Some formwork imperfections that would normally be removed by finishing were intentionally left in place, to replicate the highly variable finish of the original concrete. (e) The Jefferson Davis Memorial after completion of repairs in 2004. Photo e: Joseph Lenzi, Senler, Campbell & Associates, Inc.

due to original construction techniques, architectural design, or differential exposure to weather. Trial repairs and mock-ups are used to evaluate the proposed replacement concrete work and to refine construction techniques (Fig 20).
