National Pollutant Discharge Elimination System  
Municipal Separate Storm Sewer System  
Permit No. 11-DP-3313 MD0068276  
Permit Term October 9, 2015 to October 8, 2020

# Fifth Annual Report

## October 9, 2020

Maryland Department of Transportation  
State Highway Administration  
Office of Environmental Design  
707 North Calvert Street, C-303  
Baltimore, MD 21202

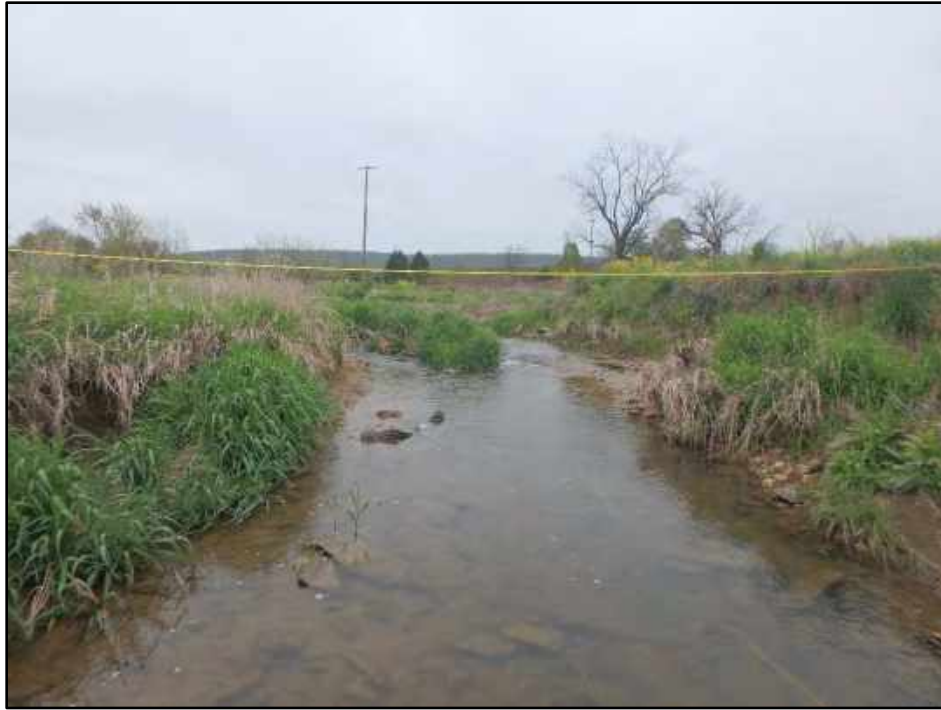
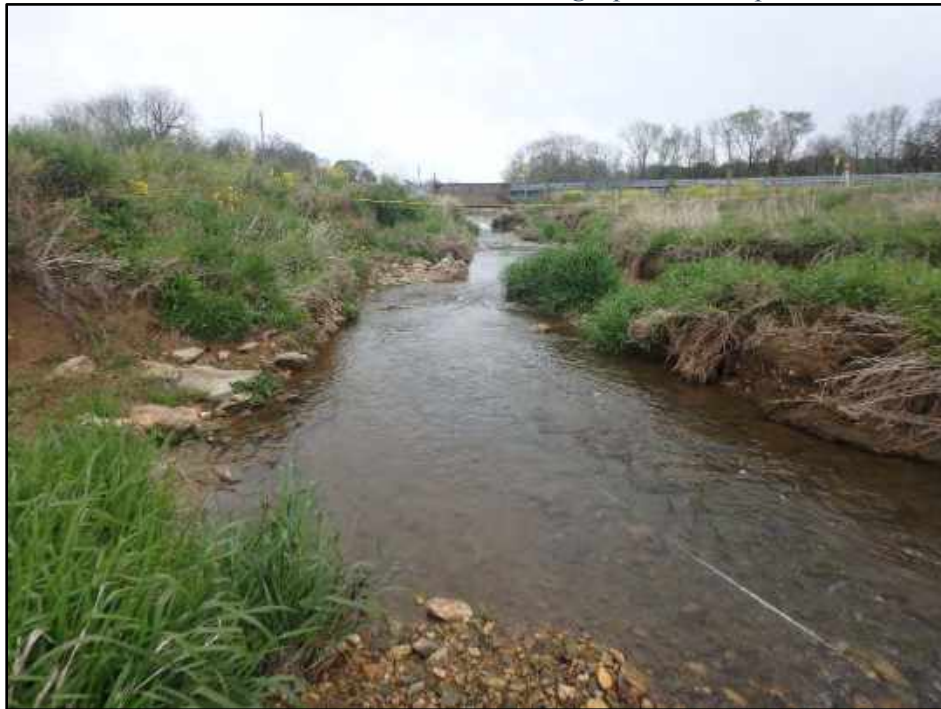
Cross Section P-1 is now located at the max depth of a pool compared to 2019 when the cross section was located at the start of a glide. Sediment deposition appears to shift regularly through the bottom of the channel in this reach. At Cross Section P-1, the left bank eroded 1.8 feet between 2017 and 2020 while the right bank aggraded vertically 0.4 feet (Figure 8). In 2020, additional erosion occurred along the left bank at the top of bank, widening the channel approximately 1.4' and lowering the vegetated bench by approximately 1.0'. Between 2019 and 2020, the thalweg has remained relatively unchanged as well as the right bank which is heavily vegetated. The channel thalweg downcut by 0.2', which is consistent with the profile comparison. Cross section P-1 is depicted as the yellow horizontal tape in Photo 1 and Photo 2. Historically, between the August 2018 and June 2019 surveys, the channel thalweg experienced significant scouring that resulted in the thalweg dropping roughly 1.5 feet as the cross section is now crossing through a pool.

*Photo 1 – Section 1 Cross Section Looking Upstream – April 2020*

*Photo 2 - Section 1 Cross Section looking downstream – April 2020*

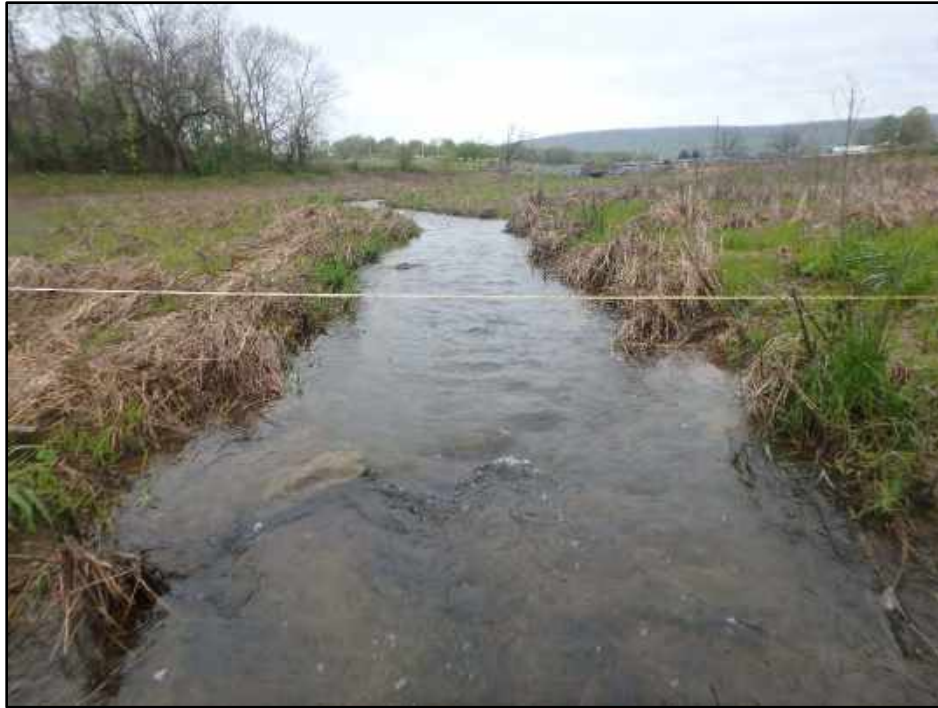
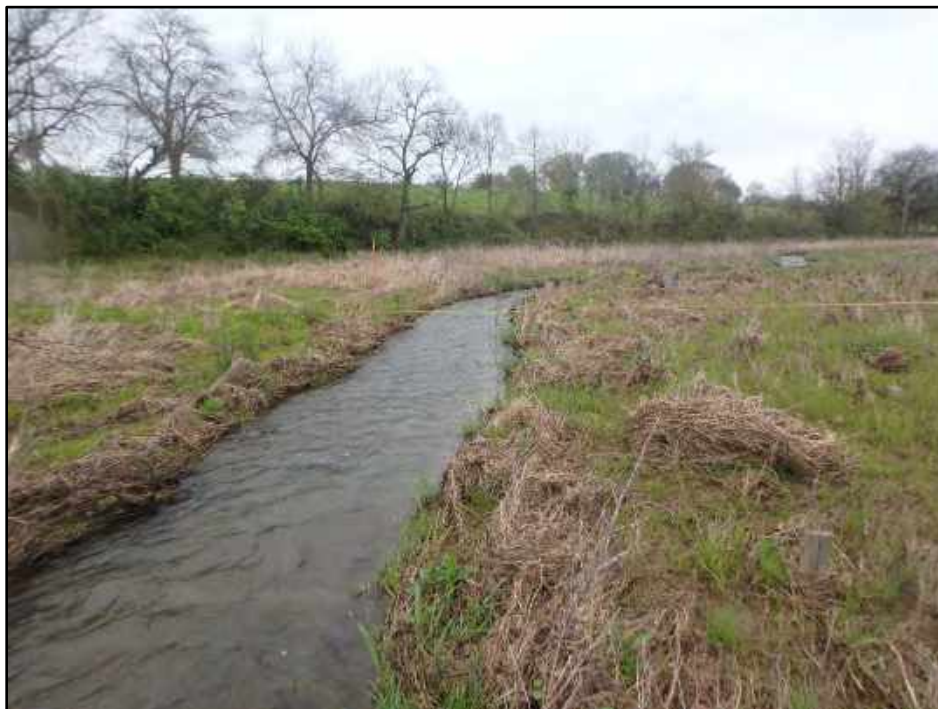
Figure 11 shows the first and second years of post-restoration cross-section surveys. Cross Section 2 is located within a riffle. Between 2019 and 2020 some minor erosion has taken place along the left bank with the top of the left bank eroding 0.4'. Deposition of a similar quantity has taken place at the top of the right bank along this cross-section as well. The channel has minor vertical erosion of about 0.2'. Overall, the channel geometry has remained very similar from 2019 to 2020. The elevated survey point at 0+45.3 is due to a dense grass located on the floodplain. Cross section P-2 is depicted as the yellow horizontal tape in Photo 3 and Photo 4.

*Photo 3 – Cross Section P-2 – Looking upstream – April 2020*

*Photo 4 - Cross Section P-2 – Looking downstream – April 2020*

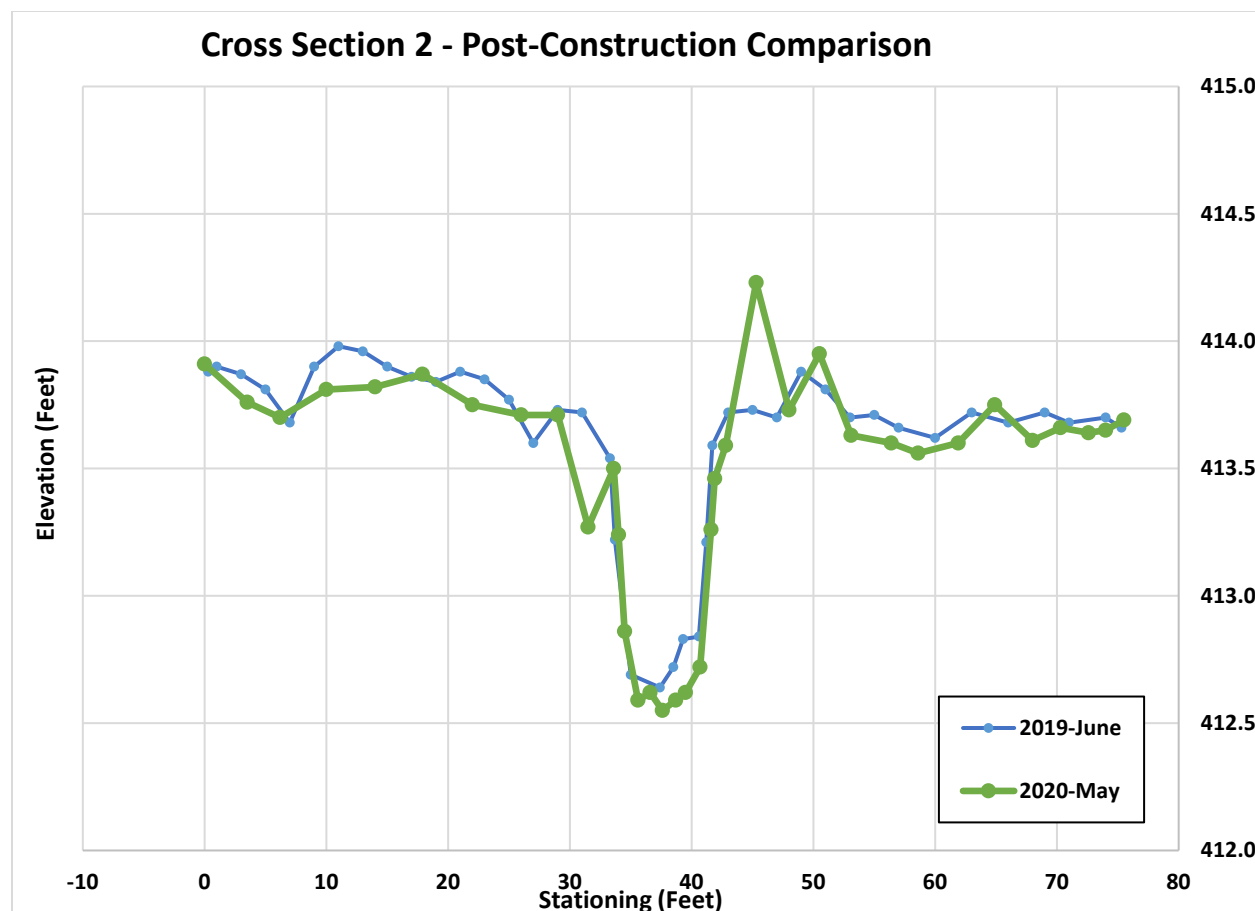
Figure 11 - Cross Section P-2 – Post-construction (2019-2020)

Prior to restoration, the left bank of Cross Section 2 had eroded approximately 4 feet (horizontally) between January and July of 2018, exposing two (2) vertical feet of the left pin. Historical surveys indicated that the gravel deposition along the banks of the channel is regularly mobilized – the 2017 survey shows a widened channel when compared to 2015. From 2017 to 2018, bed material has aggraded along the right bank.

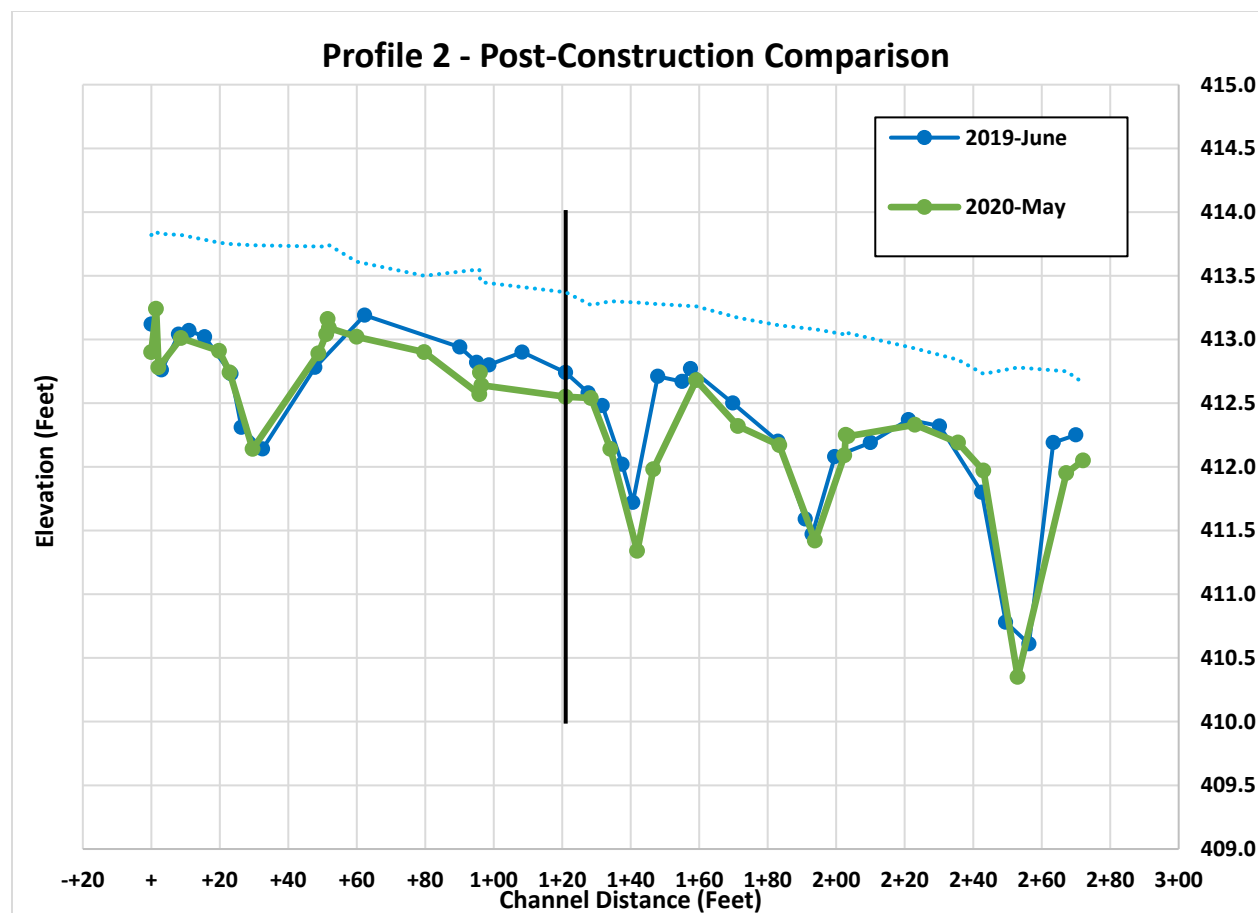
Figure 12 - Profile P-2 Comparison – Post-Construction (2019-2020)

Cross Section 2 is located at a riffle. Figure 12 shows the first and second year of post-restoration longitudinal profile surveys. The channel slope at Section 2 became steeper compared to 2019. The slope was 0.49% in 2020 and 0.40% in 2019. The overall profile remained very similar from 2019 to 2020. The profile shows some slight downcutting in the riffle and dmax of the pools, but the bed features did not shift significantly upstream or downstream between the years. Based on field observations, downcutting was not observed and the profile result may be due to variation of the survey methodology.

Prior to restoration, the pools and riffles have demonstrated adjustment of grade features in pre-restoration surveys. The overall grade had flattened from 1.154% in 2017 to 1% in 2018 when comparing the water surface slope. The grade control feature that appeared in July 2018 was the downstream end of the scour pool immediately downstream of the MD 180 bridge. The post-restoration monitoring reach has been relocated further downstream to avoid any influence of the MD 180 bridge.

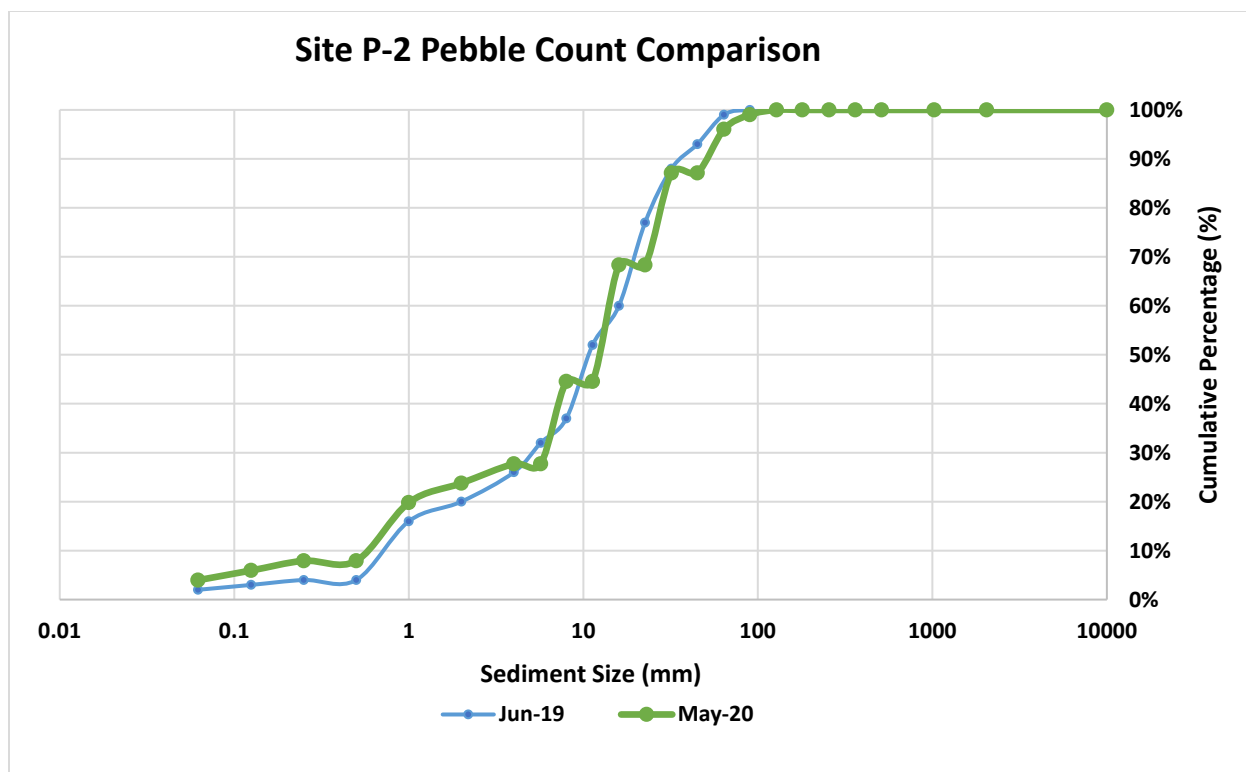
Figure 13 – Section P-2 Riffle Bed Material Comparison

The channel material remained relatively the same in 2020 (Figure 13). In 2020, the post-construction channel had a D50 of 12mm (medium gravel) and D84 of 30mm (very coarse gravel) compared to 2019 with a D50 of 11mm and D84 of 28mm. Comparison of the channel material below indicates that in 2020 the riffle material remains coarsened due to the restoration and is predominantly a gravel/cobble channel. The differences in pebble count results are most likely due to variations in sampling methodology.

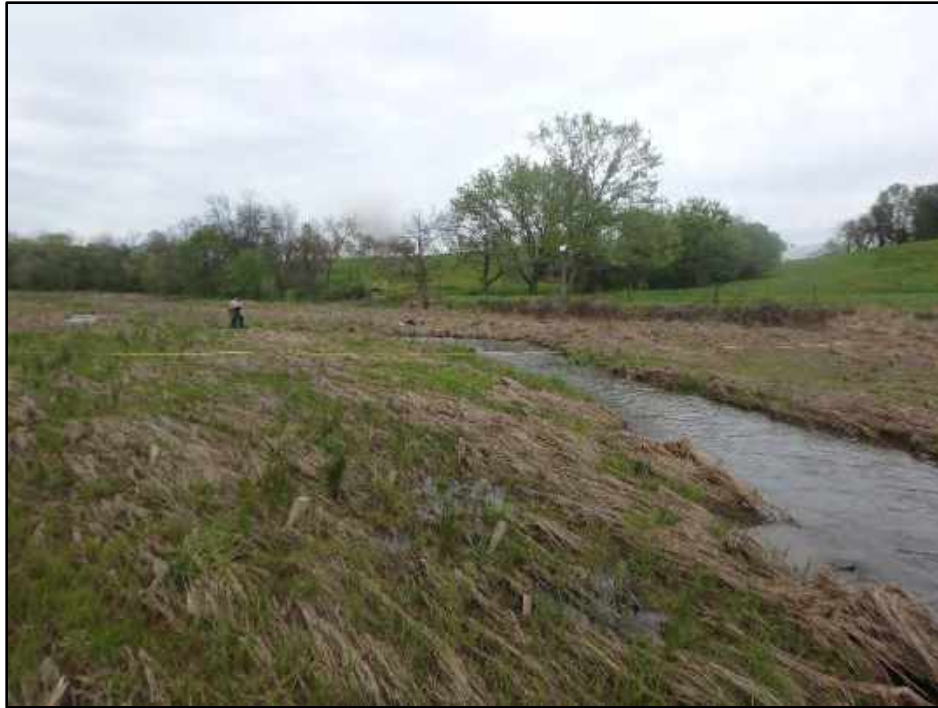
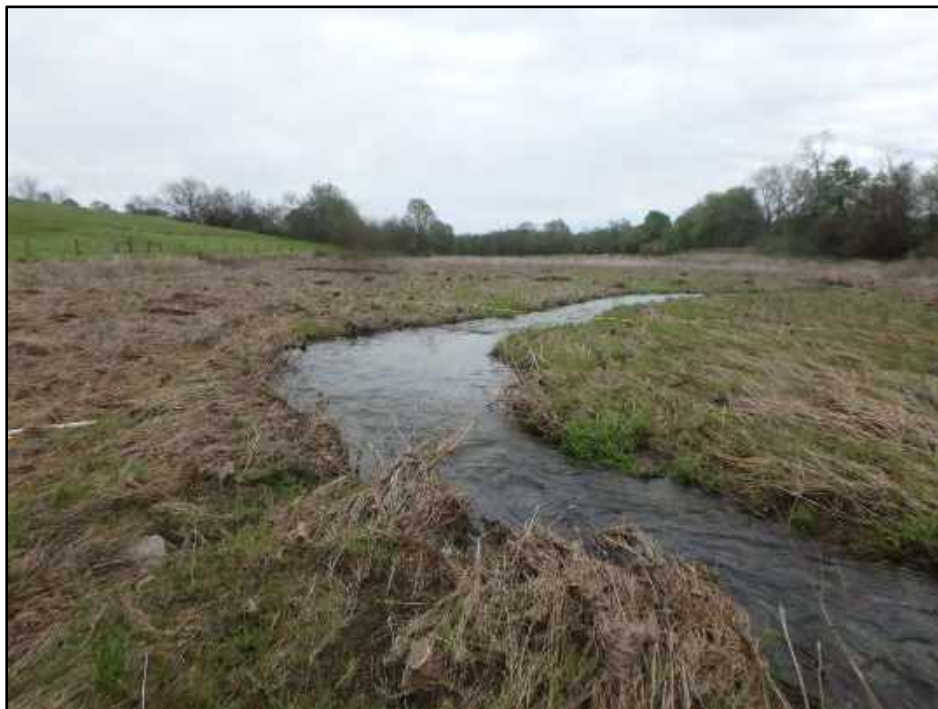
Figure 14 shows the first and second years of post-construction cross-section surveys for Section 3. The cross-section, which is located within a riffle, has remained unchanged between 2019 and 2020. Cross section P-3 is depicted as the yellow horizontal tape in Photo 5 and Photo 6.

*Photo 5 – Cross Section P-3 – Looking upstream – May 2020*

*Photo 6 - Cross Section P-3 - Looking downstream – May 2020*

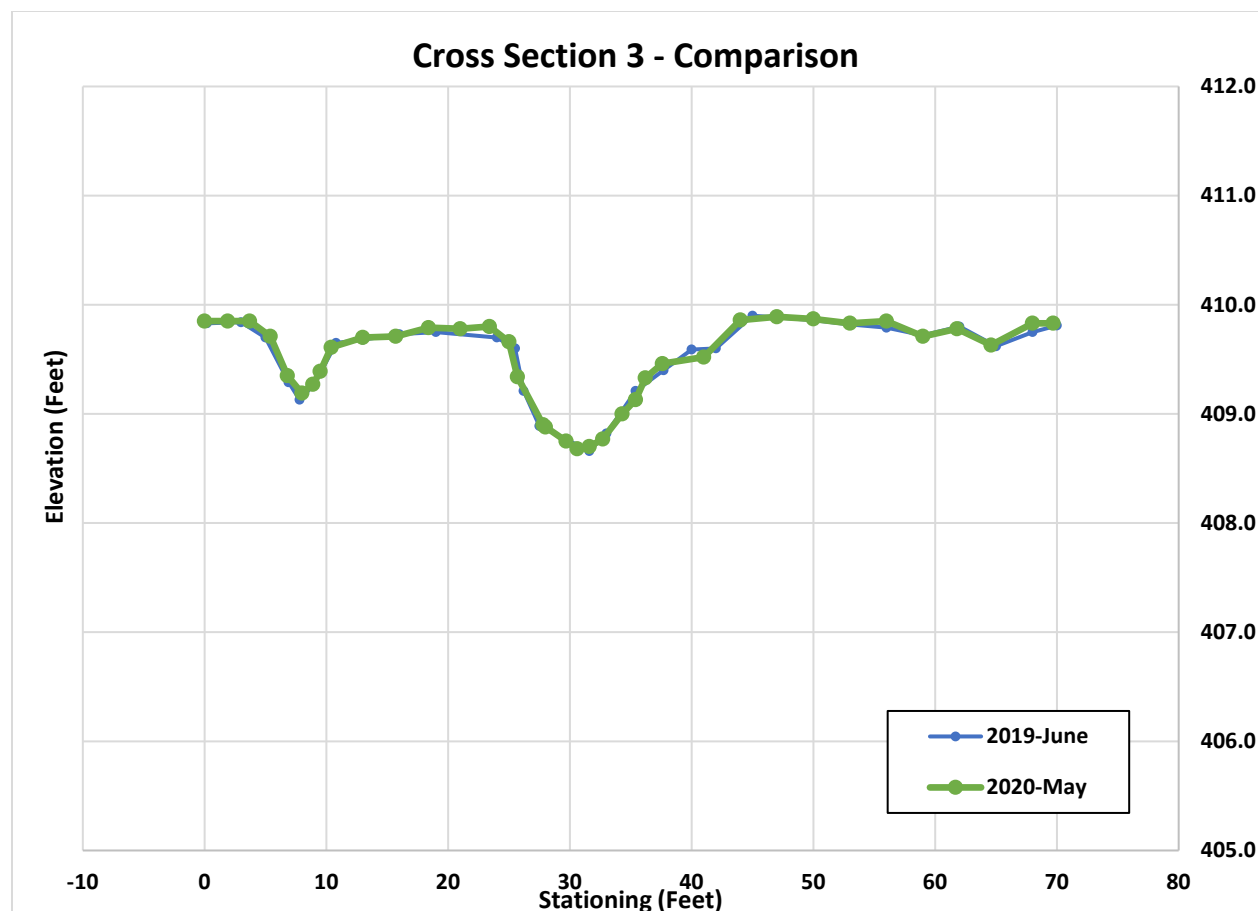
Figure 14 - Cross Section P-3 - Post-Construction (2019-2020)

Pre-restoration changes from January to July of 2018 included 2-4 inches of fine sediment deposited on the right floodplain. Minor erosion and a small depositional bar at the left toe were documented during pre-restoration surveys.

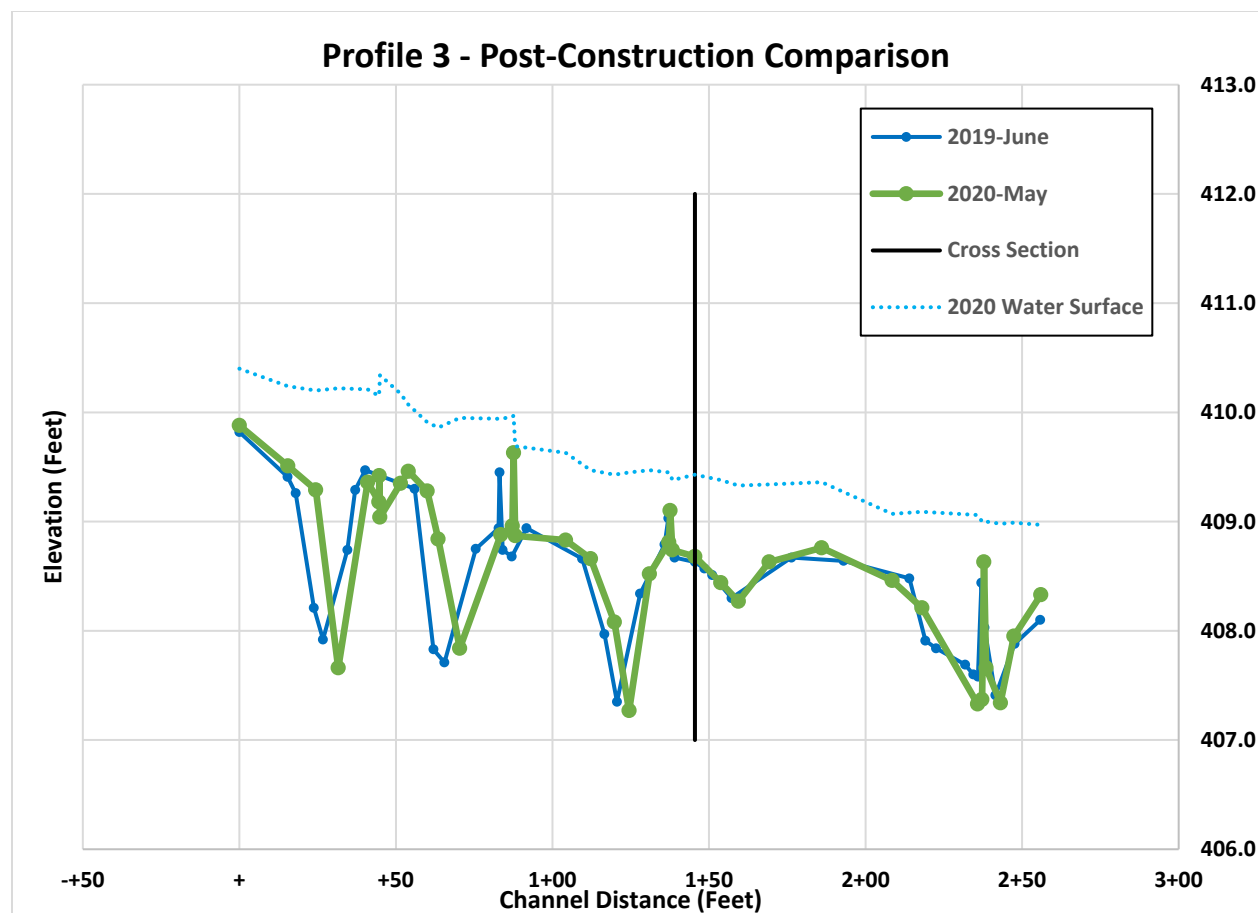
Figure 15 - Profile P-3 Comparison - Post-Construction (2019-2020)

Cross Section 3 is located at a riffle. Figure 15 shows the first and second year of post-restoration longitudinal profile surveys. Between 2019 and 2020, bed features upstream of the cross section have shifted downstream by approximately five (5) feet on average. The shift of channel features downstream could be the result in variations of survey methodology. Downstream features remain relatively unchanged likely due to the grade control feature upstream of the cross-section. This portion of the restoration reach contains three grade control structures (i.e., log sills). The post-restoration channel slope remained relatively the same at 0.56% in 2020, as compared to 0.58% in 2019.

Prior to restoration, the overall channel morphology was unchanged between 2017 and 2018. The pre-restoration slope for P-3 was 0.94%.

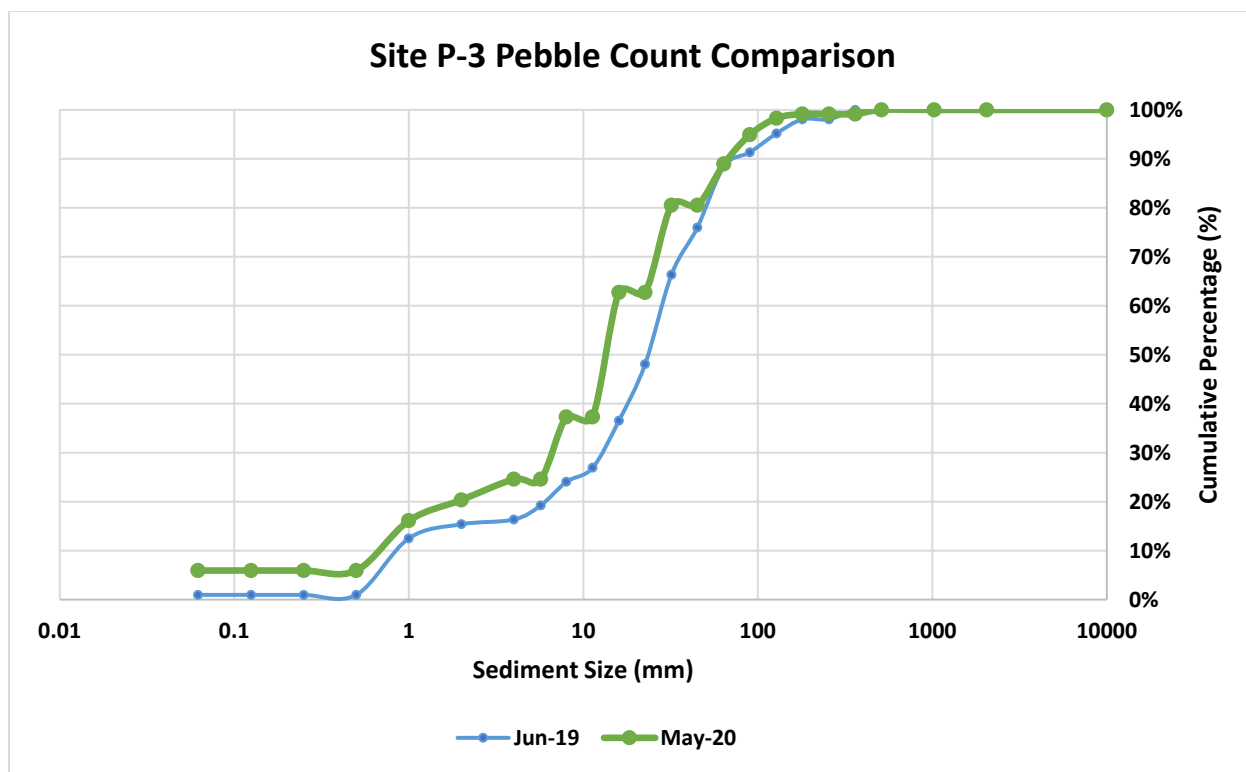
Figure 16 – Section P-3 Riffle Bed Material Comparison

Overall, the observed channel material was smaller in 2020 (Figure 16) at this section. In 2020, the post-construction channel had a D50 of 13mm (medium gravel) and D84 of 52mm (very coarse gravel) compared to 2019 with a D50 of 23mm (medium gravel) and D84 of 56mm (very coarse gravel). The differences in pebble count results are most likely due to variations in sampling methodology.

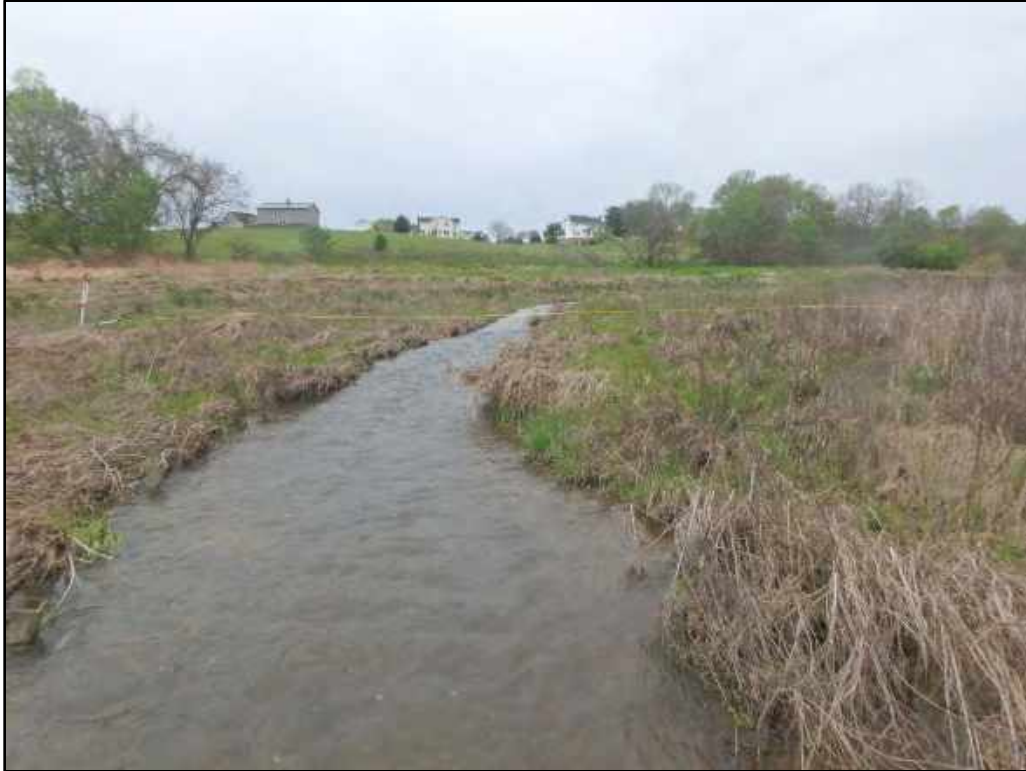
Figure 17 shows the first and second years of post-construction cross-section surveys for Section 4. Post-Construction results indicate this cross section, which is located at a riffle, has remained consistent between 2019 and 2020. Some slight deposition of fine sediments and vegetation growth have taken place along the flood plain. Cross section P-4 (post-construction) is depicted as the yellow horizontal tape in Photo 7 and Photo 8.

Historically, P-4 was highly unstable during the pre-construction phase. The left pin was exposed by two feet and the right bank had eroded by four feet between January and July of 2018. A large gravel bar had formed on the left bank and the entire channel had shifted over the two-year pre-construction monitoring period.

*Photo 7 – Cross Section P-4 – Looking upstream – May 2020*

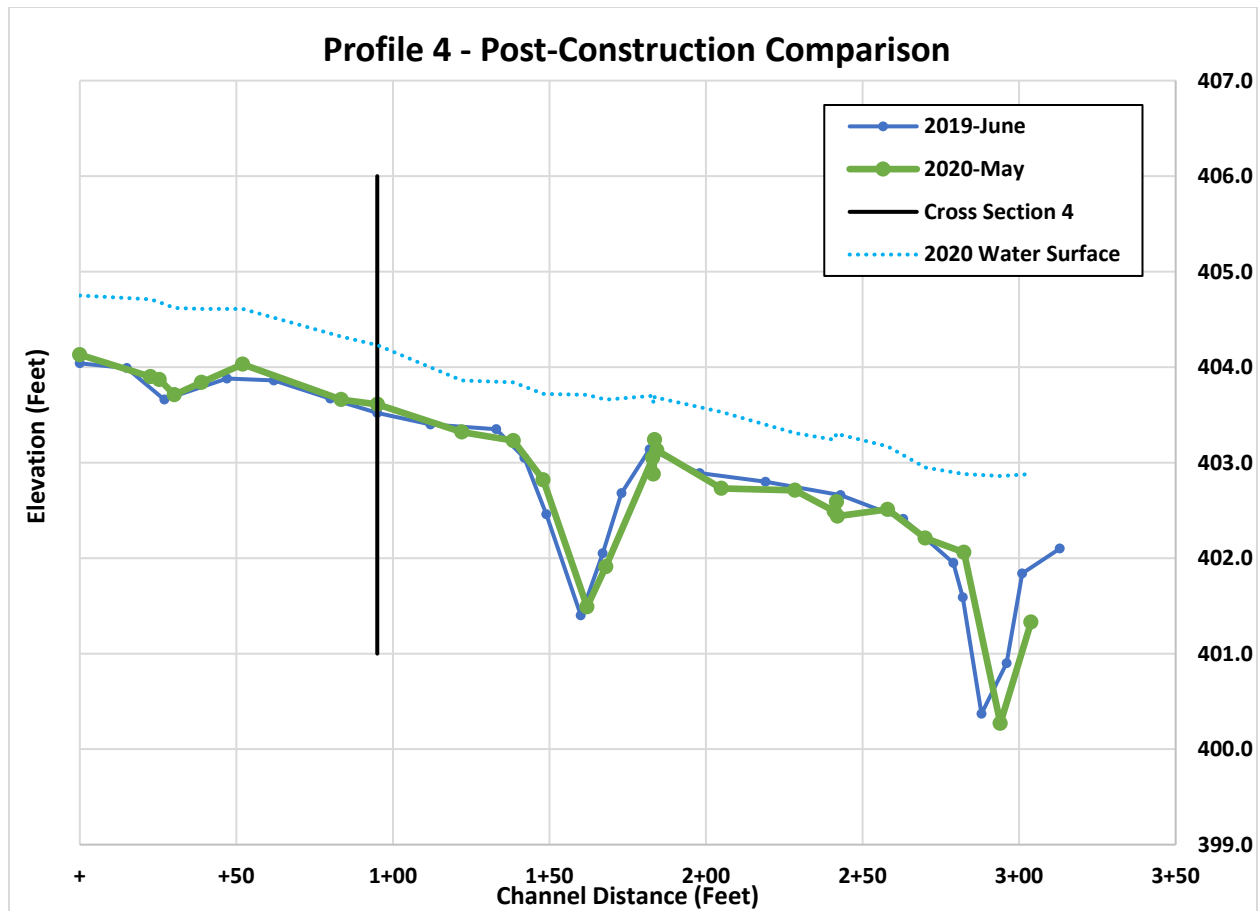
Cross Section 4 is located at a riffle. Figure 18 shows the first and second year of post-restoration longitudinal profile surveys. The post restoration channel slope remained the same at 0.58% in both 2019 and 2020. The run into the downstream pool steeped and may indicate minor instability downstream of this reach.

Prior to restoration, the pre-construction cross section for P-4 was surveyed at a riffle in 2017, but downstream migration of the riffle resulted in the formation of a pool at the cross-section location in 2018. During pre-construction, the upstream riffle migrated approximately 70 feet in the downstream direction. While the channel bed thalweg had remained at approximately the same elevation, the downstream channel had aggraded during pre-construction. The pre-construction slope for this reach in 2018 was 0.41%.

Figure 18 - Profile P-4 Comparison – Post-Construction (2019-2020)

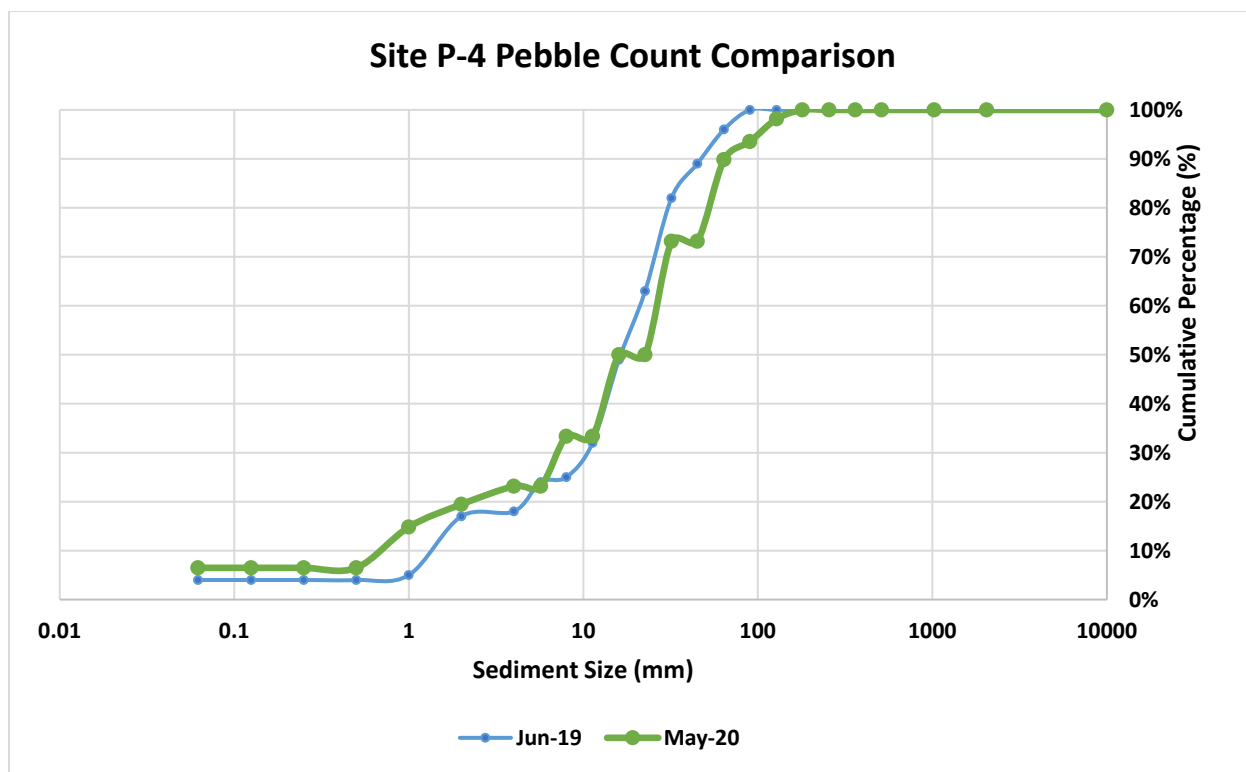
Overall channel material was observed to be the same in 2020 (Figure 19) at this section. The material of the grade control riffle feature is predominantly gravel throughout each survey. The D50 remained the same between 2019 and 2020 at 16mm (coarse gravel). The D84 increased but remained similar between 2019 (35mm) and 2020 (57mm) within the very coarse gravel category. The differences in the D84 pebble count results are most likely due to variations in sampling methodology.

Figure 19 – Section P-4 Riffle Bed Material Comparison

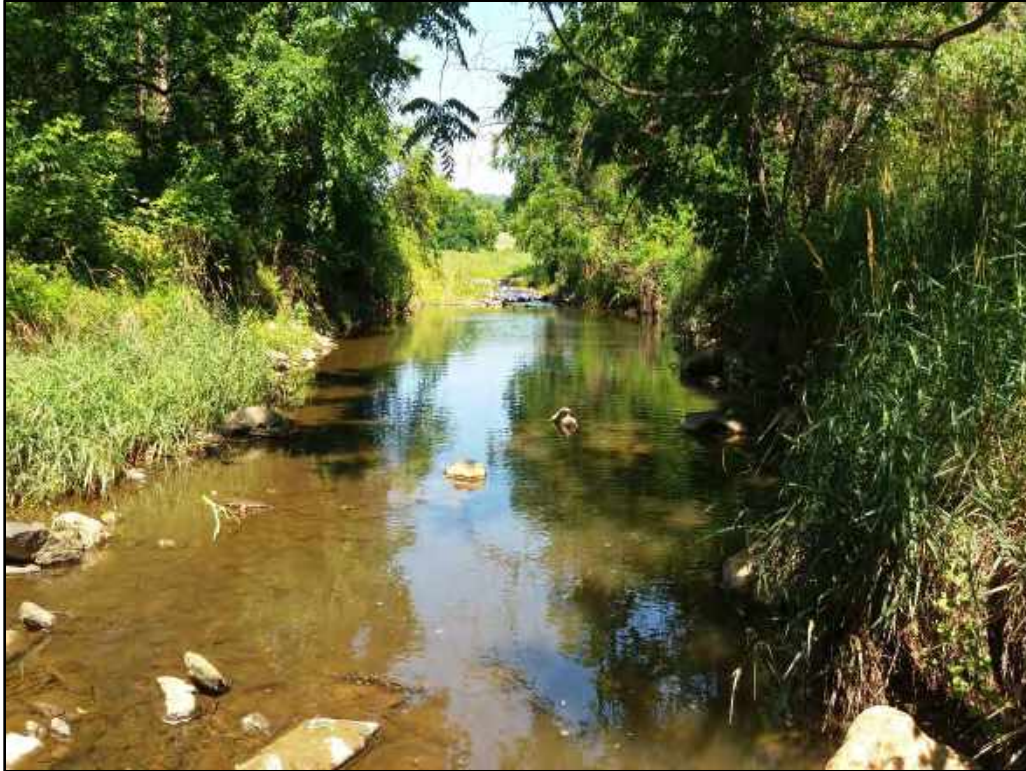
The cross section, located within a transition between a riffle and pool, did not significantly change from 2019 to 2020 (Figure 20). There was some deposition along the left bank towards the middle of the channel, but the thalweg elevation remained consistent. Cross section P-5 is depicted in Photo 9 and Photo 10.

*Photo 9 – Cross Section P-5 – Looking upstream – May 2020*

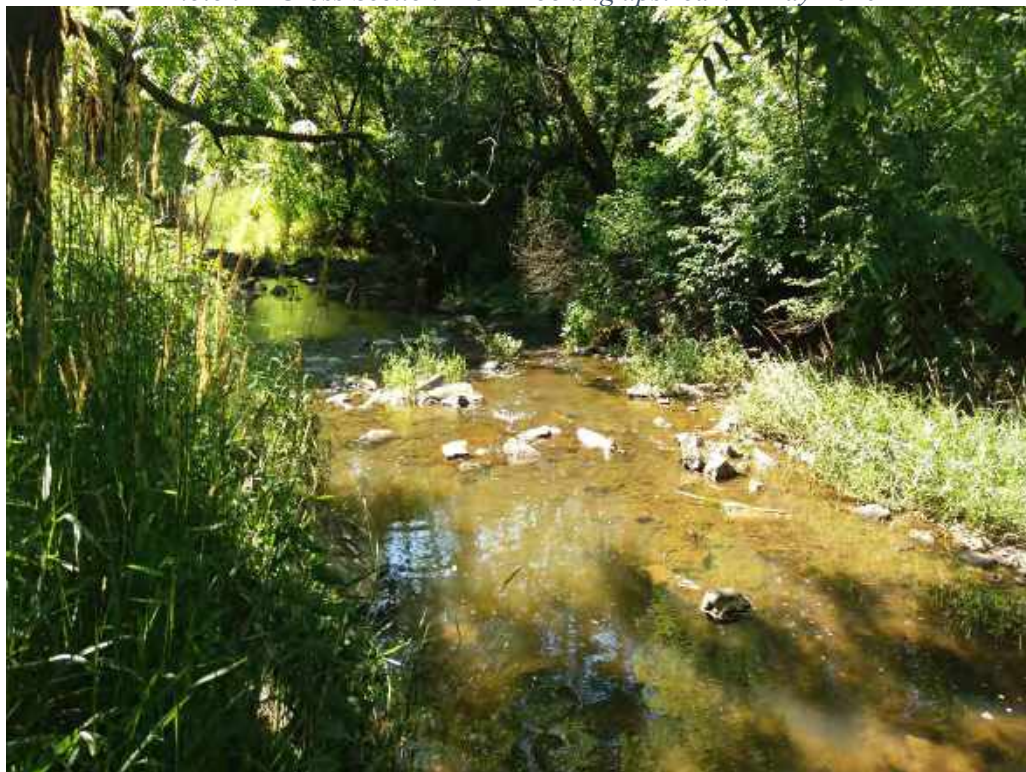
*Photo 10 - Cross Section P-5 – Looking downstream – May 2020*

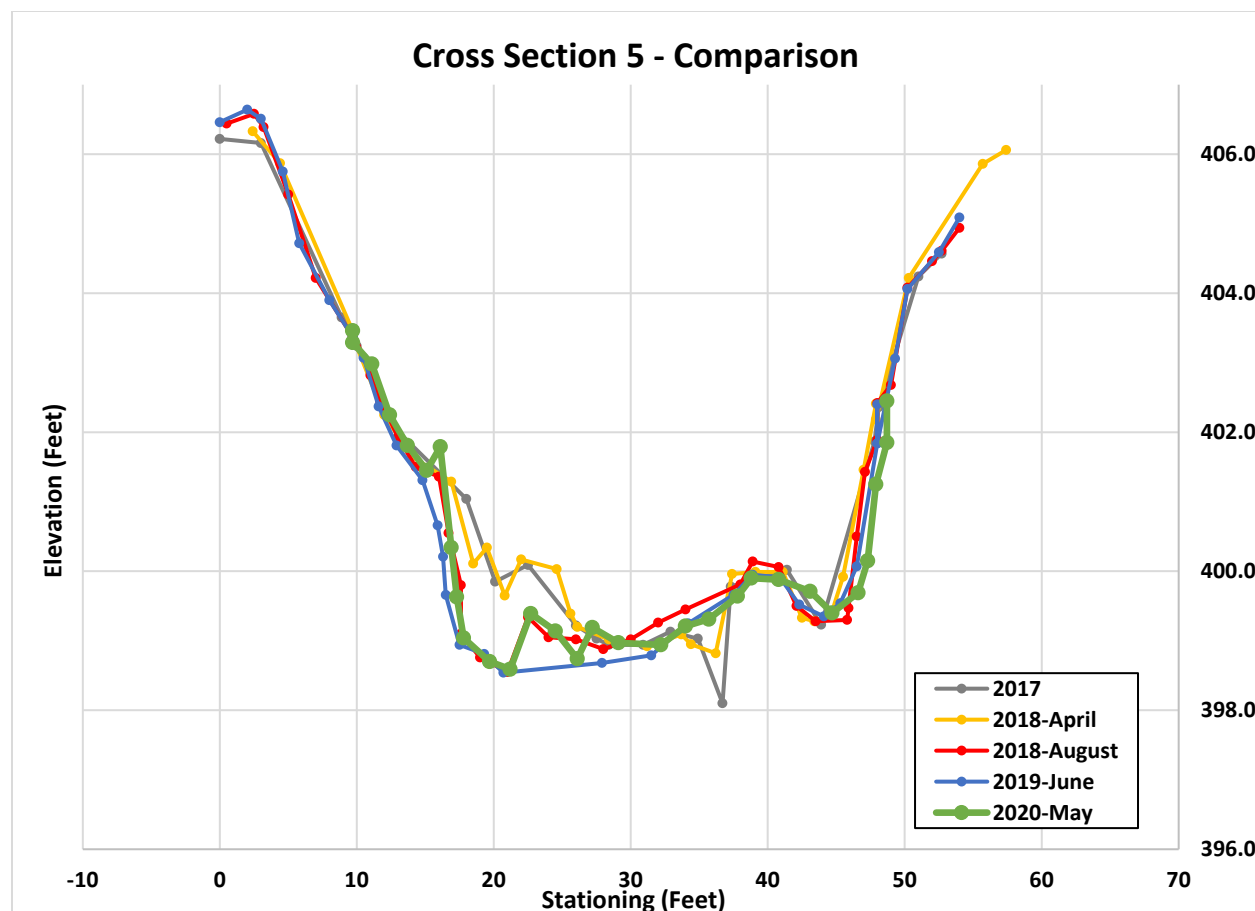
Historically, the left toe scoured down approximately one foot between April 2018 and August 2018, which likely occurred during the extreme flooding event in May 2018. The rest of the channel remained largely unchanged and both banks are fully vegetated.

Figure 20 - Cross Section P-5 Comparison (2017 to 2020)

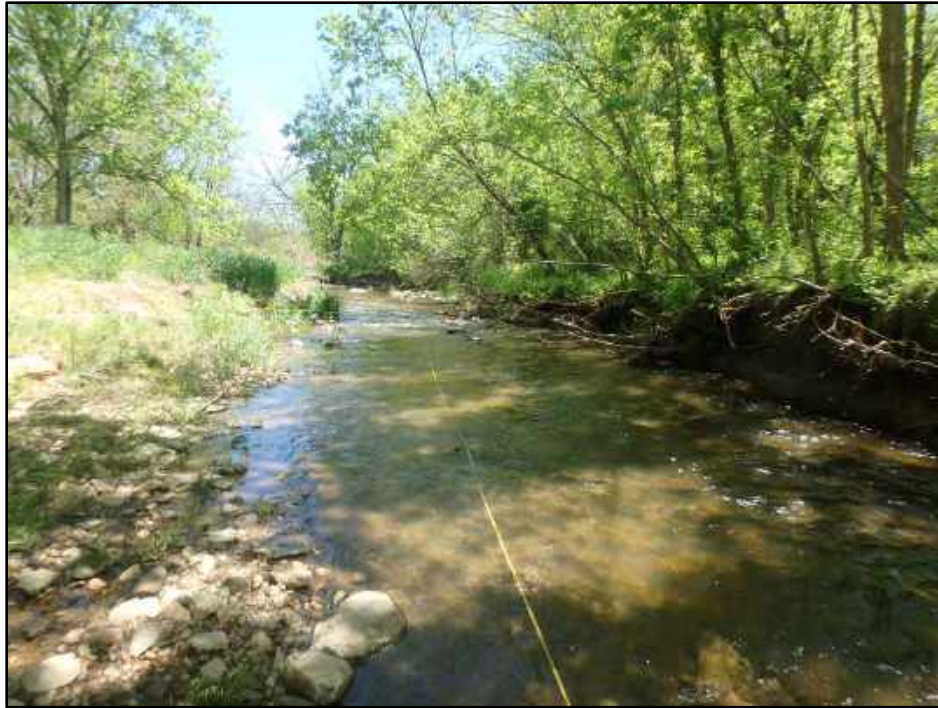
*Photo 11 – Cross Section P- 6 – Looking downstream – May 2020*

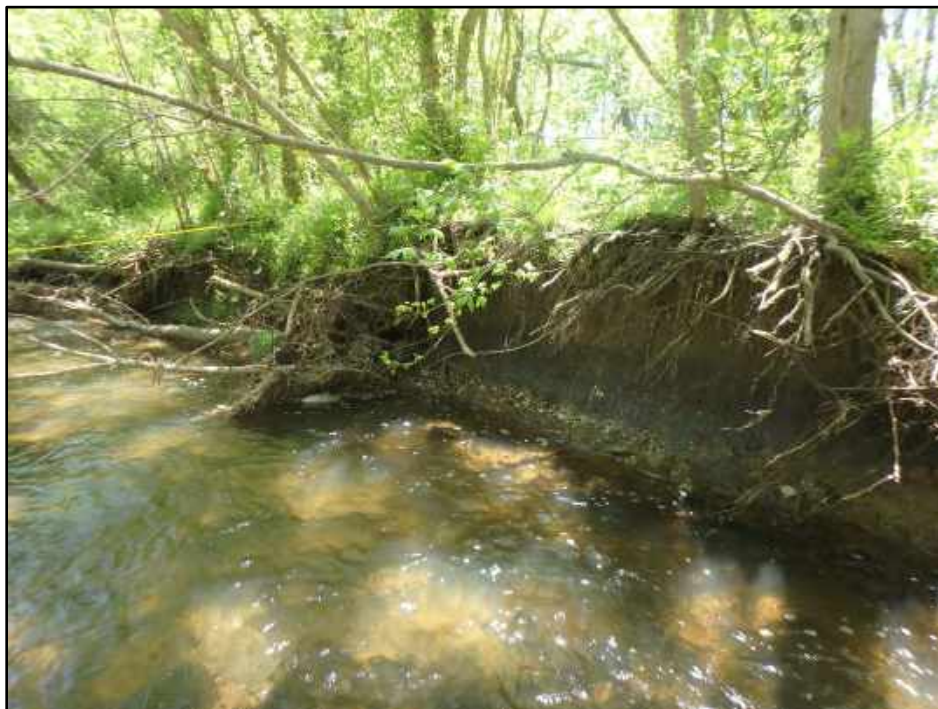
*Photo 12 - Cross Section P-6 – Looking downstream, right bank eroded – May 2020*

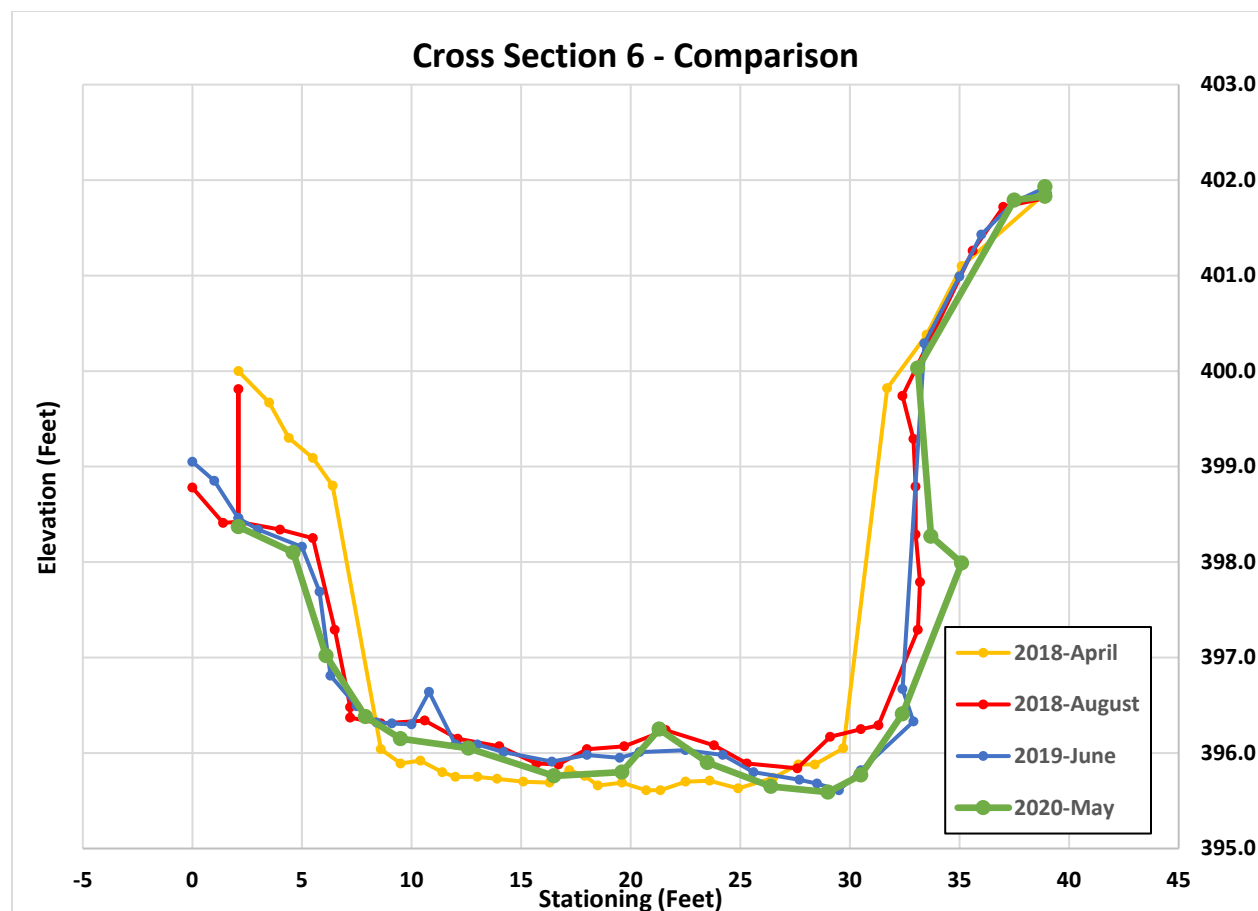
Figure 23 - Cross Section P-6 Comparison (2018 to 2020)

Section 6 is located at a riffle within the downstream control reach. Section 6 was established in 2018 and therefore only had two surveys conducted in 2018 and one in 2019. The cross-section in this reach experienced significant erosion from April 2018 to August 2018 (Figure 23). The left bank eroded about 0.8 feet and the right bank eroded 3.5 feet (Figure 23). Although, bank erosion occurred, the aggrading of the stream bed by 0.35 feet at this cross section minimized the loss in cross-sectional area (Table 7). In 2020 it was observed that the right bank had undercut by approximately 2 feet in this location. Due to root protection, the bank is still mostly intact though monitoring of this area should continue in future years. The channel slope increased in 2020 to 0.50% compared to 0.42% in 2019. Some pools also shifted downstream though the overall profile remains consistent between 2019 and 2020. Channel material in this section decreased between 2019 and 2020 with the D84 shifting from medium cobble to small cobble. Channel feature movement and active erosion along the right bank suggests fluidity and instability at this cross section. Larger precipitation events during the monitoring period attributed to the degradation at Section 6.

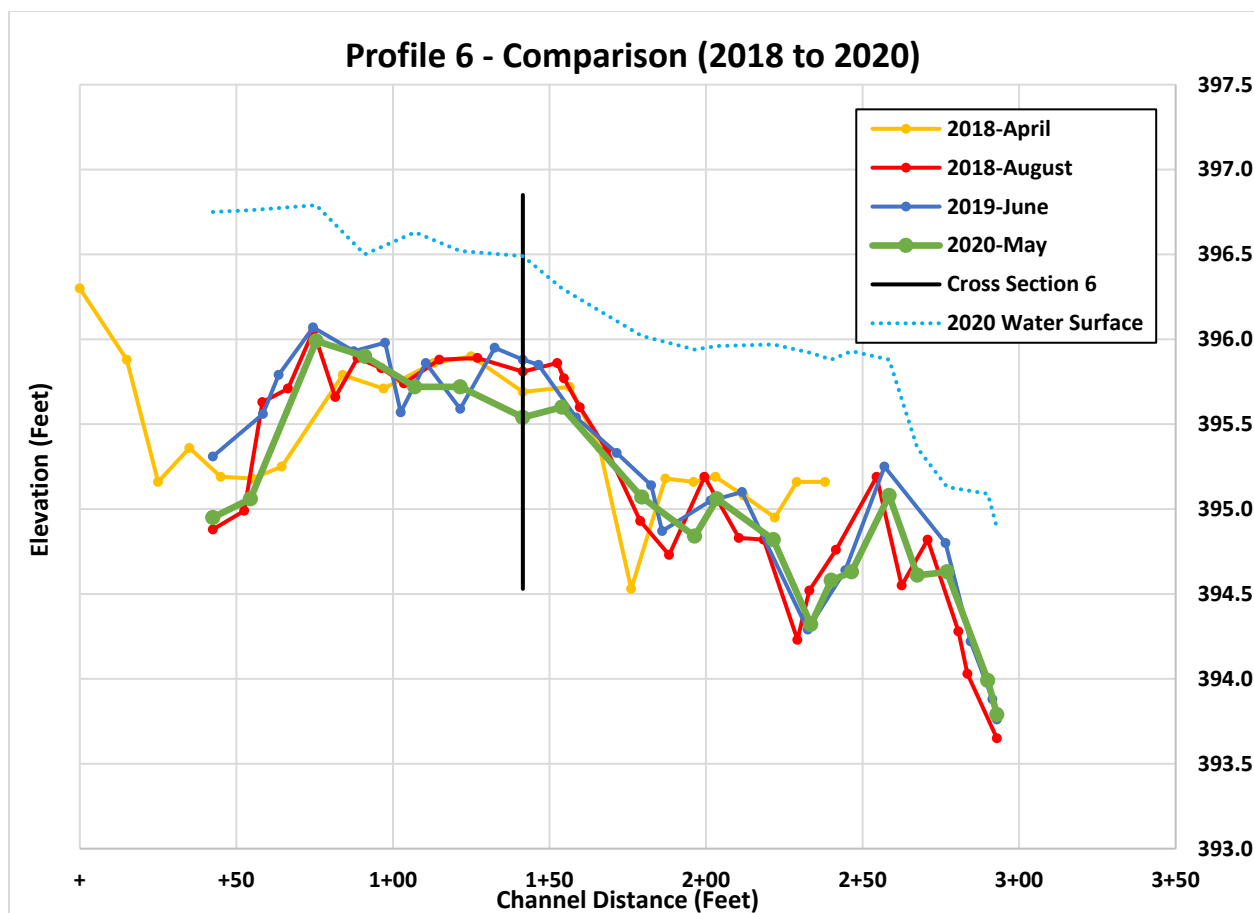
Cross Section 6 is located at a riffle. Between 2019 and 2020, the profile survey shows that the upstream pool and the lower portion of the riffle where the cross section was taken have eroded compared to the previous year which had aggraded (Figure 24). In 2020, degradation is evident at Sta. 2+50. The profile slope increased in 2020 to 0.50% compared to 2019 with a slope of 0.42%. Aside from the change in slope the bed features throughout the profile remain similar with some minor shifting of pool features downstream.

*Figure 24 - Profile P-6 Comparison (2018 to 2020)*
