National Pollutant Discharge Elimination System  
Municipal Separate Storm Sewer System  
Permit No. 11-DP-3313 MD0068276  
Permit Term October 9, 2015 to October 8, 2020

# Fifth Annual Report

## October 9, 2020

Maryland Department of Transportation  
State Highway Administration  
Office of Environmental Design  
707 North Calvert Street, C-303  
Baltimore, MD 21202

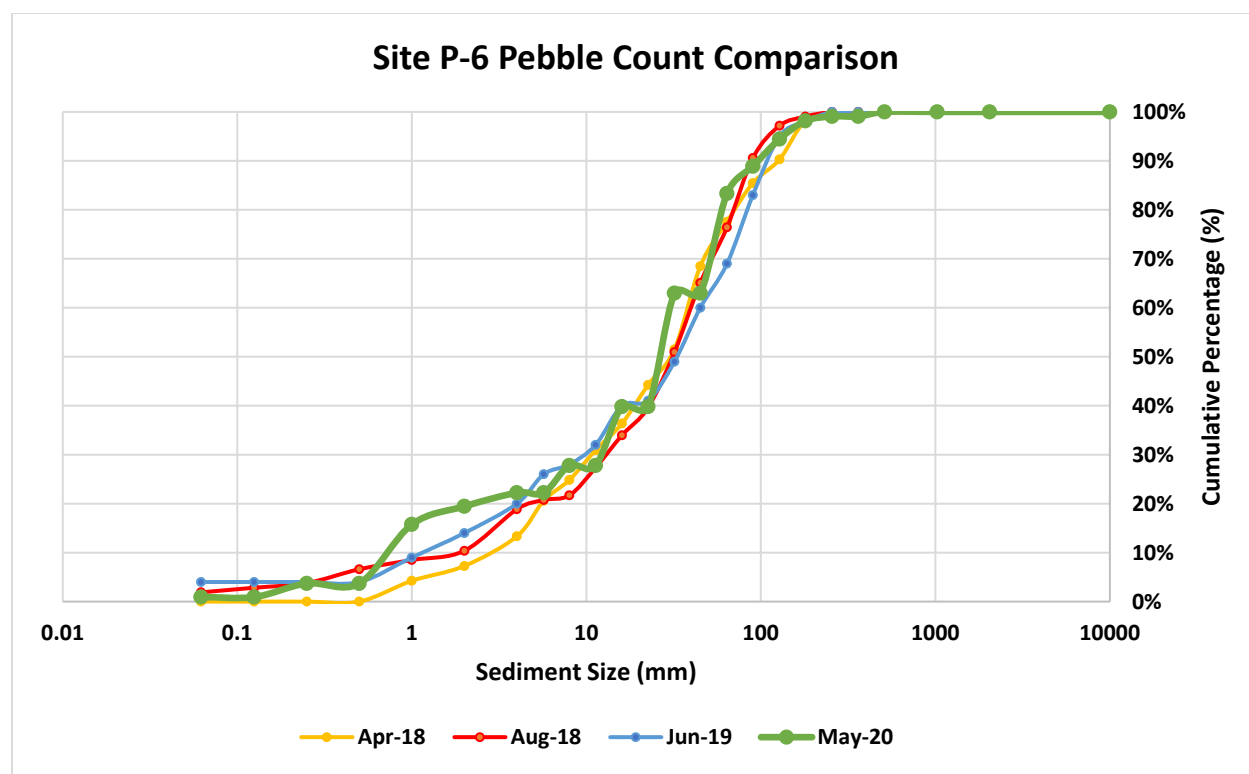
The riffle material size seems similar between 2019 and 2020. In 2020, the D50 was 26mm, and the D84 was 67mm. The reach maintained a D50 in the coarse gravel category and a D84 shifted from medium cobble to small cobble (Figure 25). The differences in the D84 pebble count results are most likely due to variations in sampling methodology.

Figure 25 – Section P-6 Riffle Bed Material Comparison

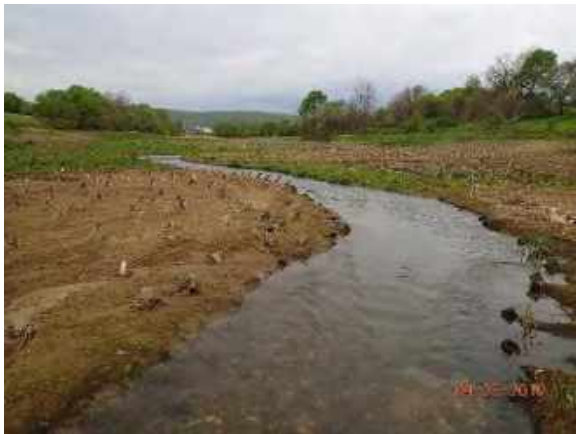
Upstream

Following construction, the area immediately surrounding the site had changed to soil without a vegetative buffer. No erosion or bar formation was observed.

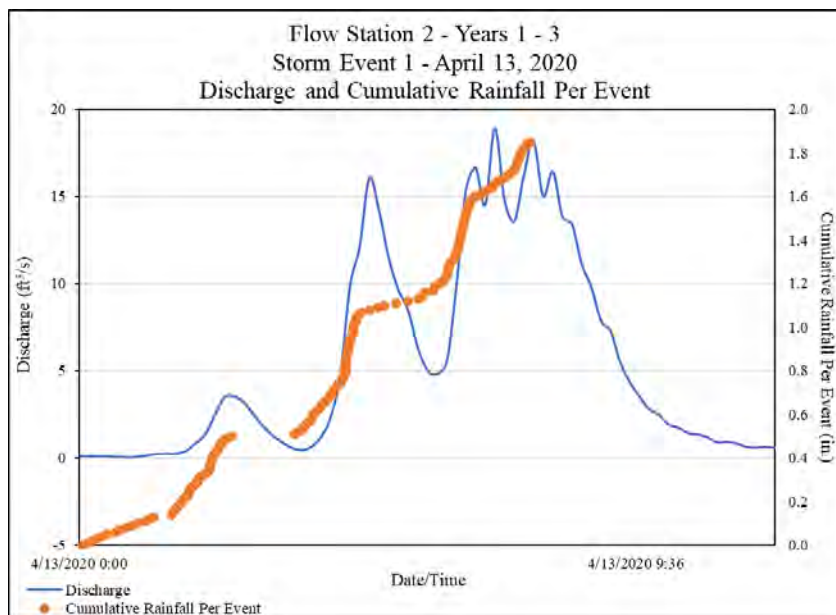
\*\*\*The data for FS-2 represents an early peak during the storm, but the later peak was not captured because the data logger was ejected from the culvert before that time

Figure 10. Discharge at FS-2 and rainfall during storm event 1 (April 13, 2020); no valid stage data is available after 12:10 to calculate discharge because the data logger was ejected from behind the weir during the storm

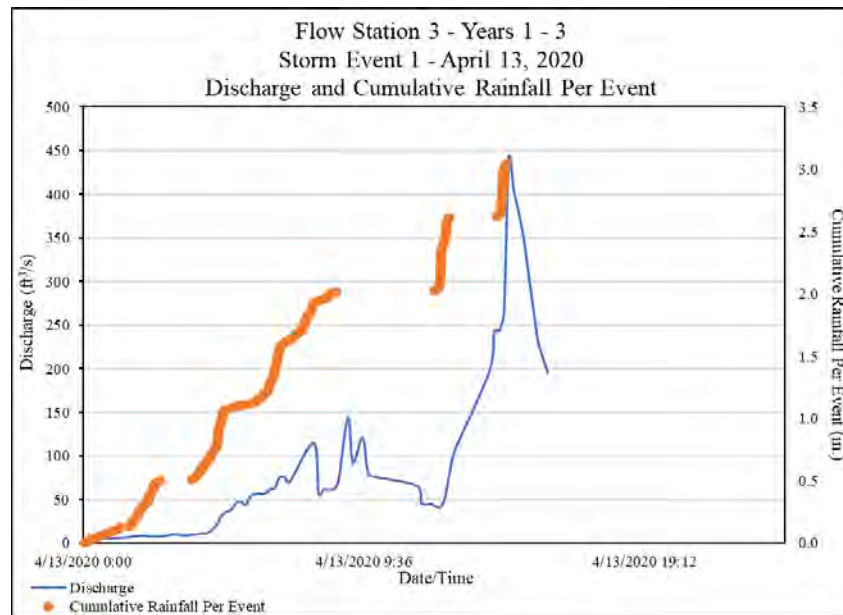
Figure 11. Discharge at FS-3 and rainfall during storm event 1 (April 13, 2020); no valid stage data is available after 15:53 to calculate discharge because storm debris interfering with equipment

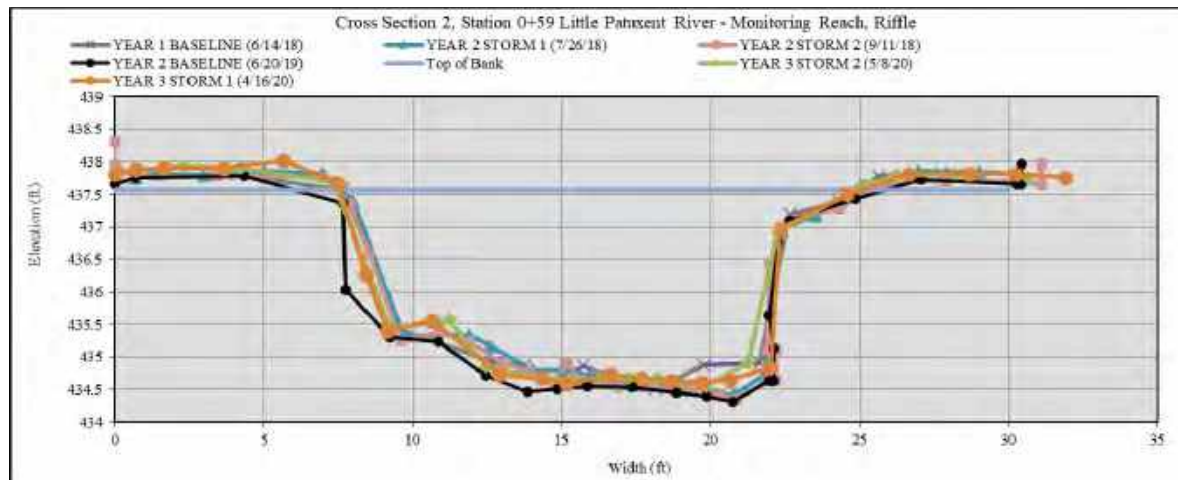
Figure 16. Cross Section 2 Survey Comparison

At Cross Section 2, the left bank eroded laterally approximately 2 feet during Year 2. During Year 3, the material accumulated on the gravel bar at the base of the left bank, which stabilized the left bank preventing further erosion. The toe of the right bank started to develop a 6-inch undercut during Year 2 and this bank stabilized to a vertical bank during Year 3. Erosion of the riverbed for Cross Section 2 can be seen from Station 11 to 22 during Year 2, where the elevation decreased approximately 6-inches. The thalweg for Cross Section 2 has also migrated laterally from Station 18.75 to 20.75 during Year 2. Year 3 observed an increase in riverbed elevation, but the thalweg remained on the right side of the channel.

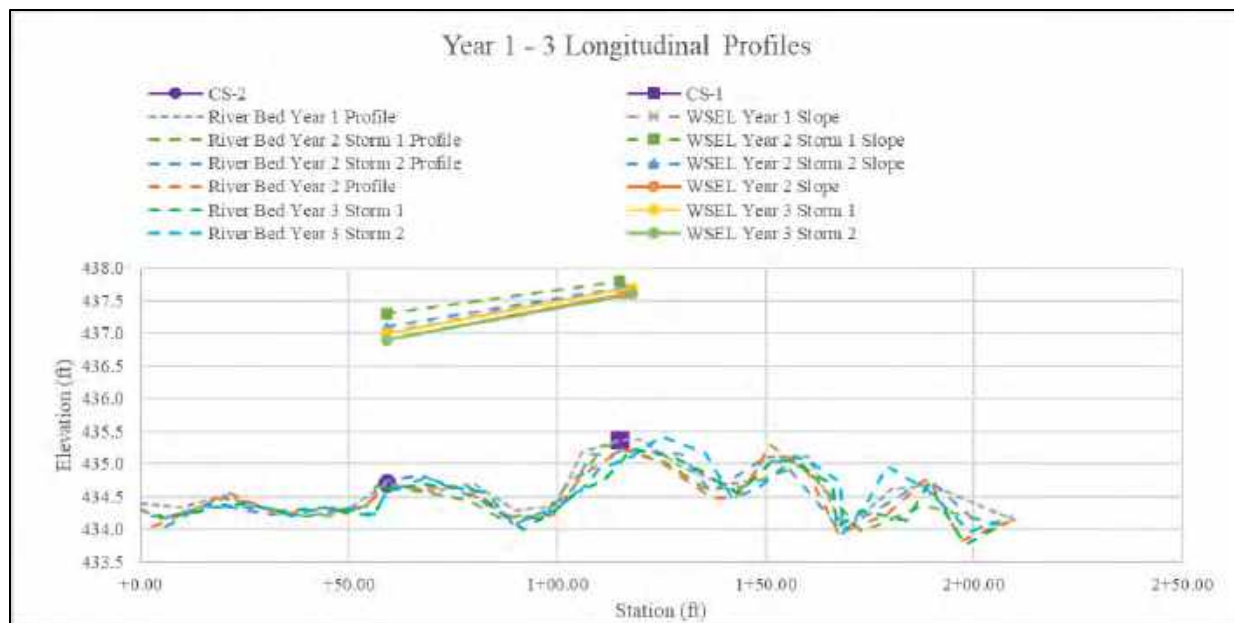
Figure 17. Year 1 & 2 Riverbed and Water Surface Elevation Profiles

Minor changes along the longitudinal profile between Year 1 baseline (06/14/18) and Year 3 Storm 2 (05/08/20) surveys have been observed. The initial downstream pool of the profile is deeper but the riverbed between the pool and 3.5 feet downstream of Cross Section 2 has remained stable. Erosion is occurring 3 feet downstream of Cross Section 2 at Station 0+53. From Cross Section 2 to 15 feet upstream of Cross Section 1, Station 0+59 to Station 1+30, the riverbed has degraded by approximately 4 inches. The top of riffle at Cross Section 1 has migrated upstream approximately 7 feet. The riffle at Station 1+50 and pool at Station 1+67 have overall remained stable, though some degradation and aggradation occurred between the annual surveys. The riverbed near Station 2+05 has also degraded by approximately 9.5-inches, forming a pool.

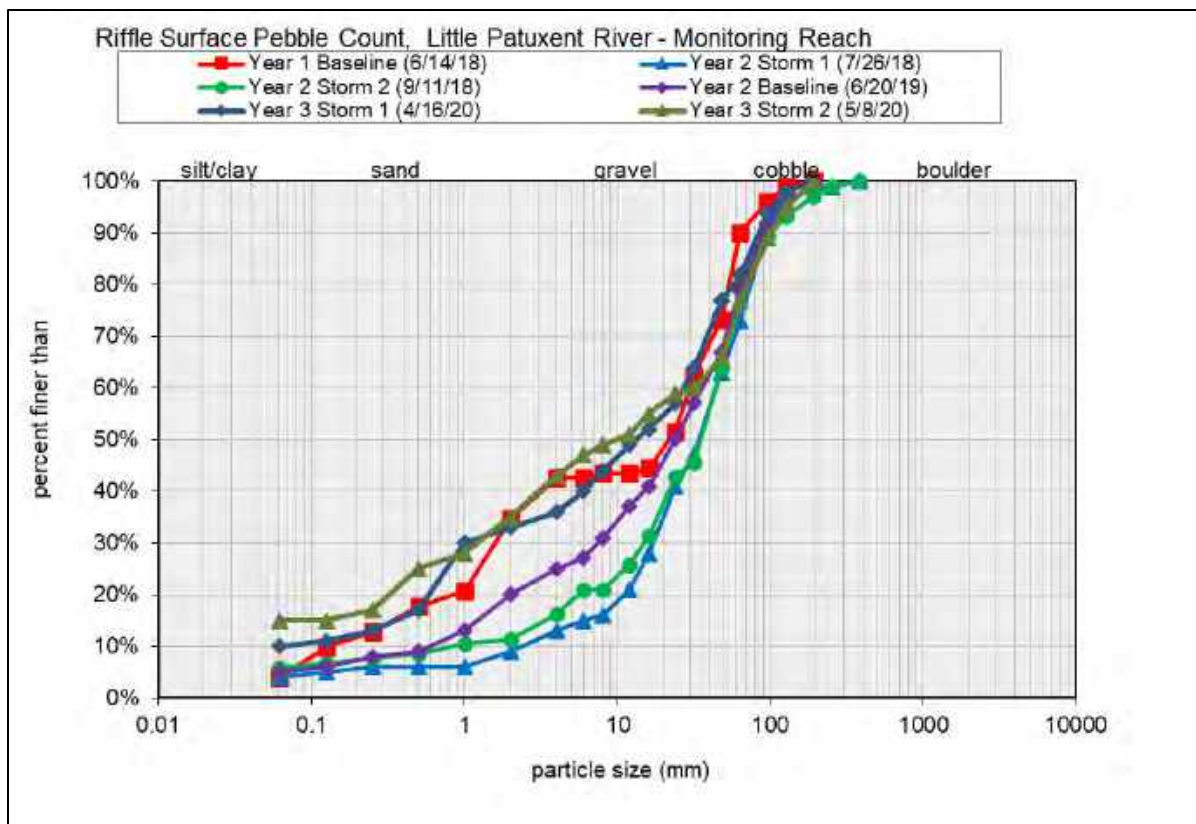
Figure 18. Cross Section 1 Bed Material Comparison

The material for Cross Section 1 coarsened between the Year 1 and Year 2 annual surveys but has trended to finer material during Year 3, with D50 decreasing from 22 to 9.8mm but with D84 increasing from 58 mm to 81 mm.

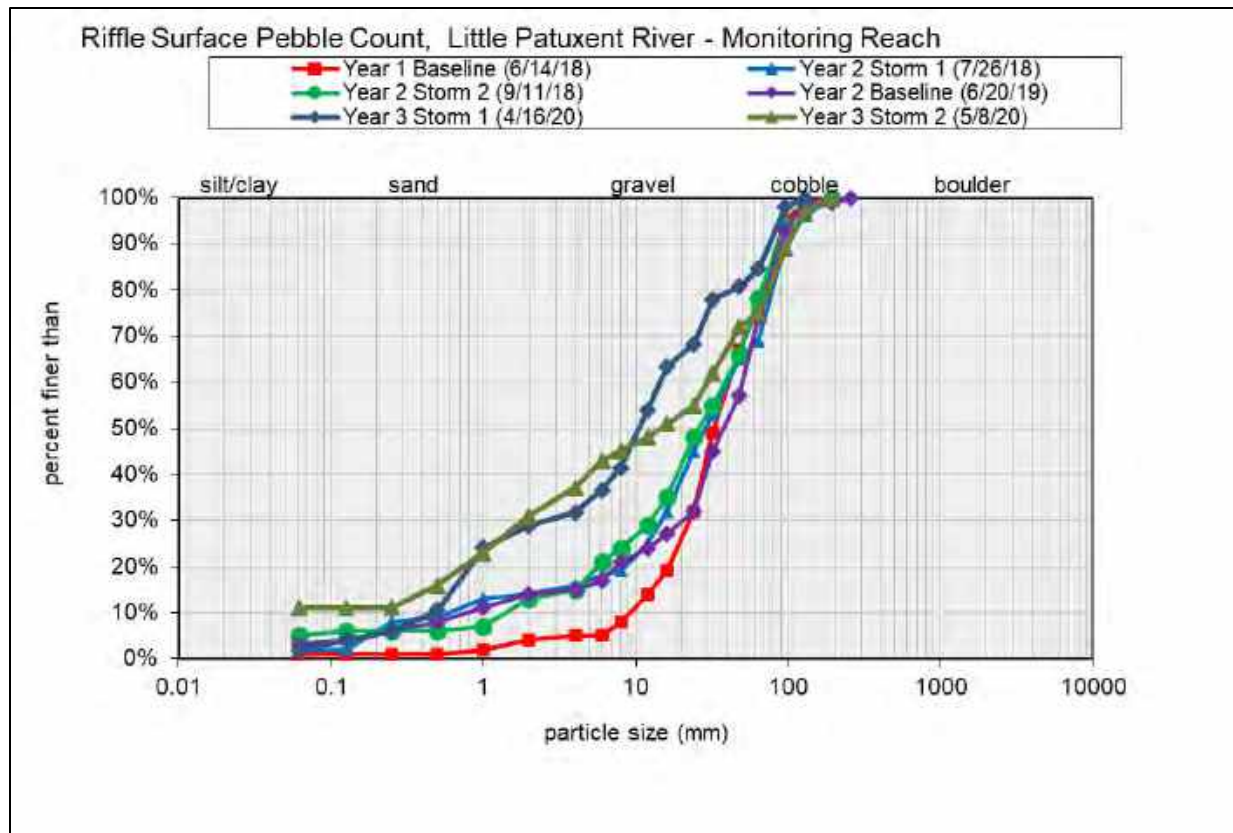
Figure 19. Cross Section 2 Bed Material Comparison

The material for Cross Section 2 has also trended to finer material Year 2 and Year 3 surveys, with D50 decreasing from 33 to 15mm but with D84 increasing from 76 mm to 83mm. However, 50% of the material for this riffle section appears to be trending towards finer substrate. This can be seen by an increase in the skewness from Year 1 baseline survey to Year 2. An increase in skewness indicates an excess in finer bed materials.

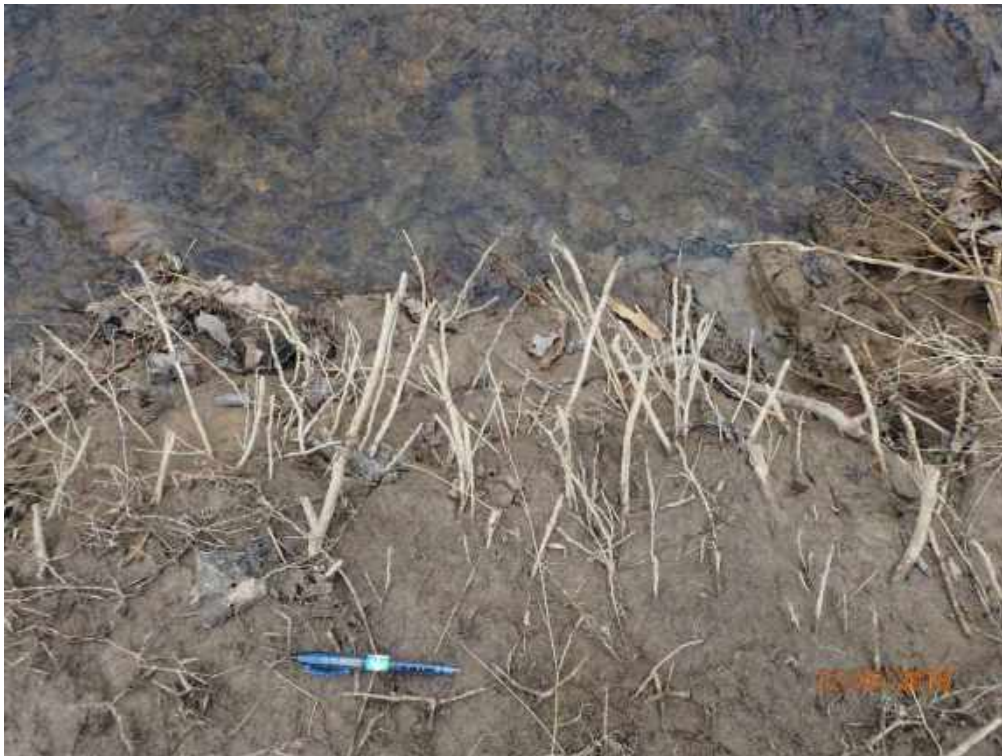
Since the riparian zone is affected by channel conditions, it is important to observe changes in the riparian zone over time. The riparian zone is forested with dense ground cover by herbaceous plants. Despite being densely vegetated, the riverbanks are eroding from the high energy within the stream channel. This is demonstrated by the exposed roots along the channel banks (Figure 20 through Figure 24).

*Figure 21. Exposed roots on left bank at Cross Section 1 on December 5, 2018*

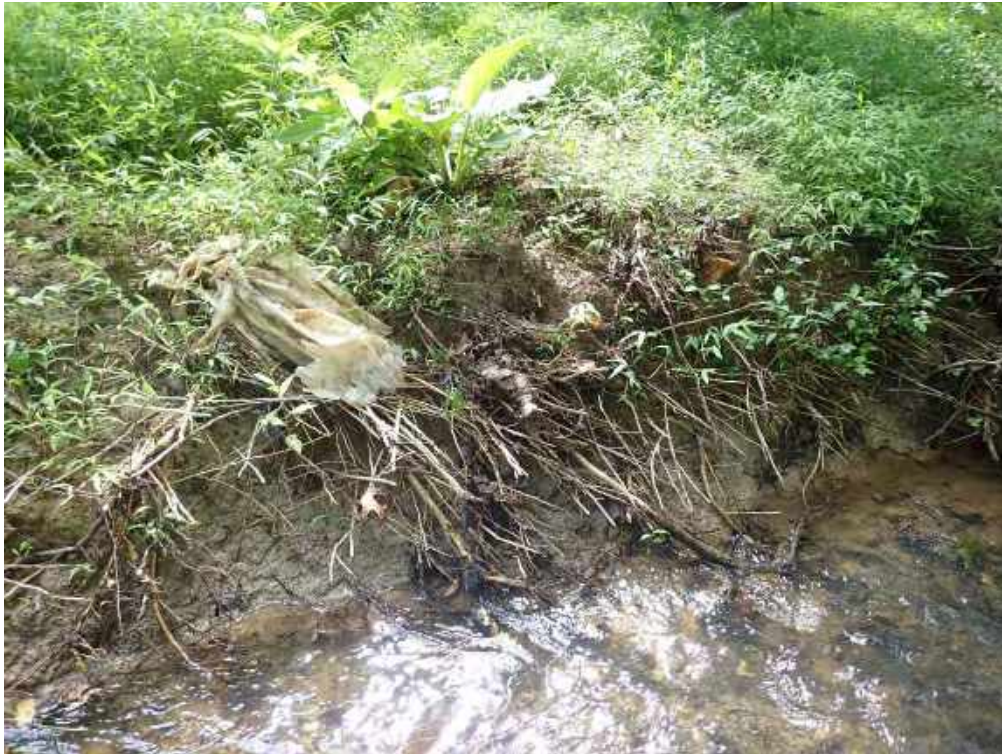
*Figure 22. Exposed roots on left bank at Cross Section 1 on June 20, 2019*

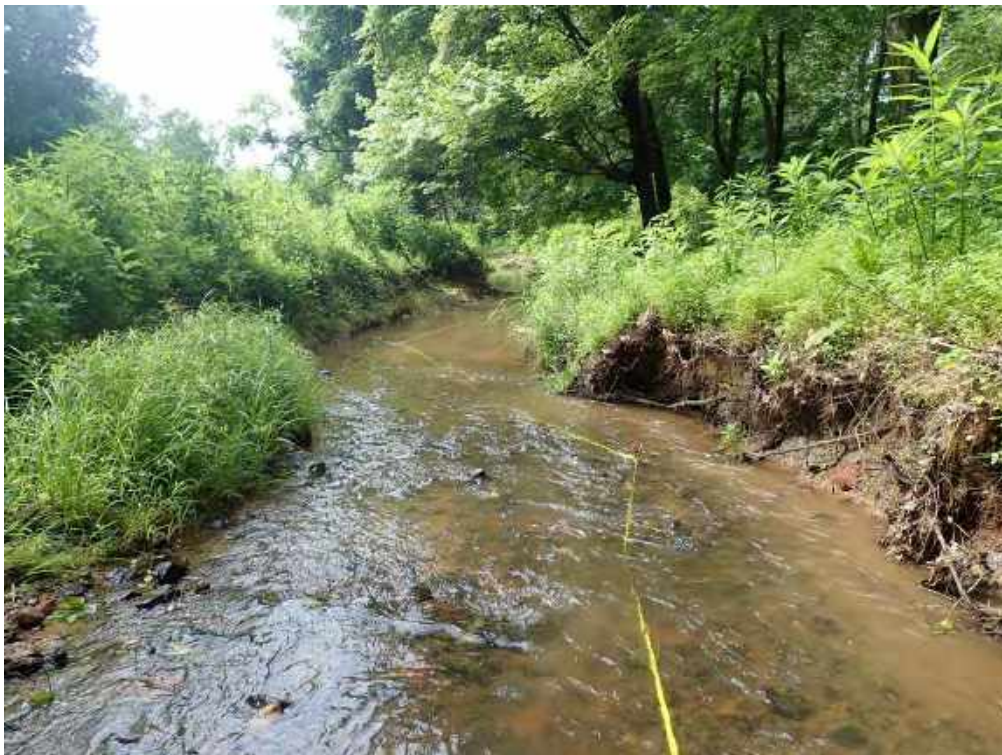
*Figure 23. Vegetated top of banks with exposed roots along Cross Section 2 reach on June 20, 2019*

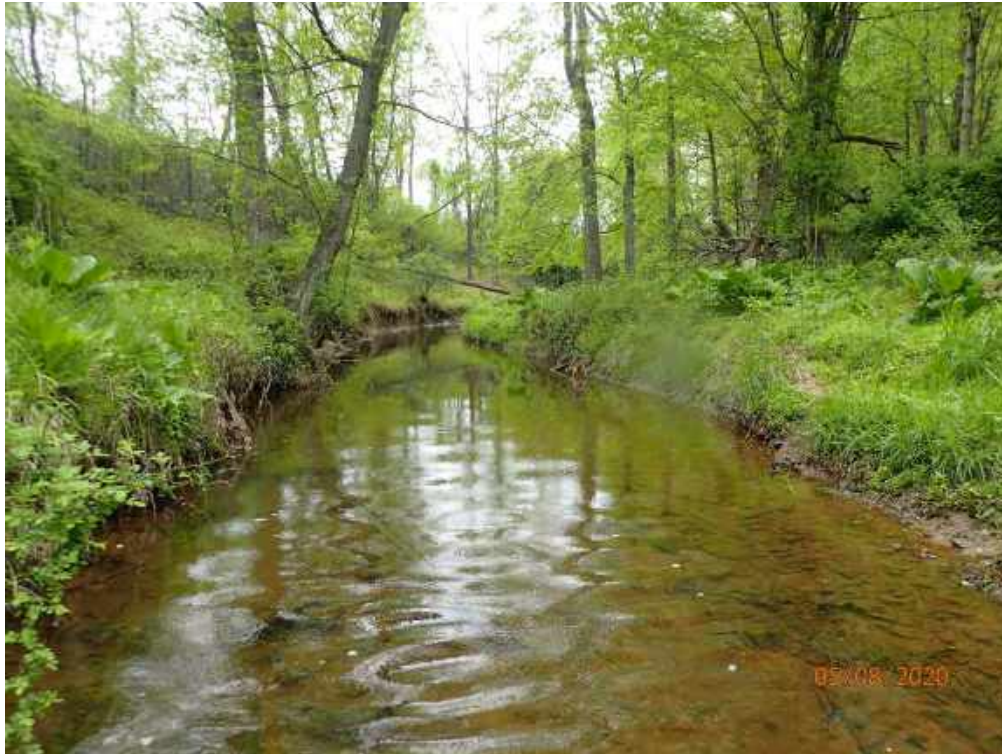
*Figure 24. Vegetated top of banks with exposed roots along Cross Section 1 reach on May 8, 2020*

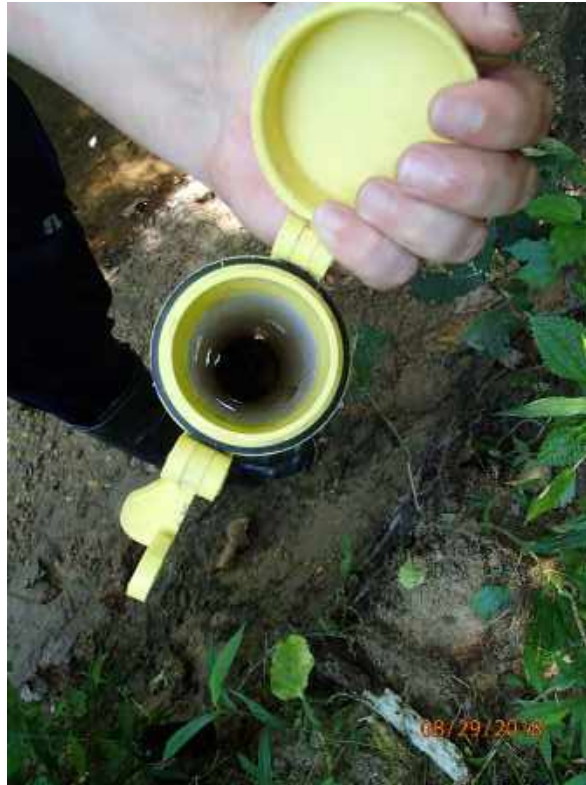
*Photograph 17. 8/29/2018: Sediment being cleaned out of Flow Station 1 housing*

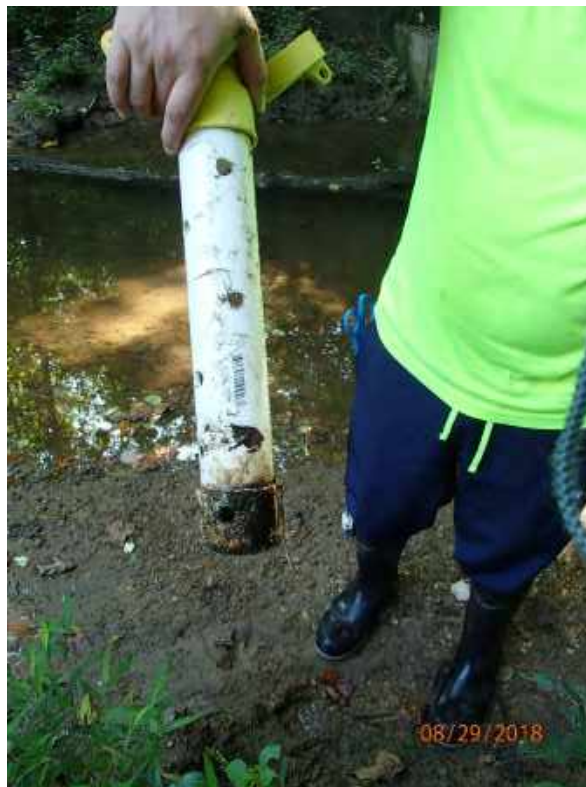
*Photograph 18. 8/29/2018: Sediment being cleaned out of Flow Station 1 housing*

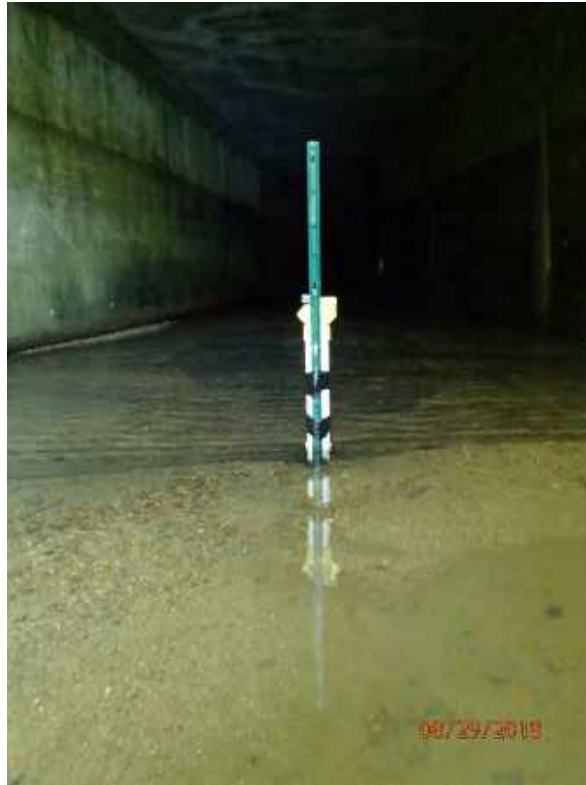
*Photograph 19. 8/29/2018: Flow Station 1 reset after maintenance*

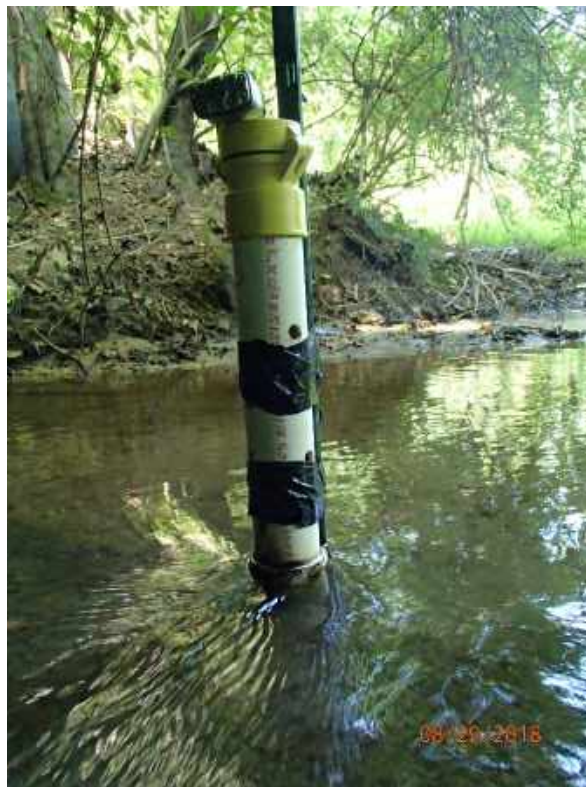
*Photograph 20. 8/29/2018: Flow Station 1 reset after maintenance*

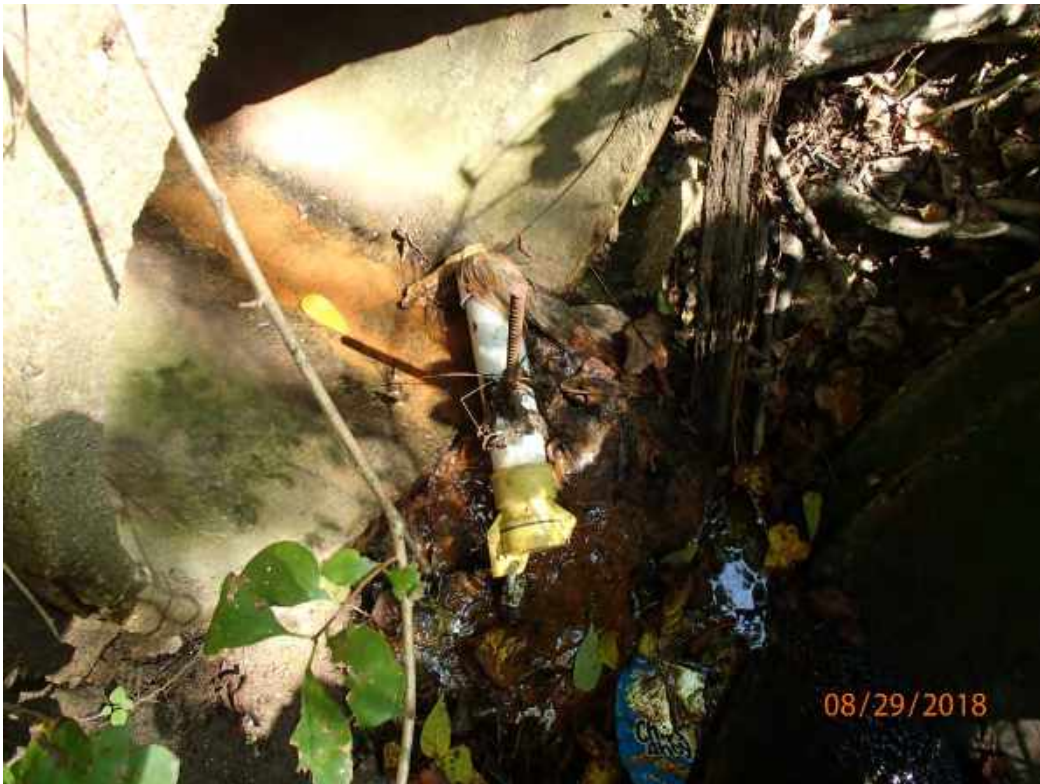
*Photograph 21. 8/29/2018: Flow Station 2, monthly download. Before maintenance.*

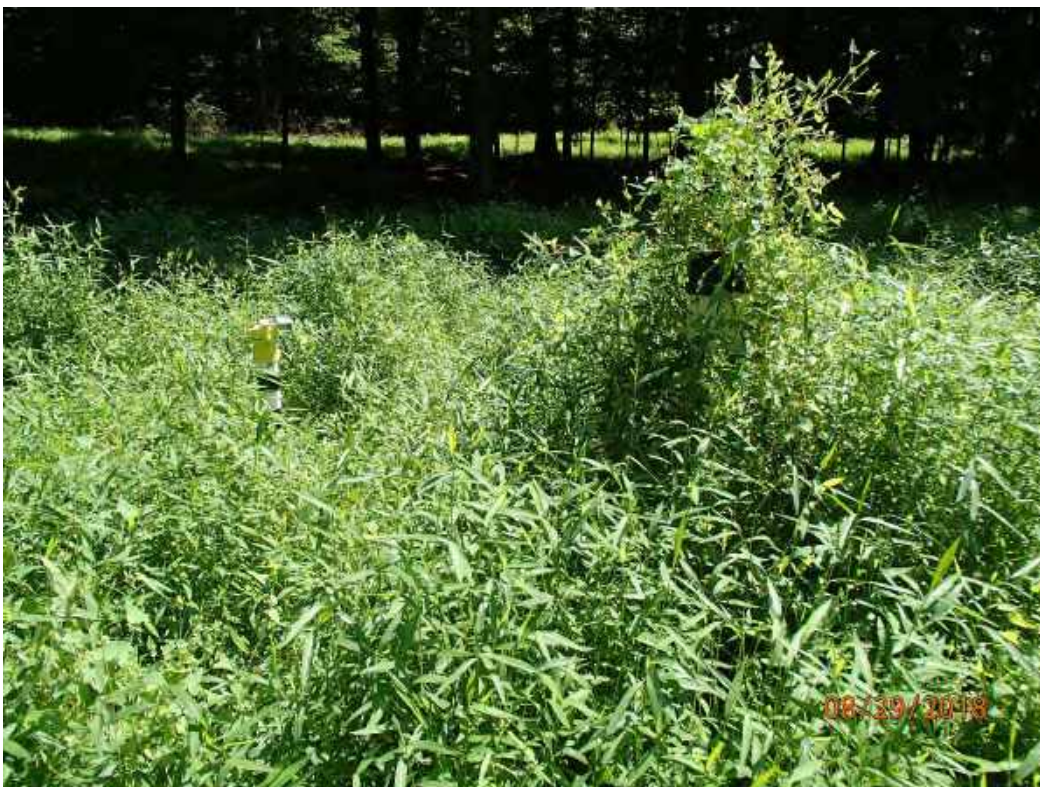
*Photograph 24. 8/29/2018: Barometer and rain gauge location, monthly download. Before maintenance.*

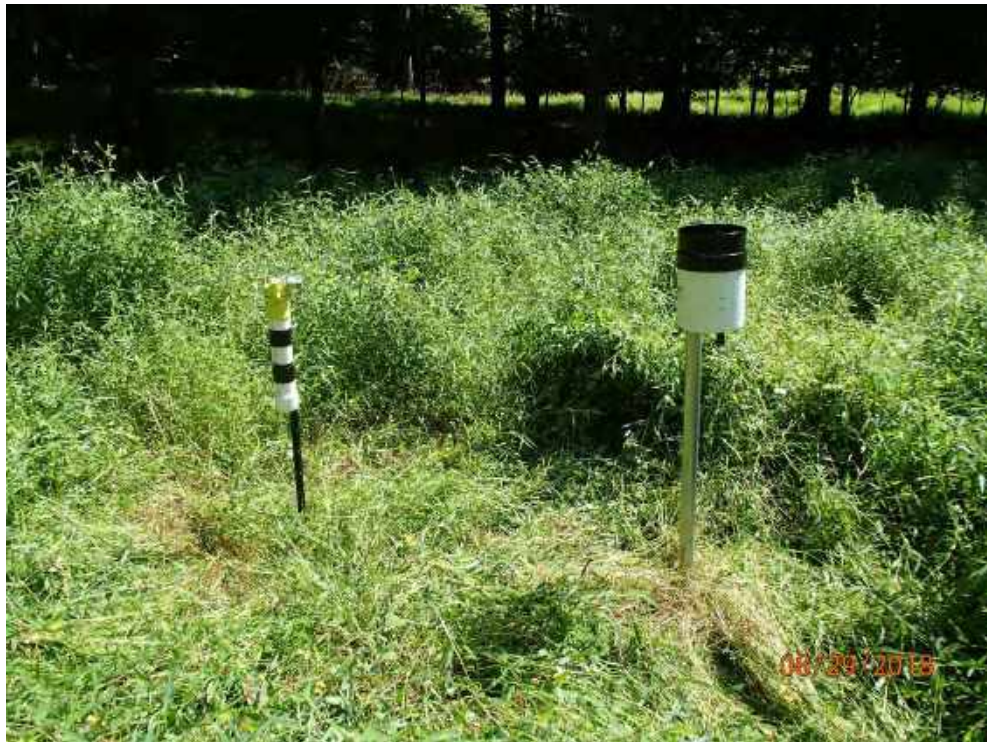
*Photograph 25. 8/29/2018: Barometer and rain gauge location, monthly download. After maintenance.*

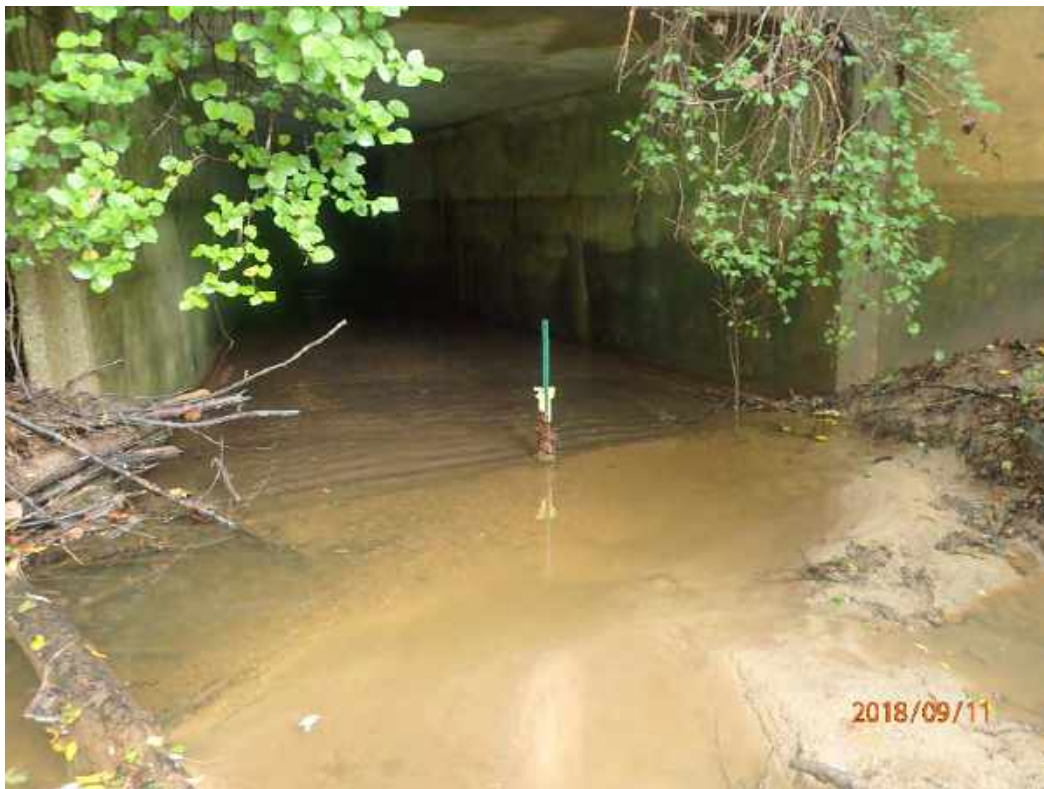
*Photograph 46. 9/11/2018: Flow Station 1, before maintenance*

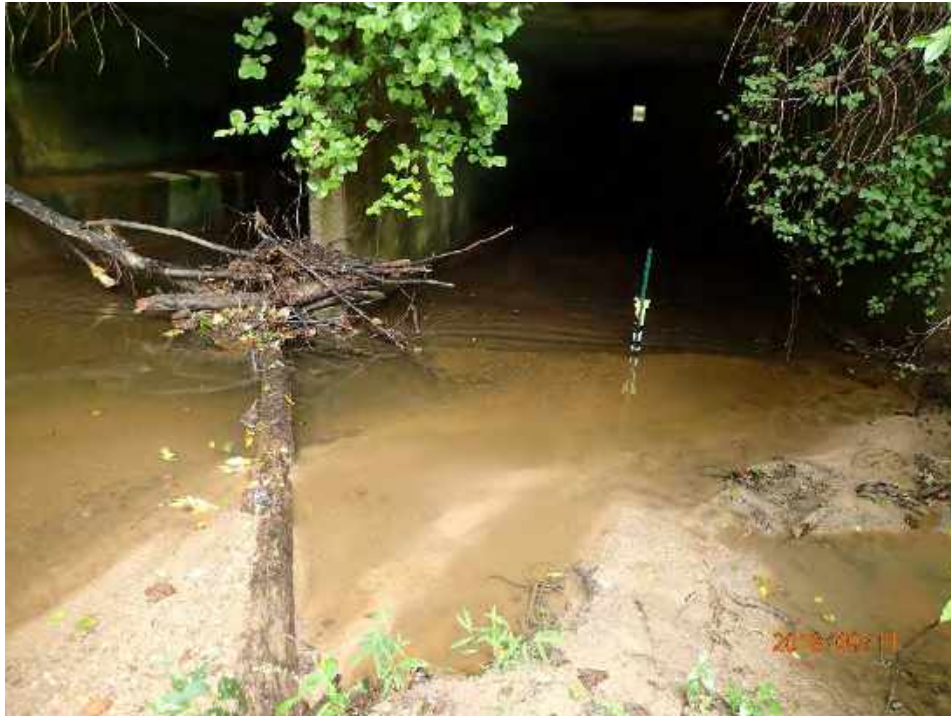
*Photograph 47. 9/11/2018: Flow Station 1, after maintenance*

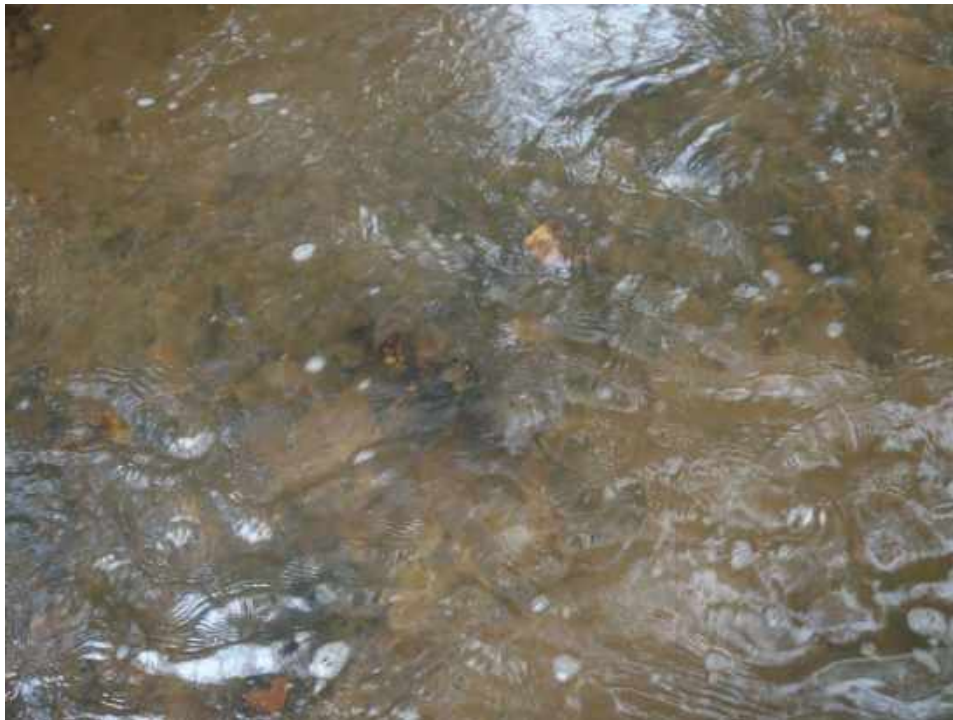
*Photograph 48. 10/08/2018: Flow Station 3, monthly download. Before maintenance*

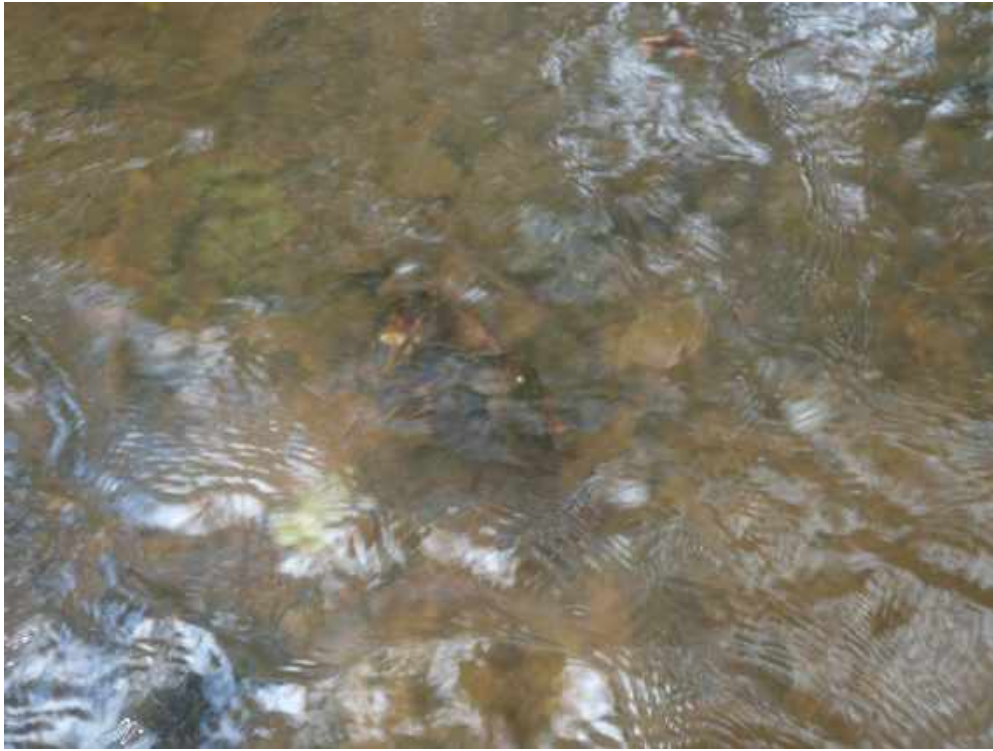
*Photograph 49. 10/08/2018: Flow Station 3, monthly download. Before maintenance*

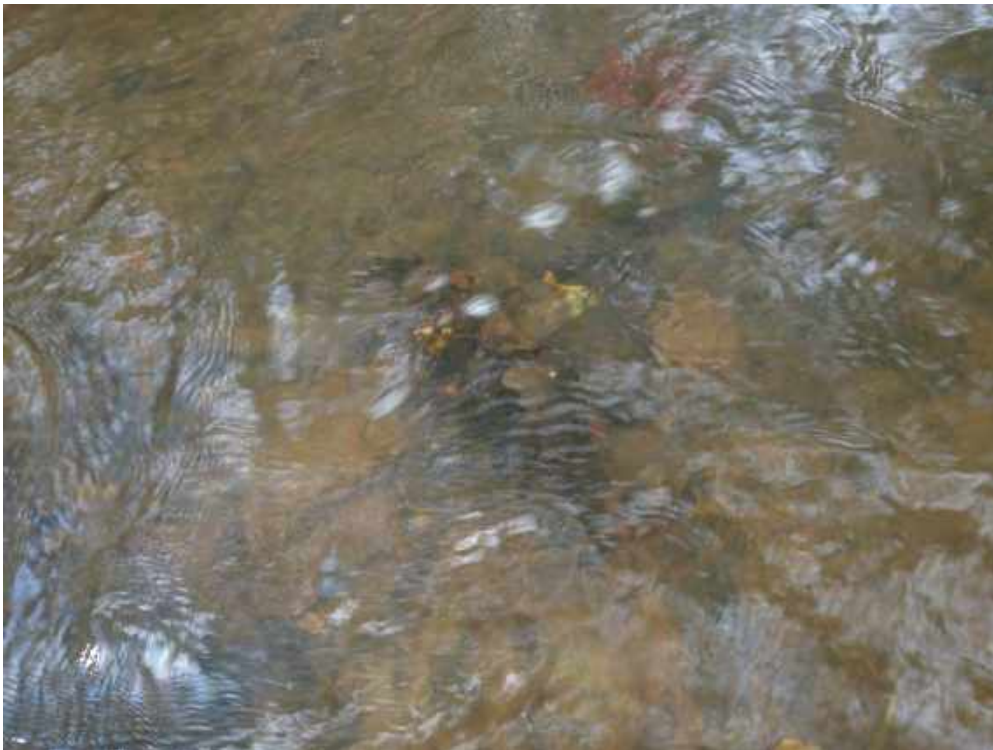
*Photograph 50. 10/08/2018: Flow Station 3, monthly download. Before maintenance*

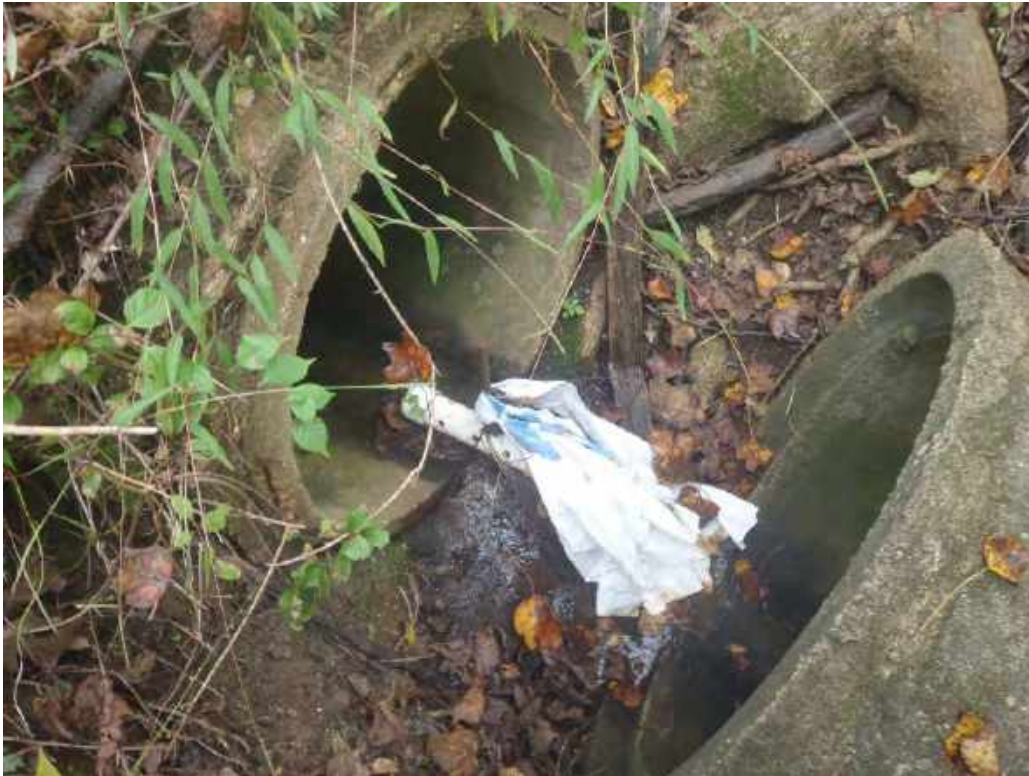
*Photograph 51. 10/08/2018: Flow Station 2, monthly download. Before maintenance*

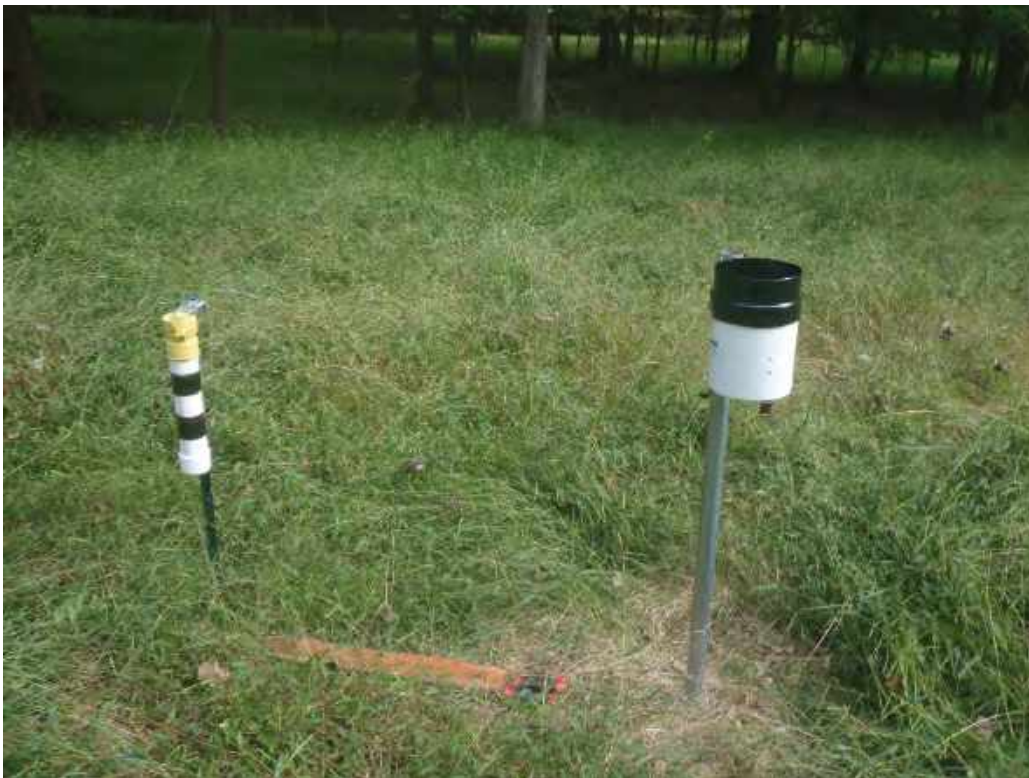
*Photograph 52. 10/08/2018: Barometer and rain gauge, monthly download. Before maintenance*

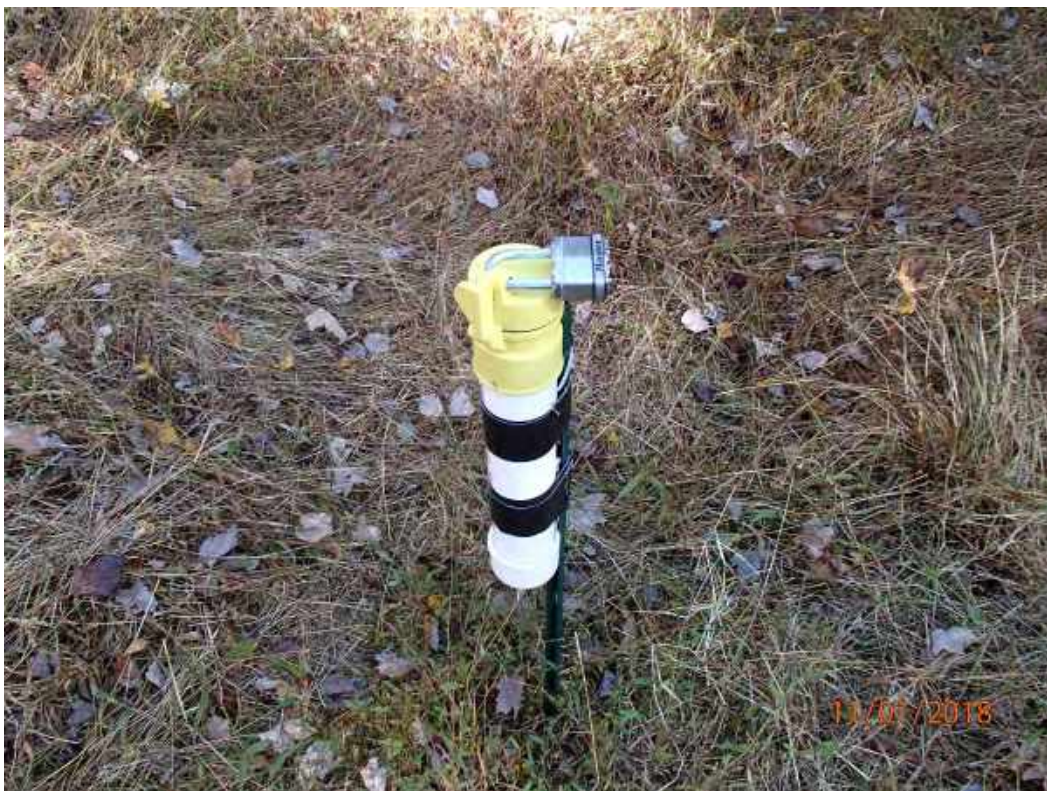
*Photograph 55. 11/01/2018: Flow Station 1 with collected debris, monthly download before maintenance*

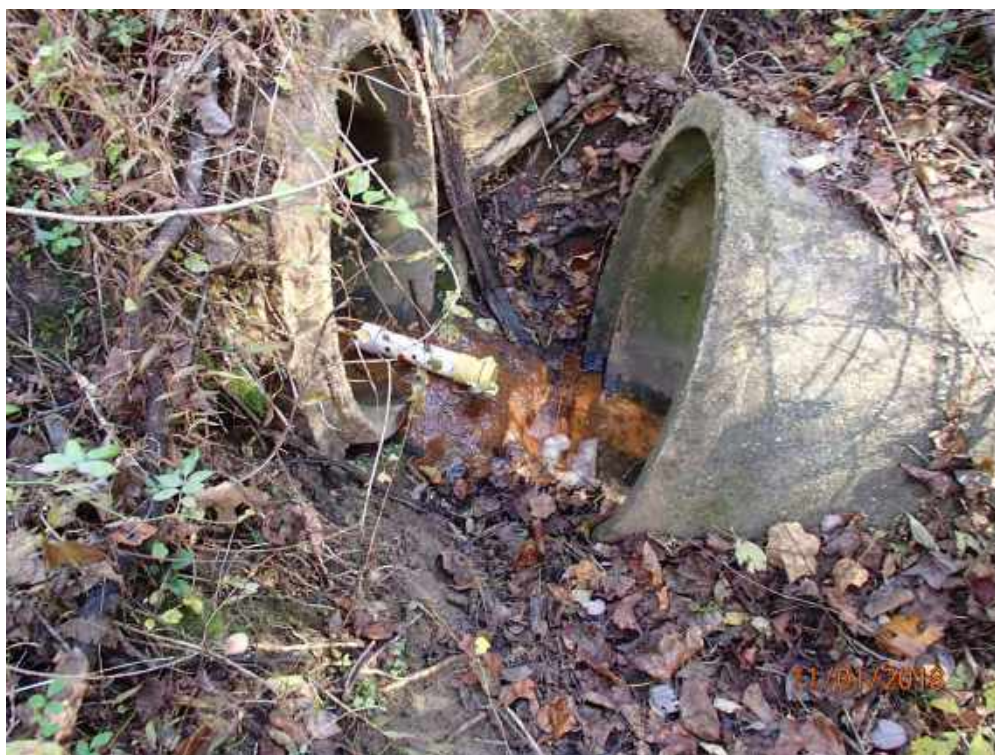
*Photograph 57. 11/01/2018: Flow Station 3 with collected debris, monthly download before maintenance*

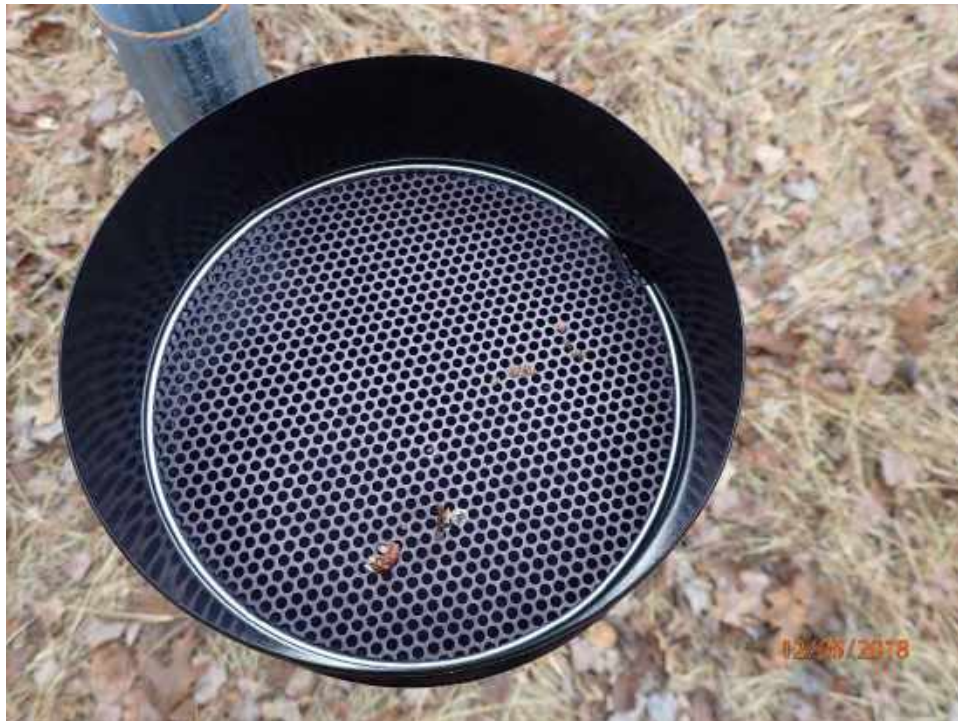
*Photograph 62. 12/05/2018: Rain gauge tipper with collected ice, monthly download before maintenance*
