National Pollutant Discharge Elimination System  
Municipal Separate Storm Sewer System  
Permit No. 11-DP-3313 MD0068276  
Permit Term October 9, 2015 to October 8, 2020

# Fifth Annual Report

## October 9, 2020

Maryland Department of Transportation  
State Highway Administration  
Office of Environmental Design  
707 North Calvert Street, C-303  
Baltimore, MD 21202

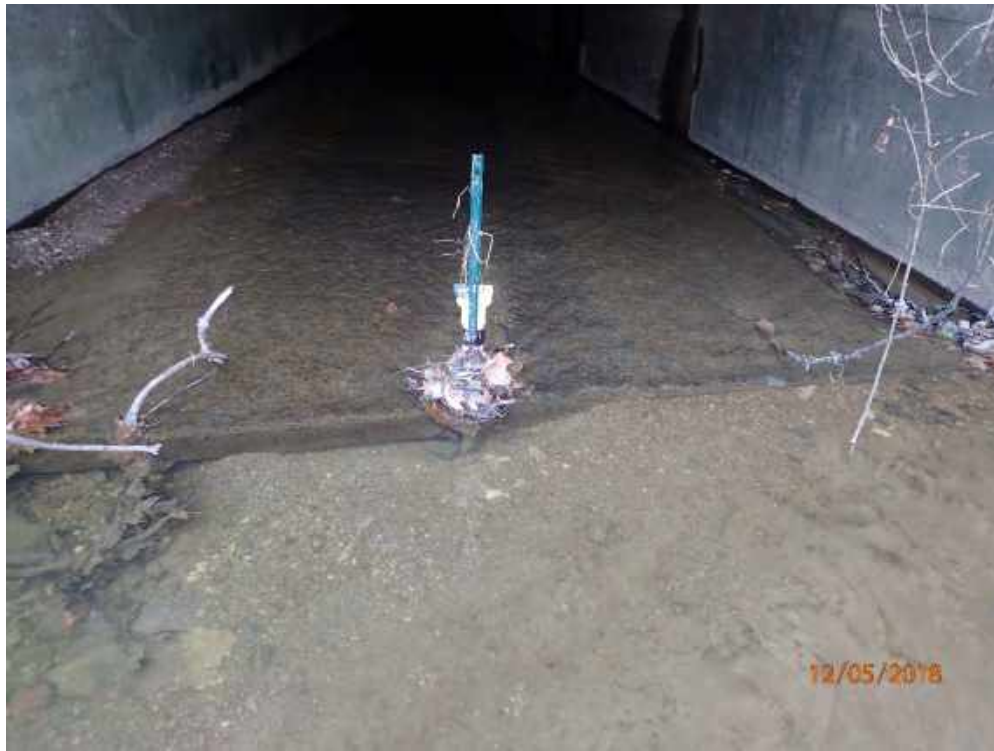
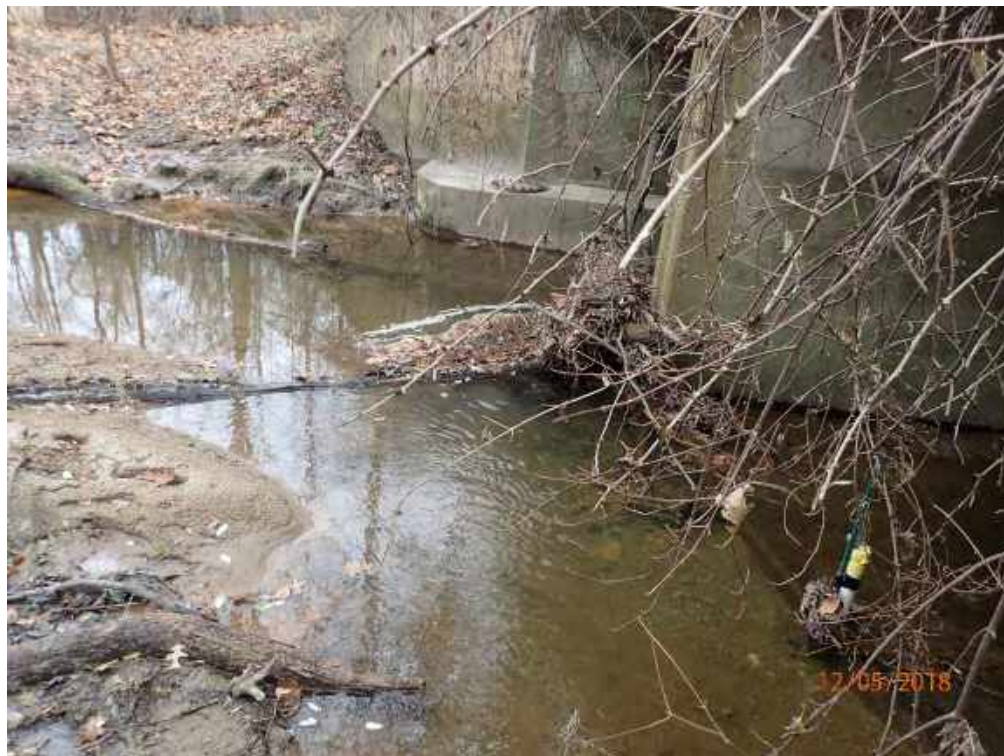
*Photograph 66. 12/05/2018: Debris jam at box culvert for Flow Station 1*

*Photograph 67. 12/05/2018: Debris jam at box culvert for Flow Station 1*

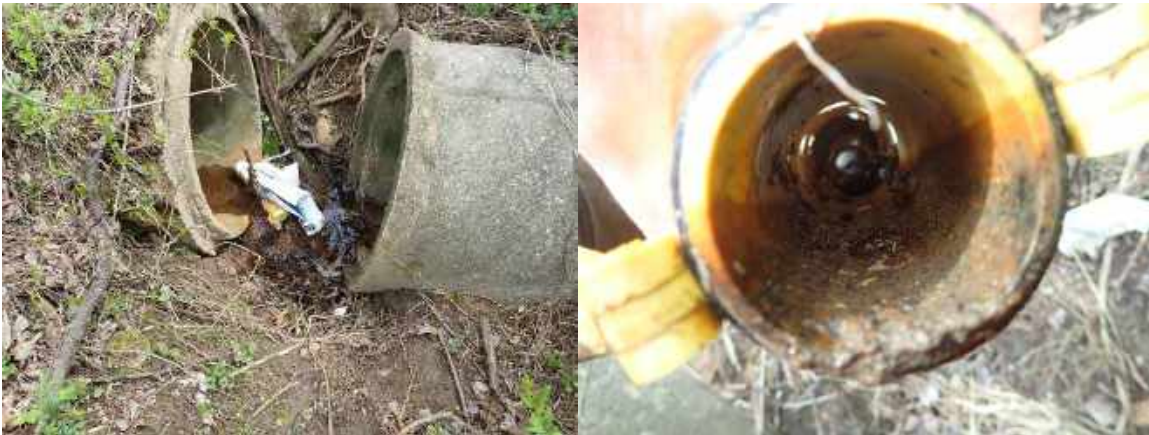
*Photograph 73. 04/16/2019: Flow Station 3 before monthly maintenance – connection cord pulled downstream by leaf litter (left) and velocity meter completely covered in debris (right)*

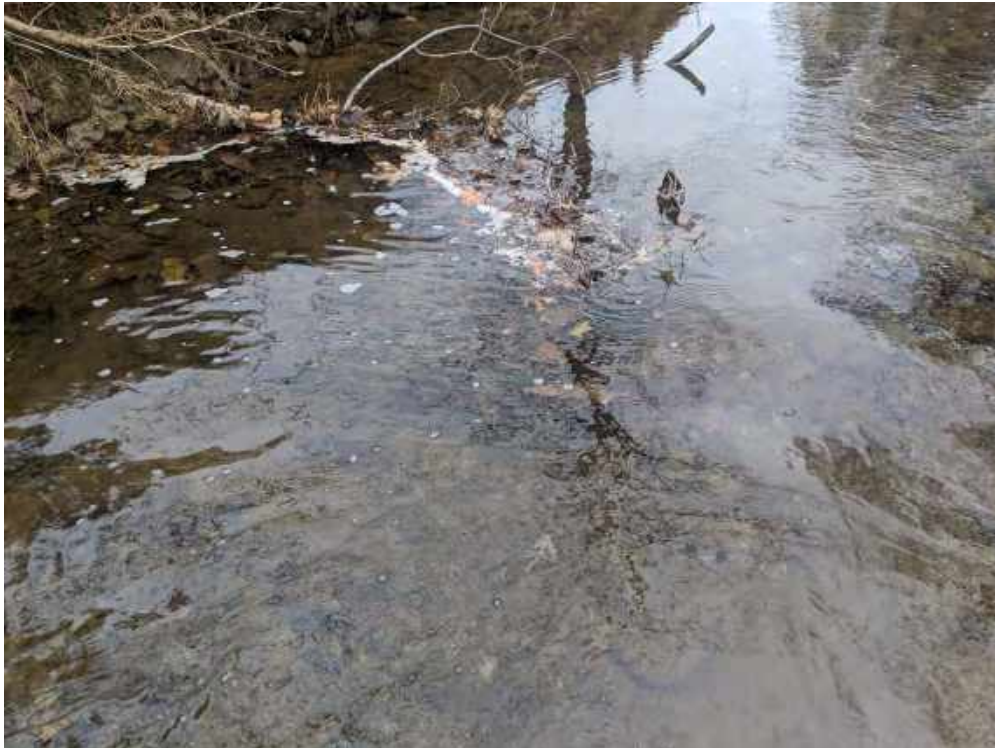
*Photograph 114. 11/22/2019 Year 3 Monthly Download and Maintenance, Flow Station 1 covered in debris before maintenance*

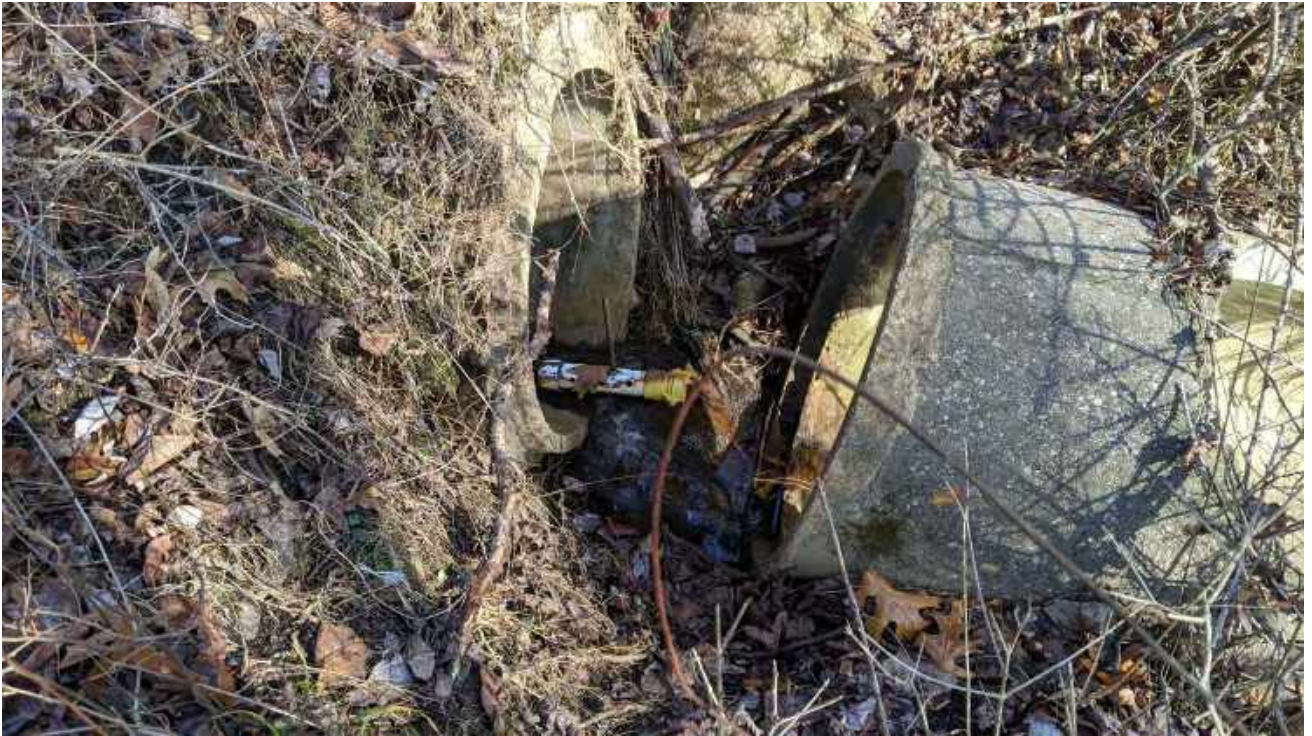
*Photograph 118. 12/18/2019 Year 3 Monthly Download and Maintenance, Flow Station 2 weir installation*

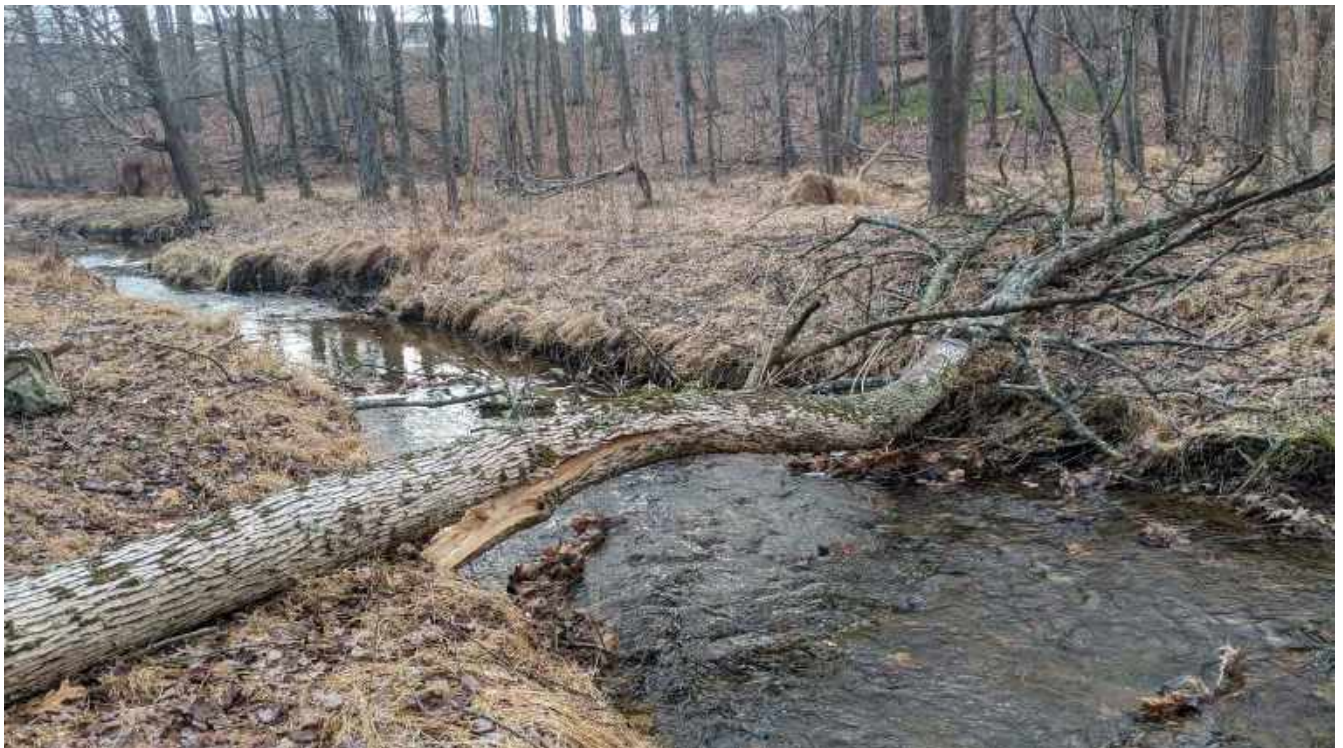
*Photograph 121. 12/18/2019 Year 3 Monthly Download and Maintenance, newly fallen tree at Cross Section 1, debris build up*

11/5/2019	14:43	11/22/2019	16:03	System Error - errant data values due to debris jams	11.85
12/1/2019	14:43	12/18/2019	12:43	Ash tree fell across study reach causing debris jam	10.12
12/18/2019	13:15	12/24/2019	16:06	Equipment malfunction during battery replacement	5.90
2/12/2020	15:26	3/18/2020	10:53	Equipment malfunction - defaulted back to idle mode after monthly download	3.34
4/13/2020	15:53	4/22/2020	14:27	System Error – errant data values due to debris jam and power failure - low battery	4.91

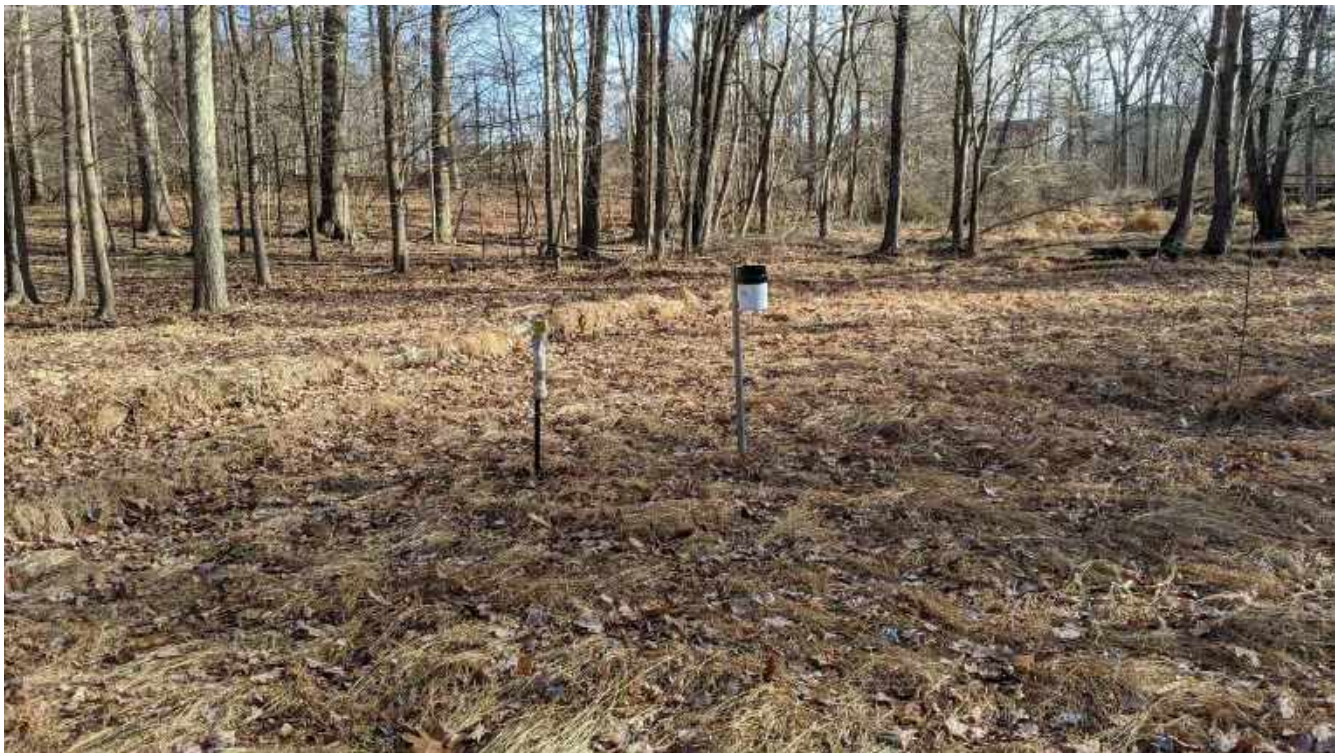
*Photograph 127. 1/15/2020: Year 3 Monthly Download and Maintenance, Rain gauge with collected debris before maintenance*

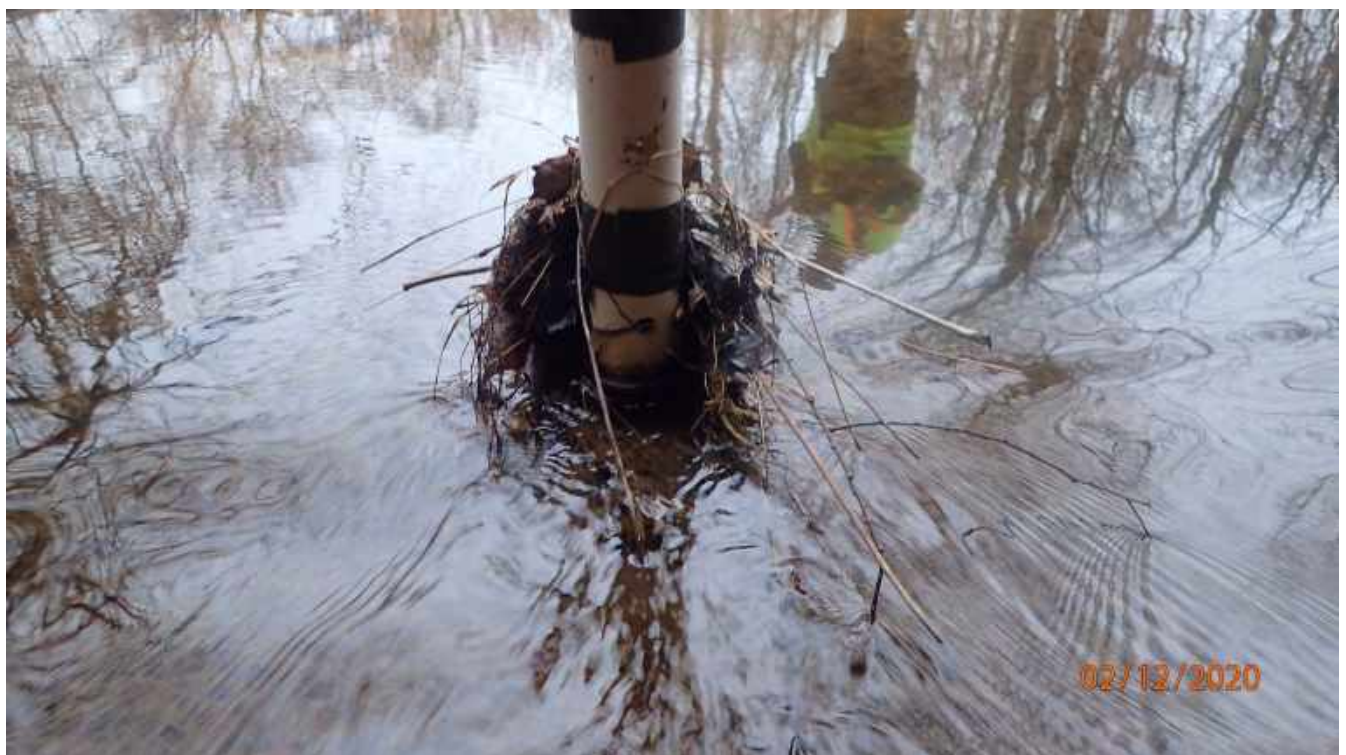
*Photograph 134. 2/12/2020 Year 3 Monthly Download and Maintenance, Flow Station 1 with debris before maintenance*

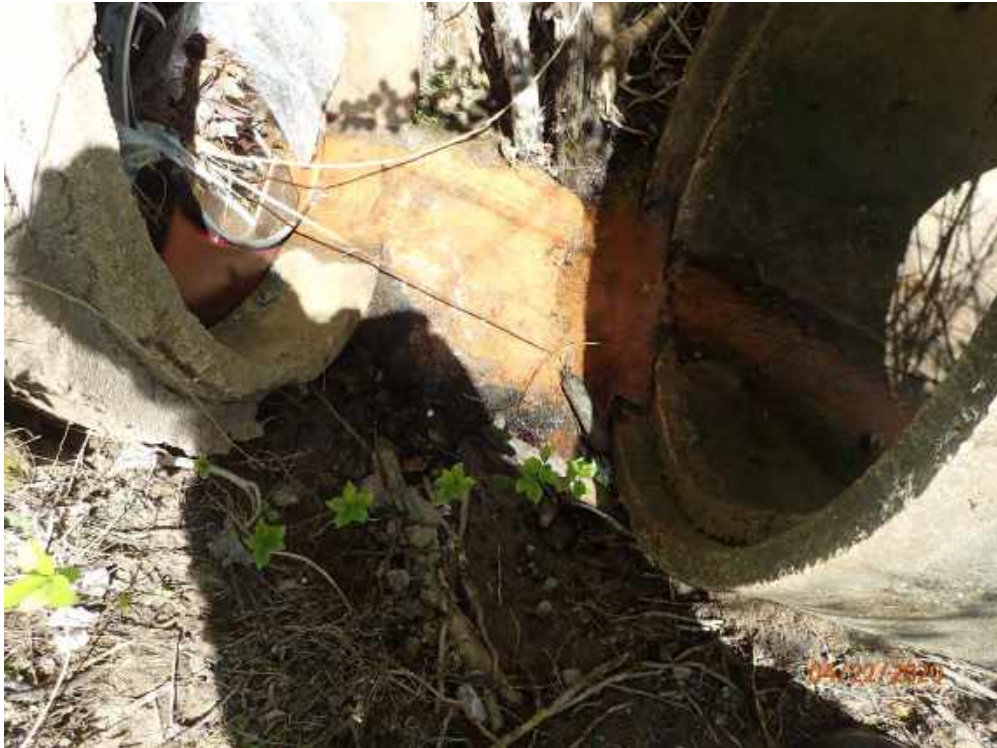
*Photograph 139. 4/22/2020: Year 3 Monthly Download and Maintenance, Flow Station 2 with debris build-up and logger ejected*

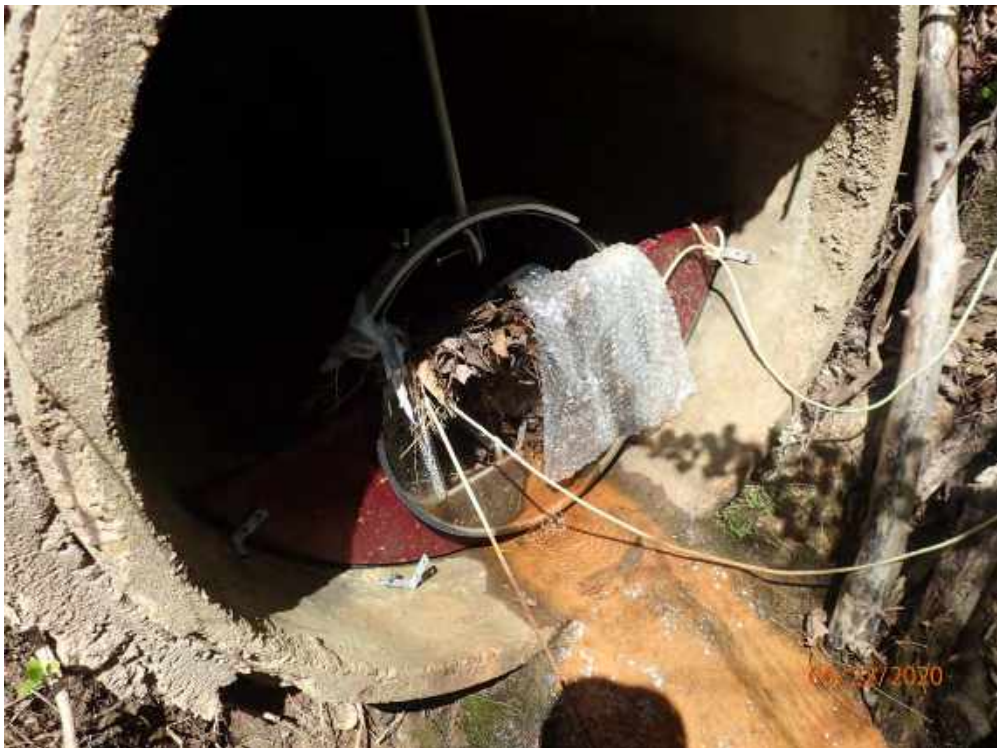
*Photograph 140. 4/22/2020: Year 3 Monthly Download and Maintenance, Flow Station 2 with debris build-up*

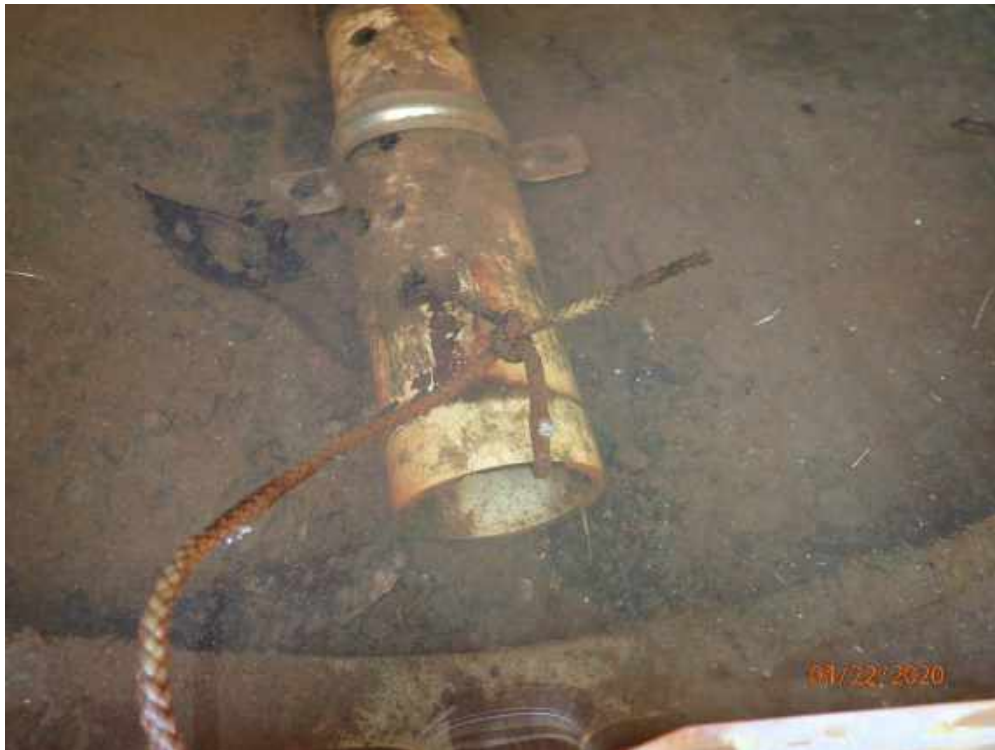
*Photograph 141. 4/22/2020: Year 3 Monthly Download and Maintenance, Flow Station 2 secured logger to housing*

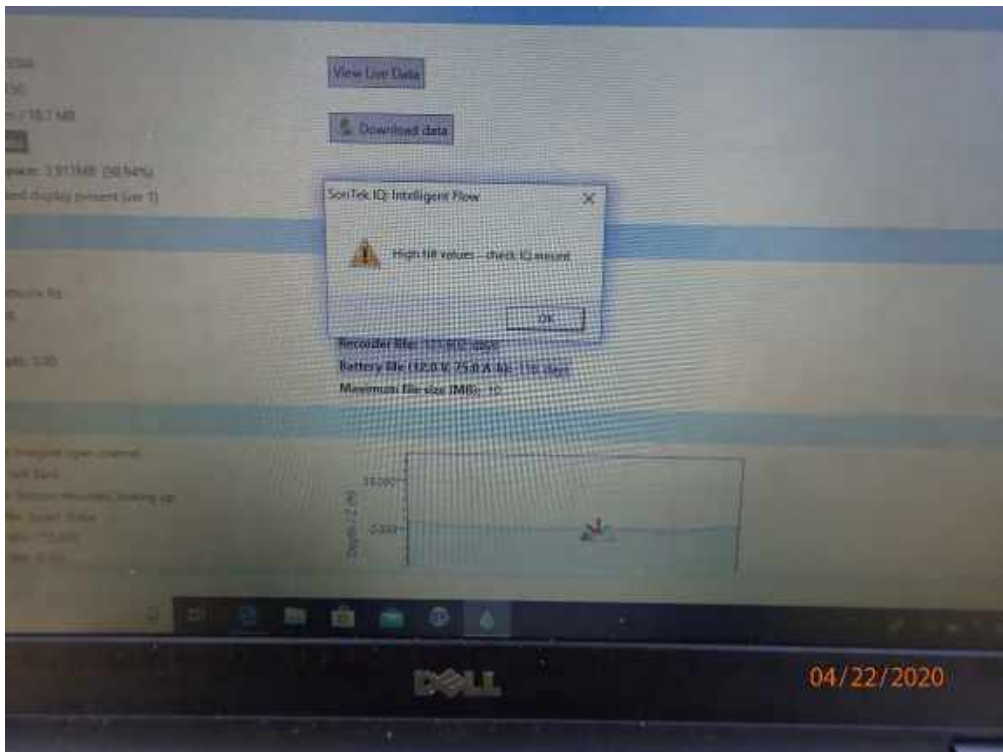
*Photograph 143. 4/22/2020: Year 3 Monthly Download and Maintenance, Flow Station 3, reason for error*

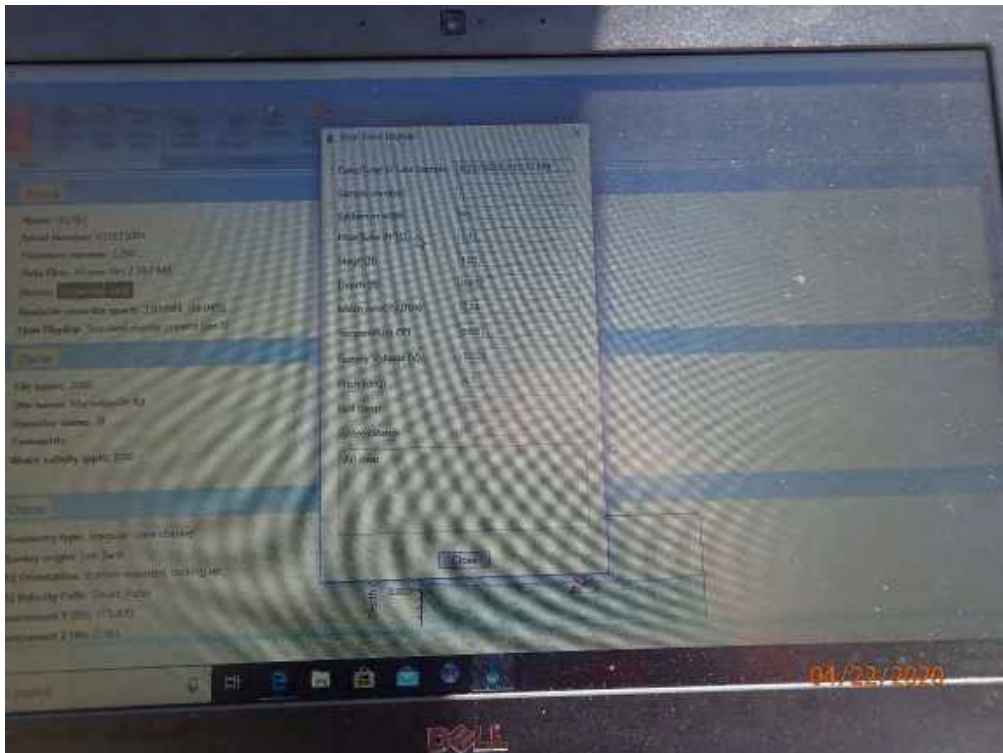
*Photograph 144. 4/22/2020: Year 3 Monthly Download and Maintenance, Flow Station 3, errors resolved*

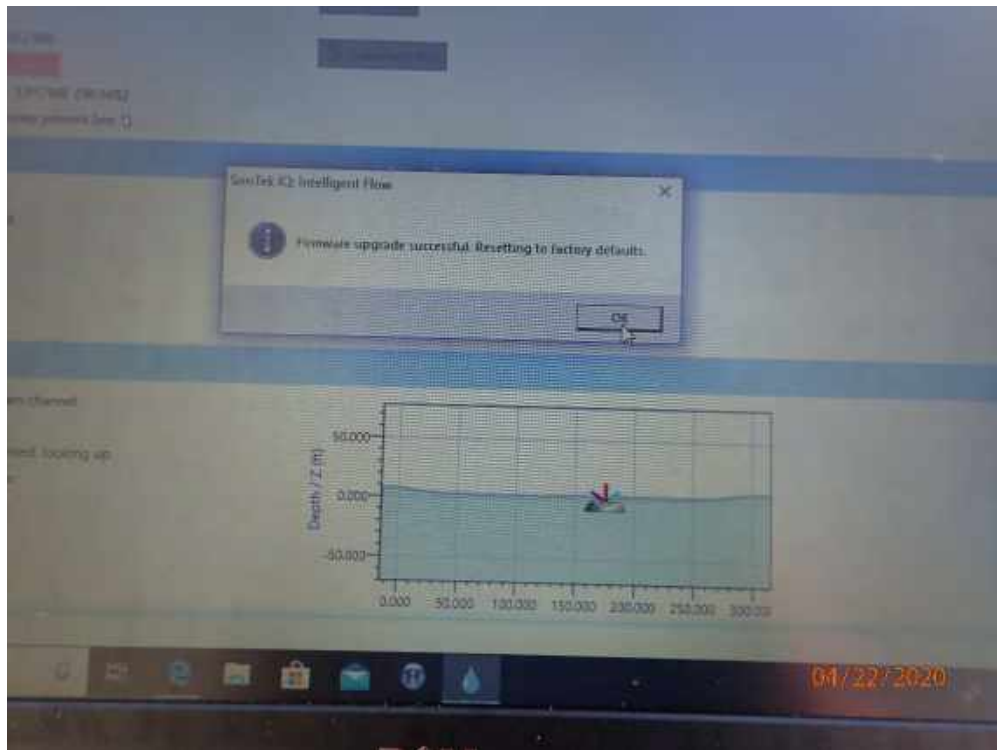
*Photograph 145. 4/22/2020: Year 3 Monthly Download and Maintenance, Flow Station 3, firmware upgrade performed*

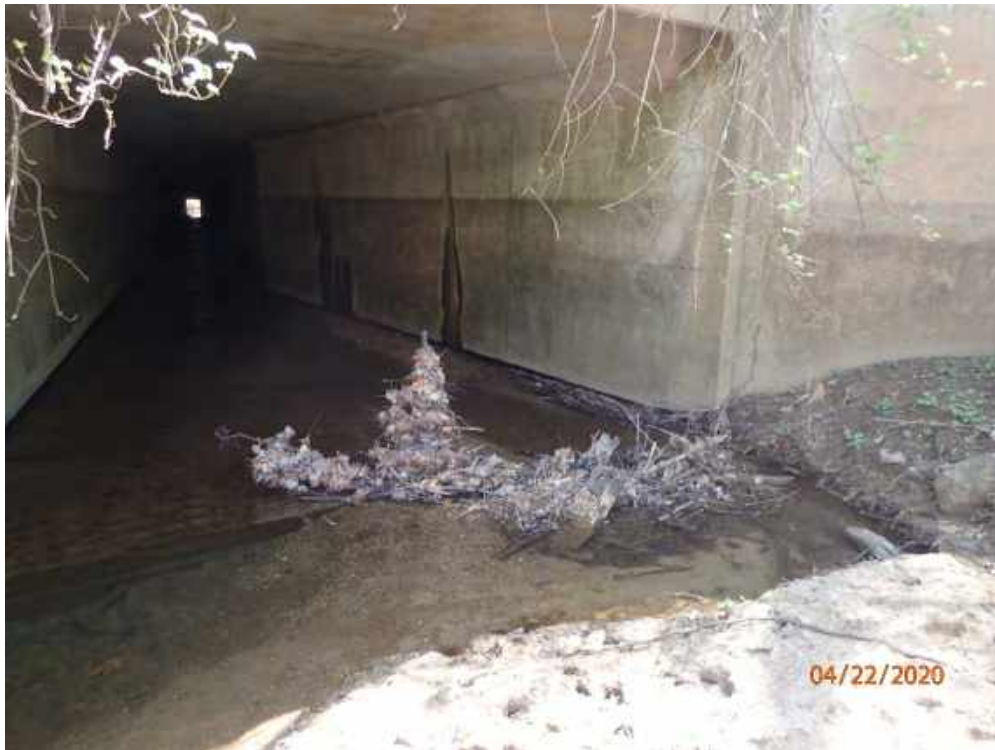
*Photograph 147. 4/22/2020: Year 3 Monthly Download and Maintenance, Flow Station 1, debris build-up*

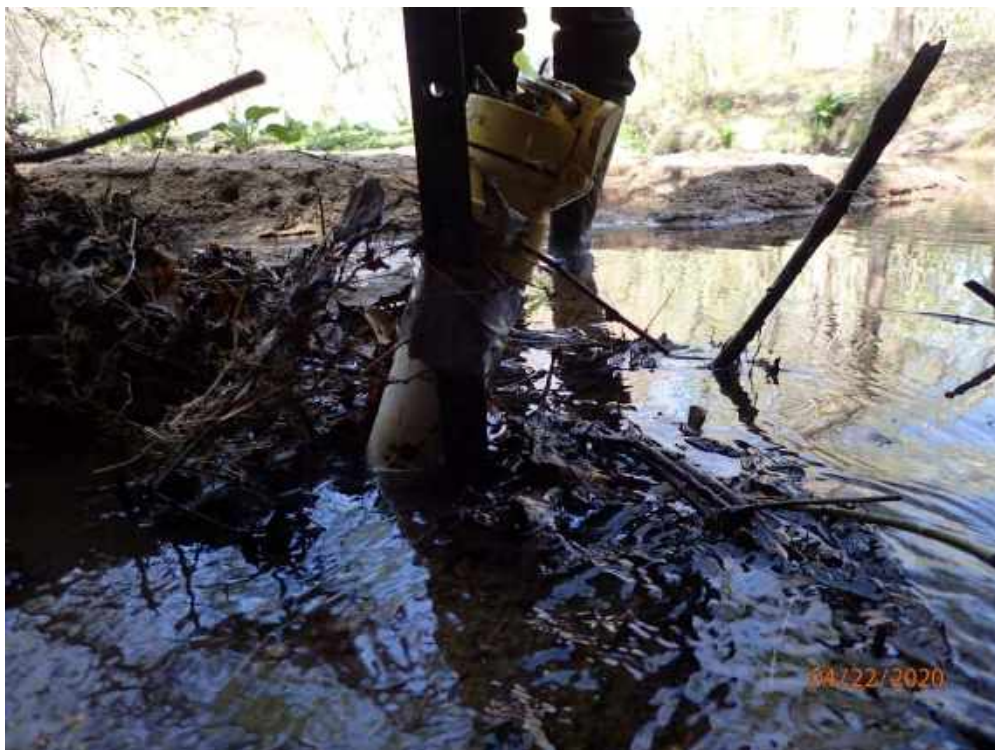
*Photograph 148. 4/22/2020: Year 3 Monthly Download and Maintenance, Flow Station 1, dislodged and out of position under weight of debris*

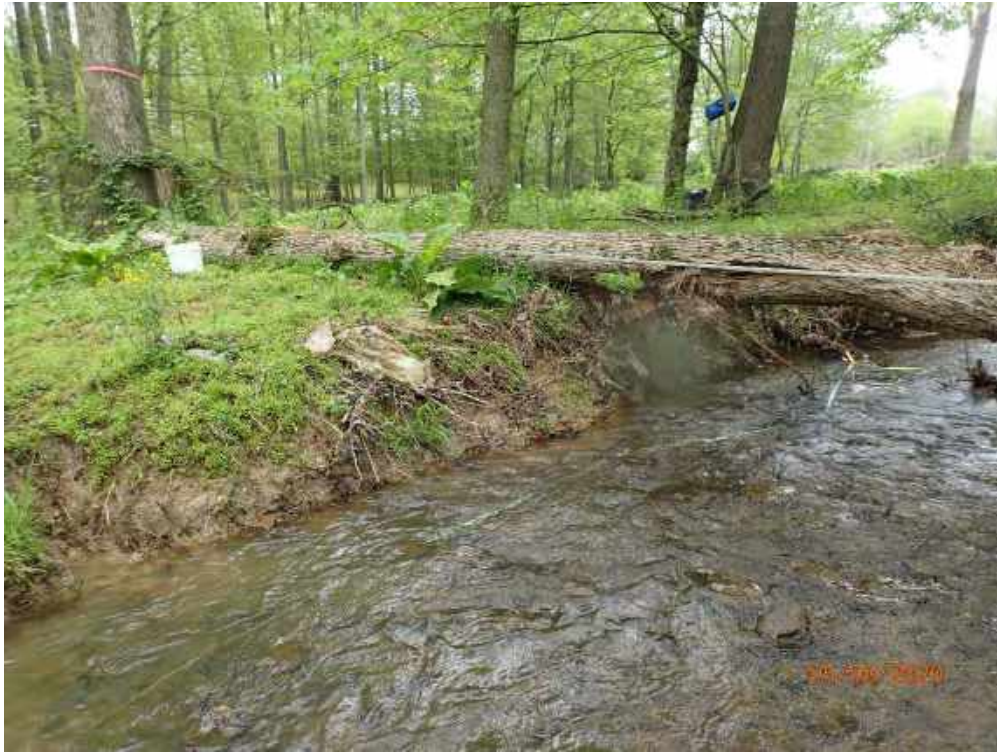
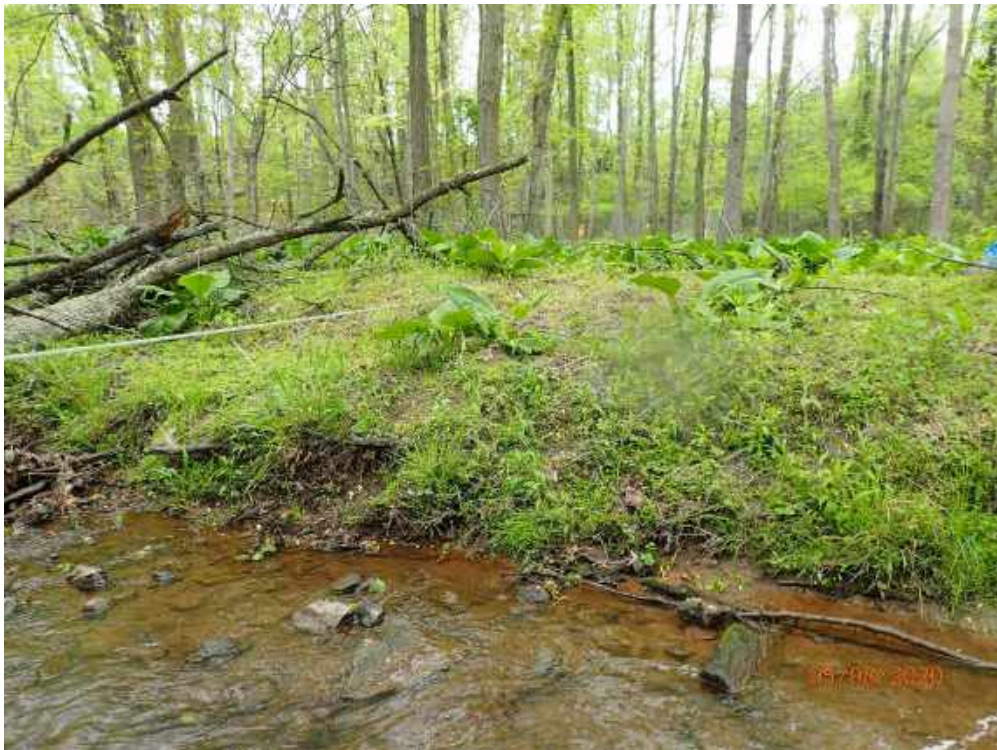
At Cross Section 1, the left bank has eroded vertically by about 6 inches while the right bank has eroded laterally approximately 6 inches between the Year 1 baseline (06/14/18) and Year 3 Storm 2 (05/08/20). Minor erosion of the riverbed can also be observed between Stations 10 and 23.

*Photograph 155. 5/8/2020: Year 3 Storm 2 Post-Storm Monitoring, Cross Section 1, facing left bank*

*Photograph 156. 5/8/2020: Year 3 Storm 2 Post-Storm Monitoring, Cross Section 1, facing right bank*

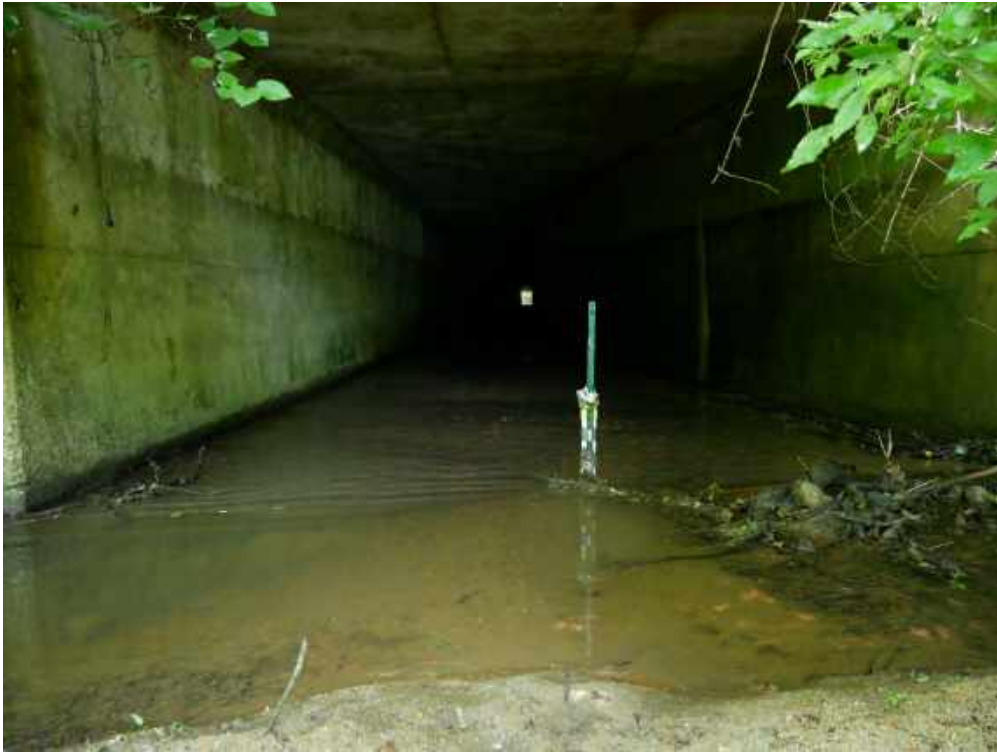
*Photograph 175. 6/23/2020: Year 3 Monthly Download and Maintenance, Flow Station 1*

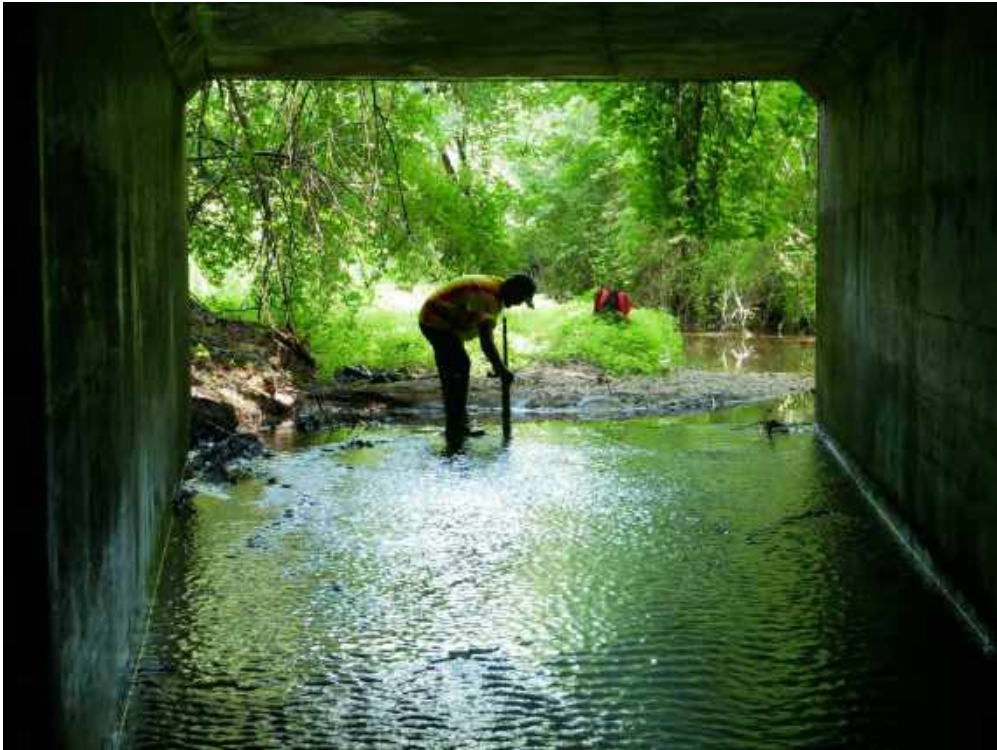
*Photograph 176. 6/23/2020: Year 3 Monthly Download and Maintenance, Flow Station 1*

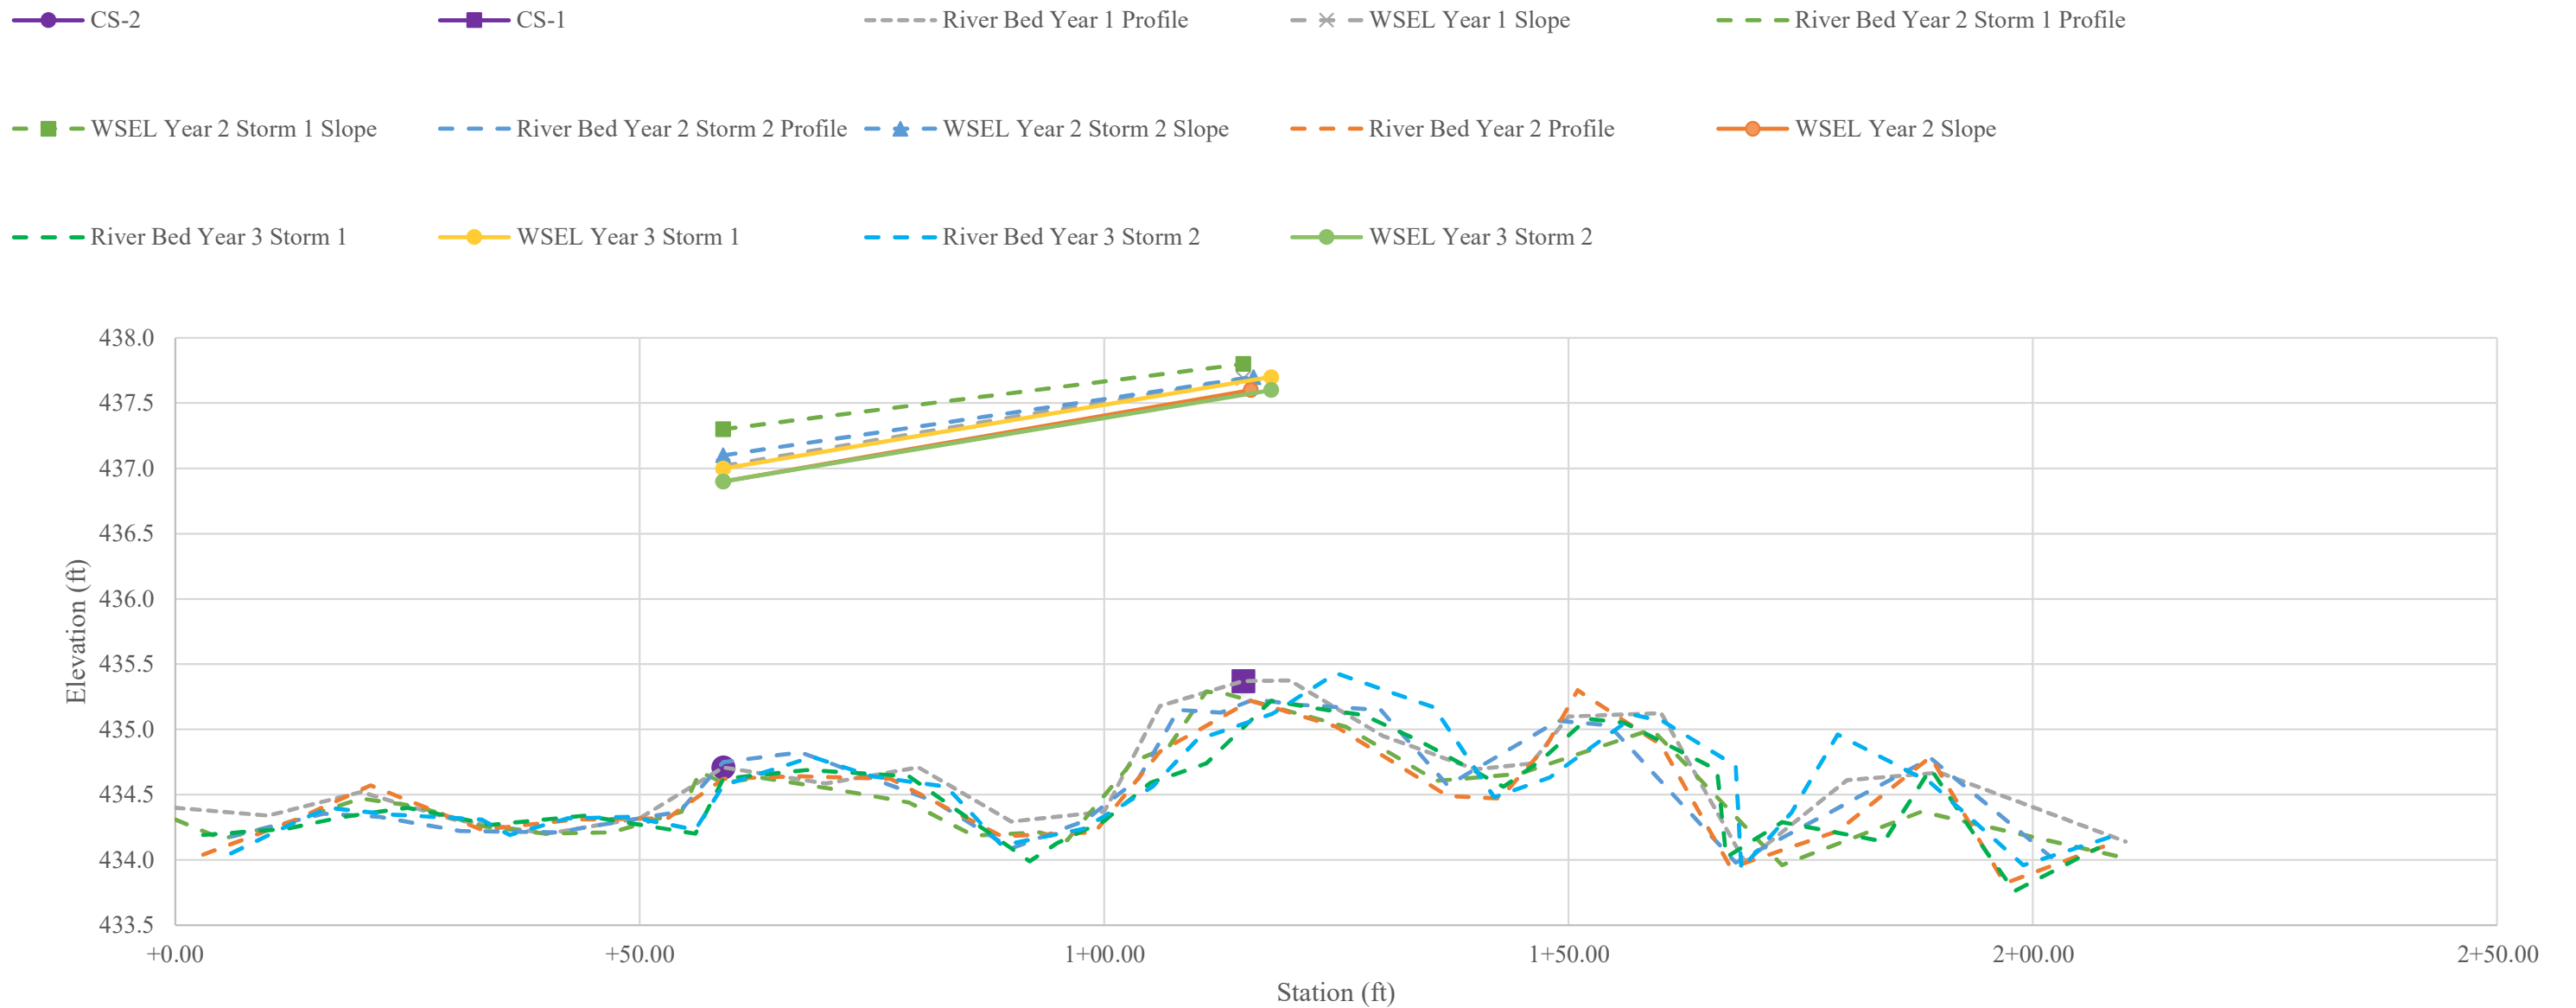
## Year 1 - 3 Longitudinal Profile

Minor changes along the longitudinal profile between Year 1 baseline (06/14/18) and Year 3 Storm 2 (05/08/20) surveys have been observed. The initial downstream pool of the profile is deeper but the riverbed between the pool and 3.5 feet downstream of Cross Section 2 has remained stable. Erosion is occurring 3 feet downstream of Cross Section 2 at Station 0+53. From Cross Section 2 to 15 feet upstream of Cross Section 1, Station 0+59 to Station 1+30, the riverbed has degraded by approximately 4 inches. The top of riffle at Cross Section 1 has migrated upstream approximately 7 feet. The riffle at Station 1+50 and pool at Station 1+67 have overall remained stable, though some degradation and aggradation occurred between the annual surveys. The riverbed near Station 2+05 has also degraded by approximately 9.5-inches, forming a pool.

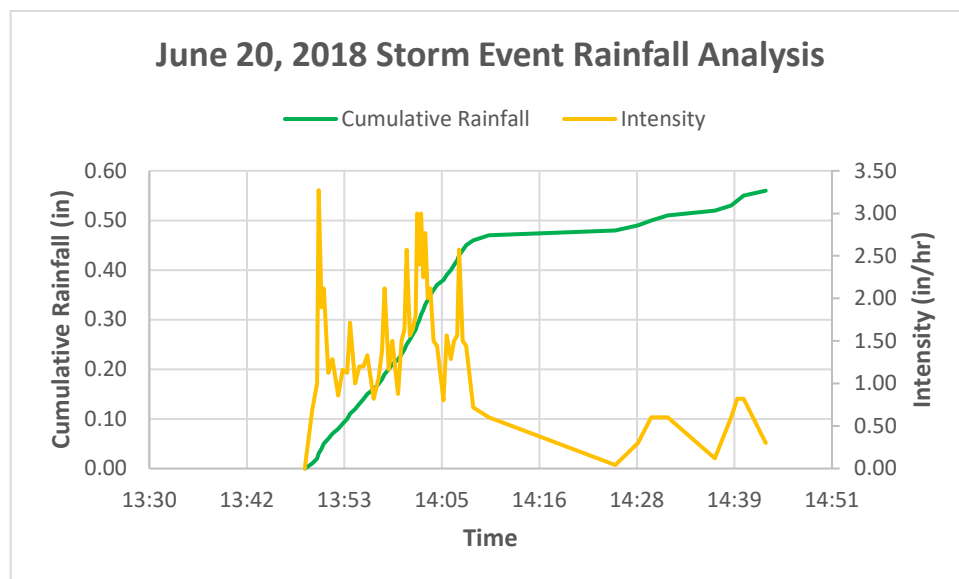
Figure 1. June 20, 2018 storm event rainfall analysis

Quality control was performed on the rain gauge when it was installed. The rain gauge in Figure 1 shows data recorded on June 20, 2018. Using the raw data file containing tip timestamps and known amount of rain per tip (.01”), cumulative rainfall (primary axis) and intensity (secondary axis) were calculated.

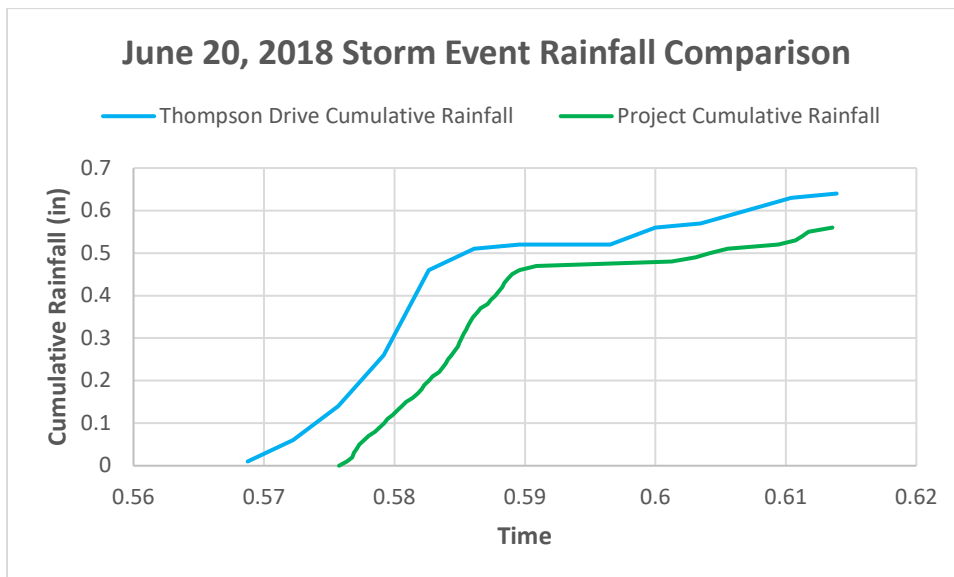
Figure 2. June 20, 2018 storm event rainfall comparison

To determine the validity of the results, MDOT SHA compared this rain event to a near-by independent rain gauge. The closest rain gauge with readily available data is the Thompson Drive (KMDELLIC68) weather station from Weather Underground (<https://www.wunderground.com/personal-weather-station/dashboard?ID=KMDELLIC68>). The rain gauge is approximately 1.20 miles west of the project rain gauge and is considered comparable due to its proximity. Figure 2 shows the cumulative rainfall recorded by the Weather Underground rain gauge and the project rain gauge from the rain event on June 20, 2018.

The lag between the events is explained by the difference in rain gauge locations. The difference between cumulative rainfall results is minimal and probably due to the path of the storm.

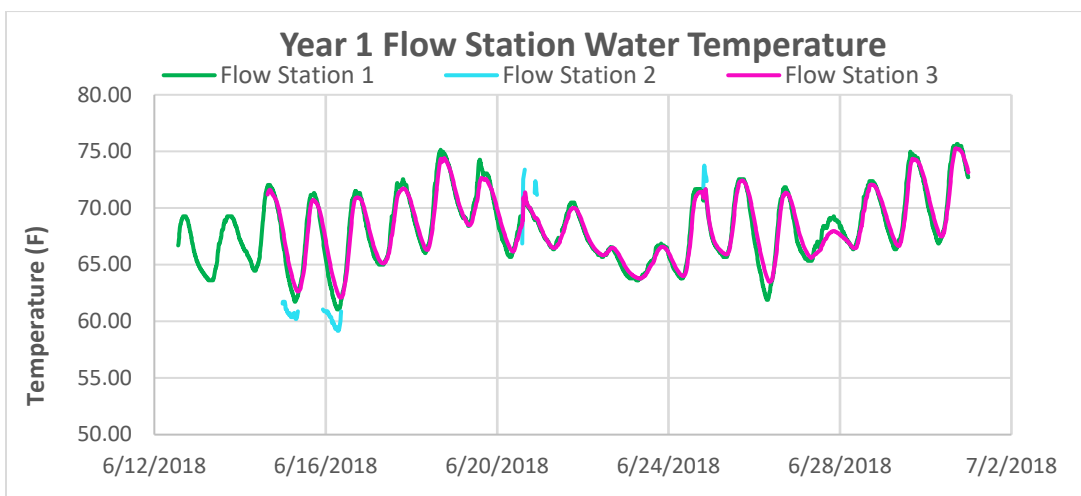
Figure 3. Year 1 Flow Station Water Temperature

Quality control of the recorded water temperature values was performed on July 18, 2018. A YSI Professional Plus water quality instrument was used for a field measurement while on-site at Flow Station 3. The field measurement at 10:11 AM yielded a value of 20.3 degrees Celsius or 68.5 degrees Fahrenheit. Comparing this to the recorded value of 68.9 degrees Fahrenheit at 9:54 AM for Flow Station 3, the equipment is believed to be operating correctly. Furthermore, the parallel values recorded between Flow Station 1 and 3 also confirm that the temperature is being measured accurately. The difference in Flow Station 2 water temperature when compared to Flow Station 1 and Flow Station 3 is likely due to the fact that the water from Flow Station 2 is runoff from I-70. This runoff travels across dark-colored impervious surfaces, which has the ability to retain heat and therefore transfer this energy to the water as it travels across its surface. See Figure 3 below for a comparison of water temperatures during Year 1 monitoring.

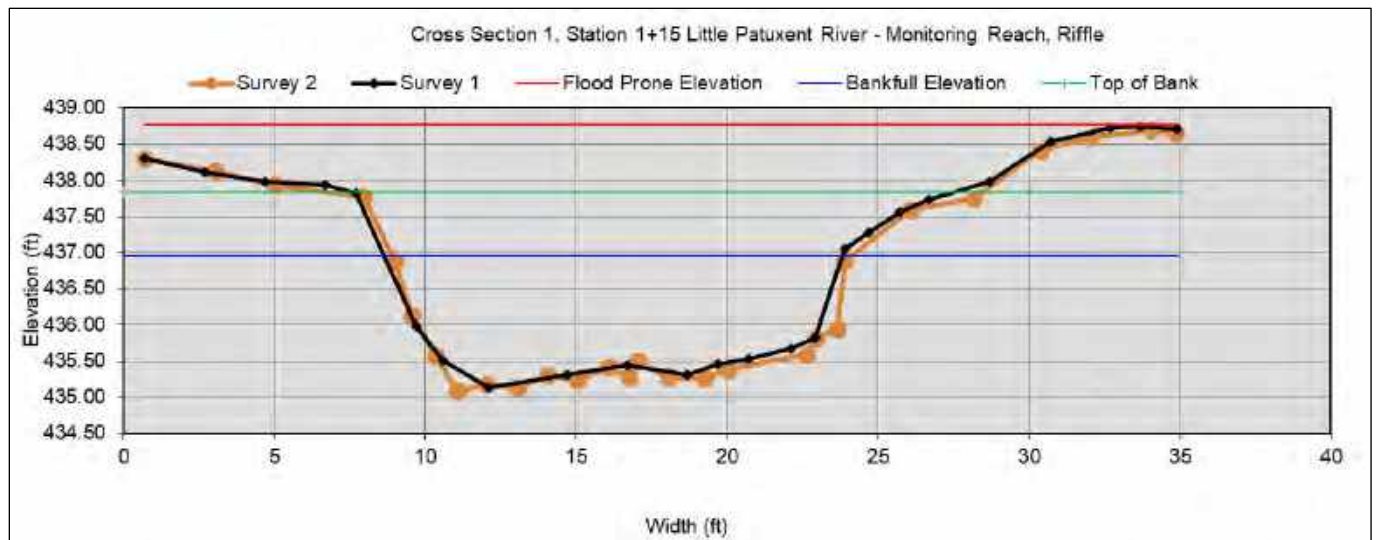
Figure 4. Survey 1 and 2 comparison at Cross Section 1

To validate the results of this correction to Survey 1, another survey of the cross sections, Survey 2, was performed on August 7, 2018, using the proper self-leveling settings for the laser level. Results of Survey 2 compared to the benchmark elevations at Cross Section 1 were within .04 feet of each other, while Cross Section 2 was within 0.12 feet. A real-time kinematic GPS unit was used to survey the elevations of the benchmarks. Depending on the exact GPS unit used and the distance to the base station, an accuracy of 0.15 feet can be expected. Since the survey results are within this range, it is believed that the results from the survey are reasonable.

Survey 2 results were then overlaid with the Survey 1 to see how they compared. The top of bank elevations were determined to have minimal elevation differences while some change can be seen along the stream bottom, which is to be expected for an active stream where the riverbed material is dynamic. Based on these results and the accuracy to be expected from this type of physical monitoring, the corrected data from Survey 1 is believed to be acceptable and was used as the Year 1 baseline survey for the project.
