**Office of Structures
Manual for Hydrologic and Hydraulic Design**

Chapter 14: Stream Morphology and Channel Crossings

August 2007

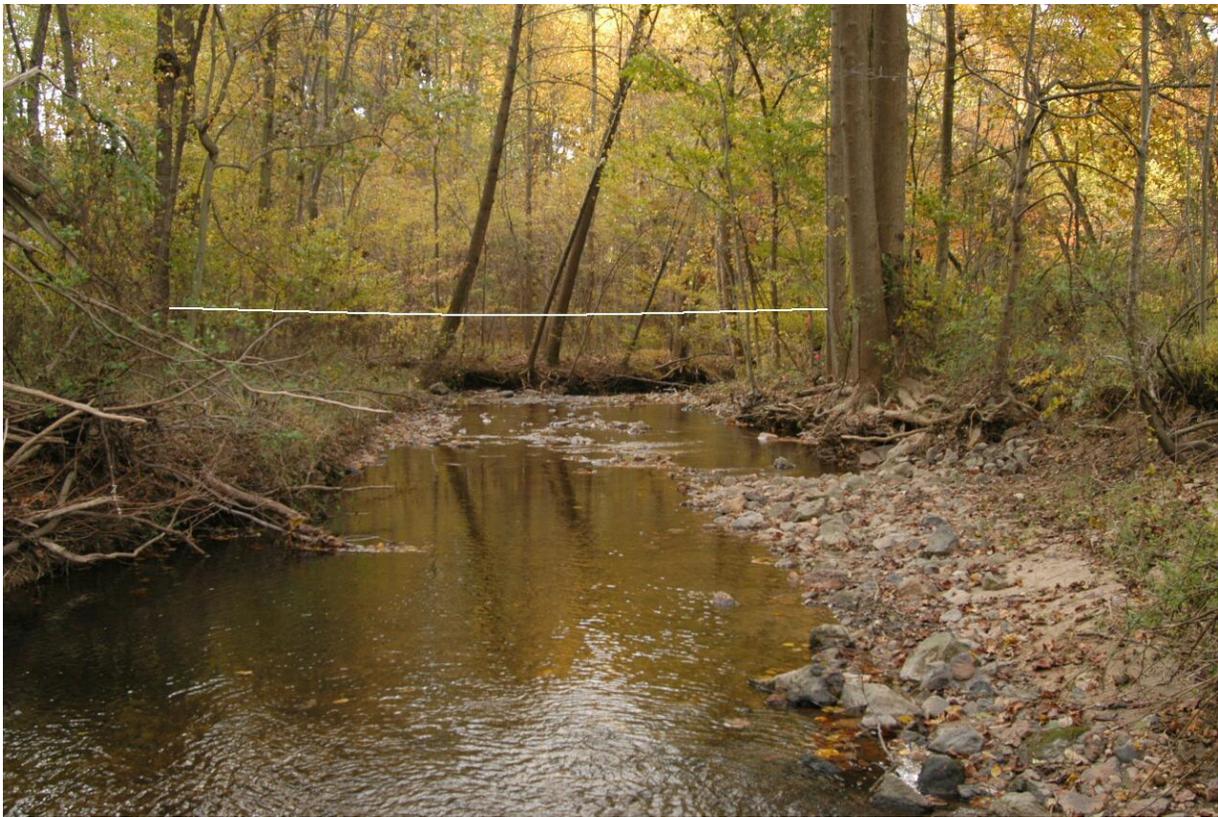
Figure 14-2 Downstream view of sediment assessment reach cross section.

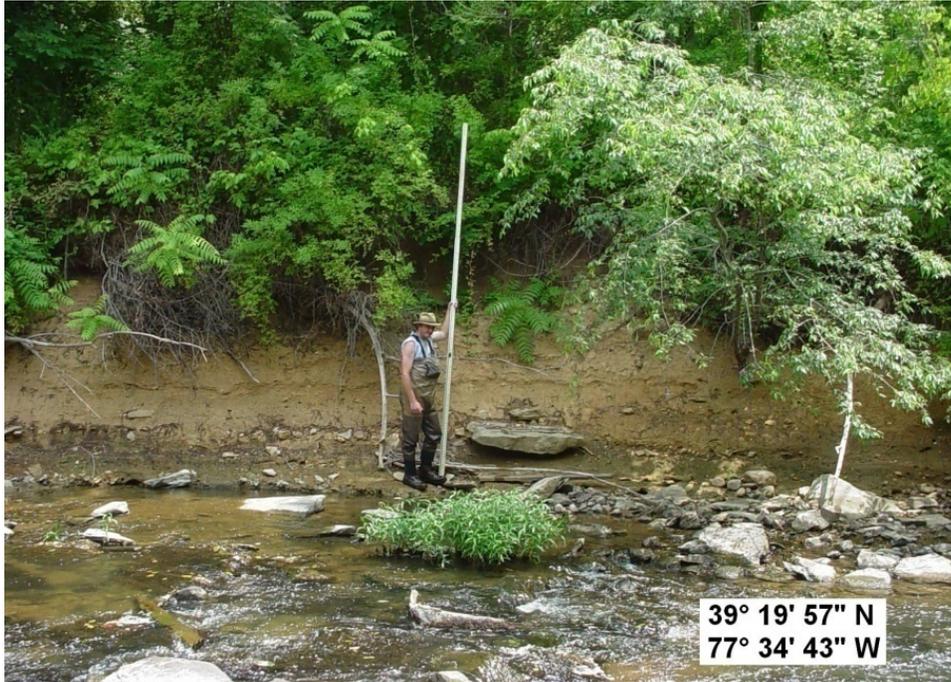
Photo 70: Left bank height (11') between MD 464 Bridge and existing bridge abutment. This vertical bank is composed of legacy sediments and is typical of the banks found throughout the site.

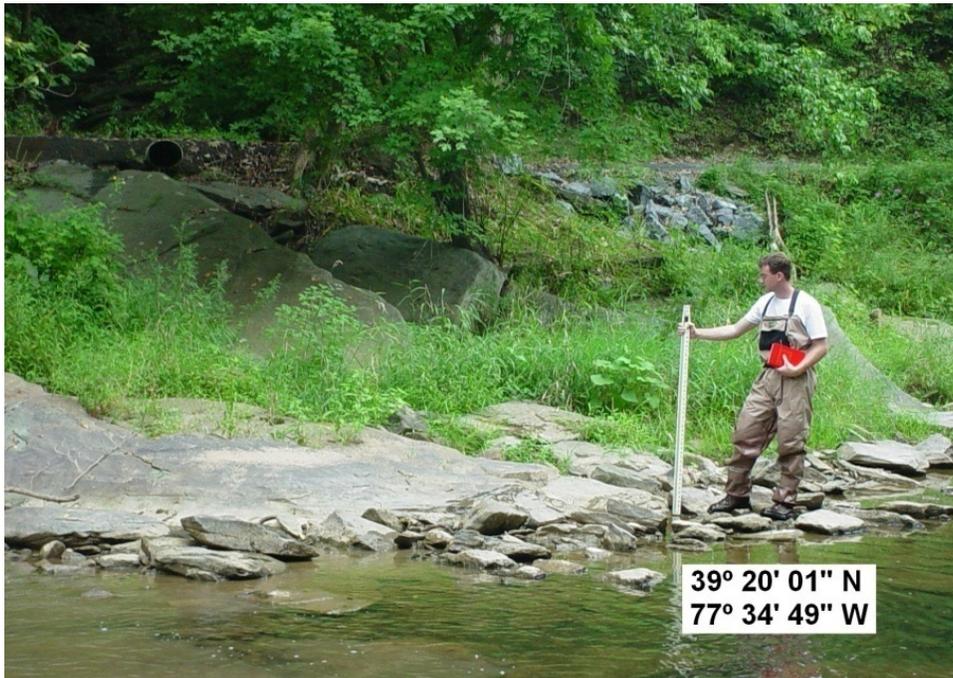
Photo 109: Bedrock outcrop on west (right) bank directing flows to the left.

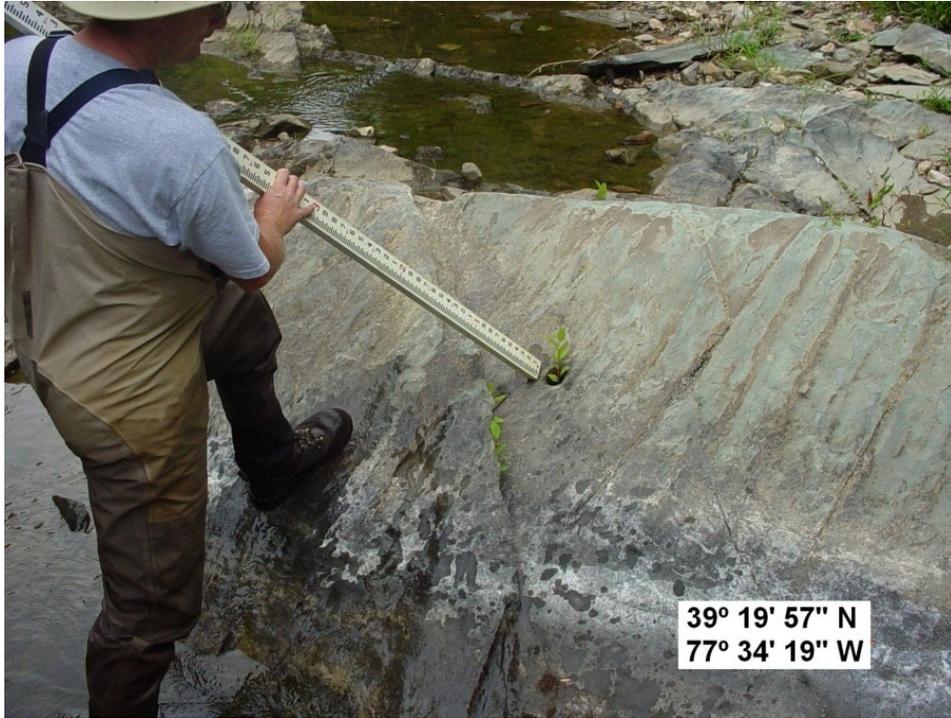
Photo 37: Bedrock with bore hole indicating blasting activity in this region of Catoclin Creek.

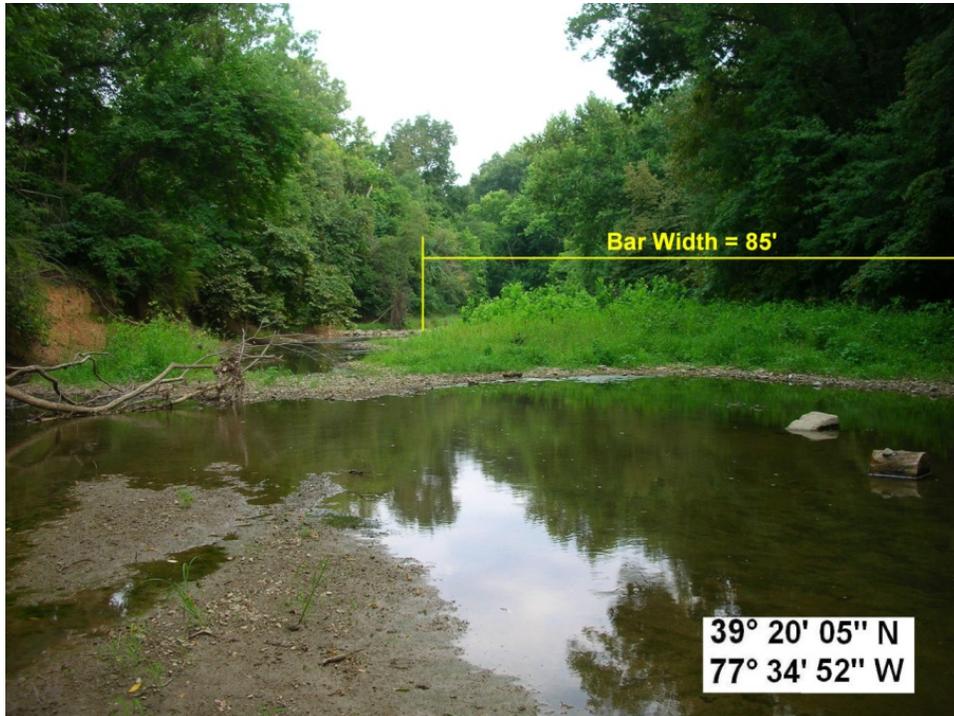
Photo 121: High bank, low depositional features.

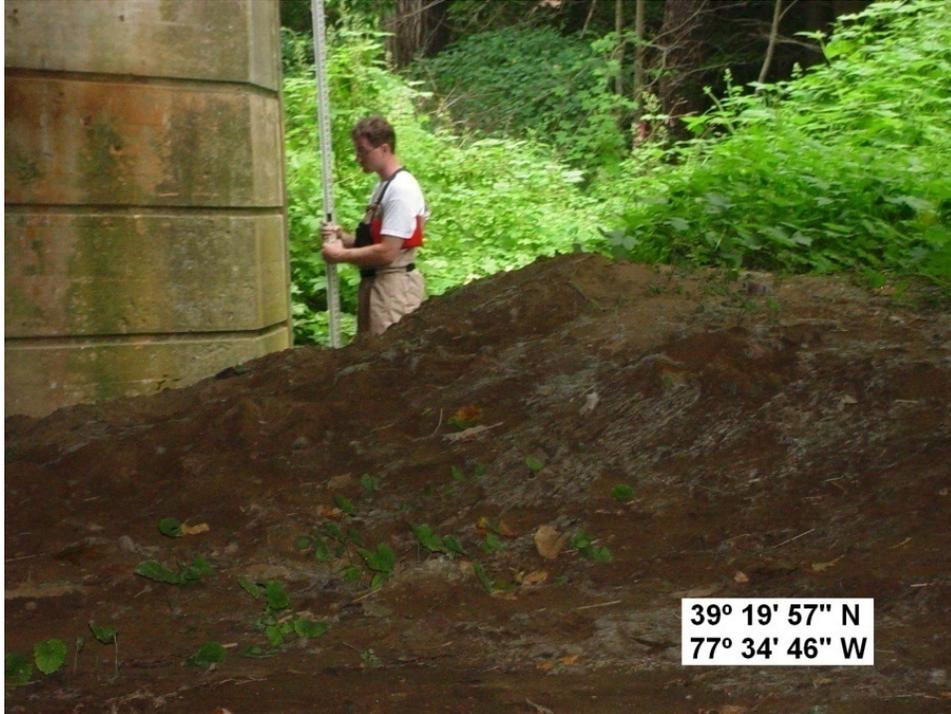
Photo 83: Scour at Pier B and deposition in the B-C span.

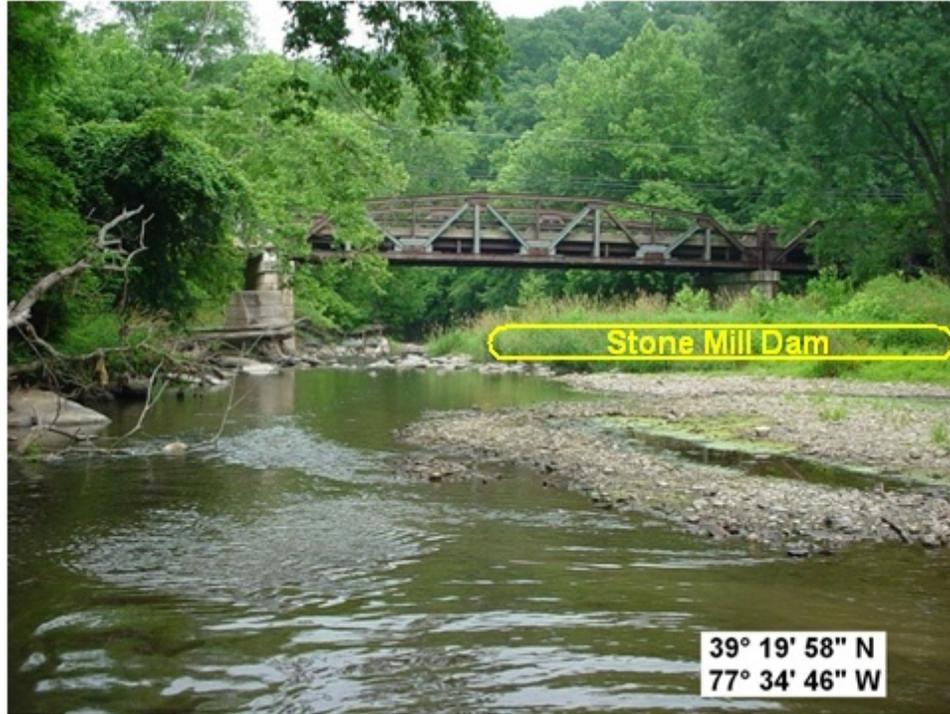
Photo 101: Approach flows constricted by 6' high stone mill dam on right (in vegetation) and high banks with debris jam on left.

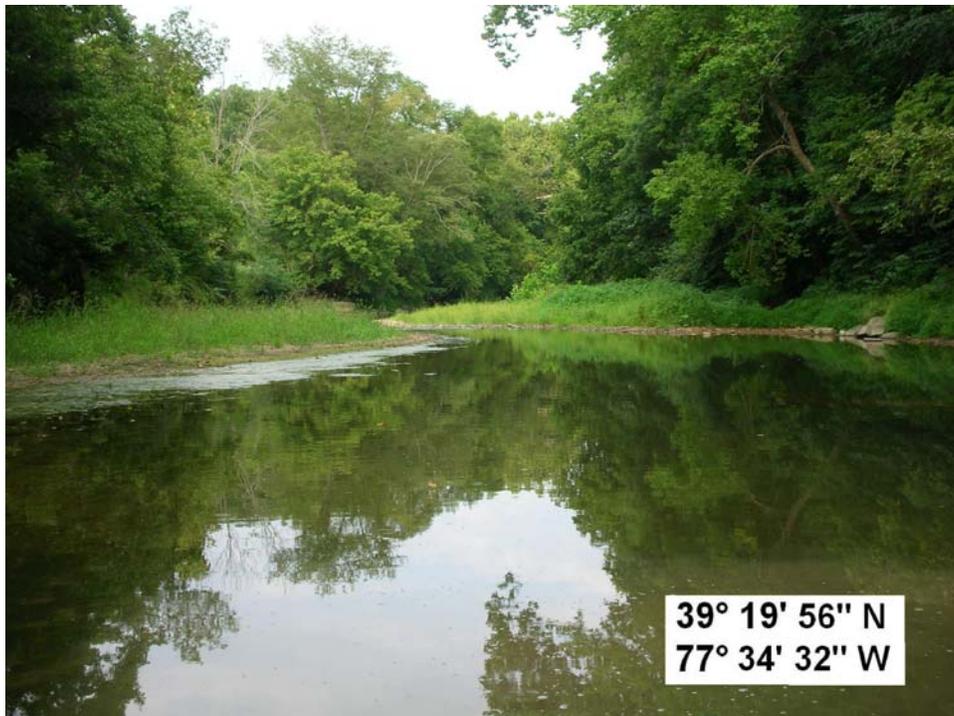
Photo 59: Channel movement, low depositional feature.

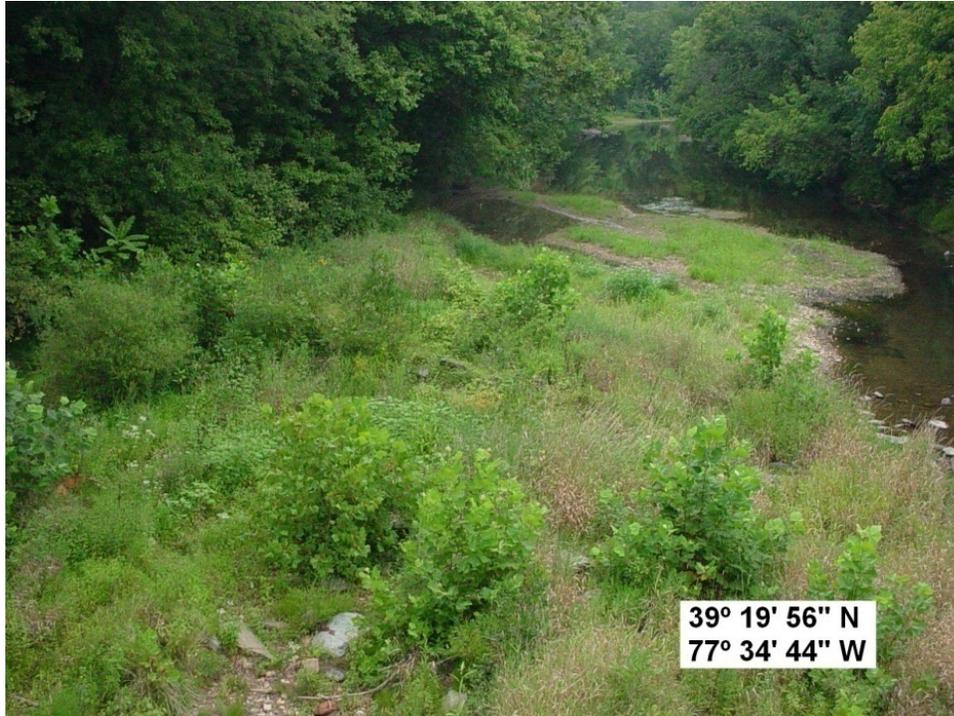
Photo 133: Top of B-C span looking upstream. Mill dam is in vegetation.

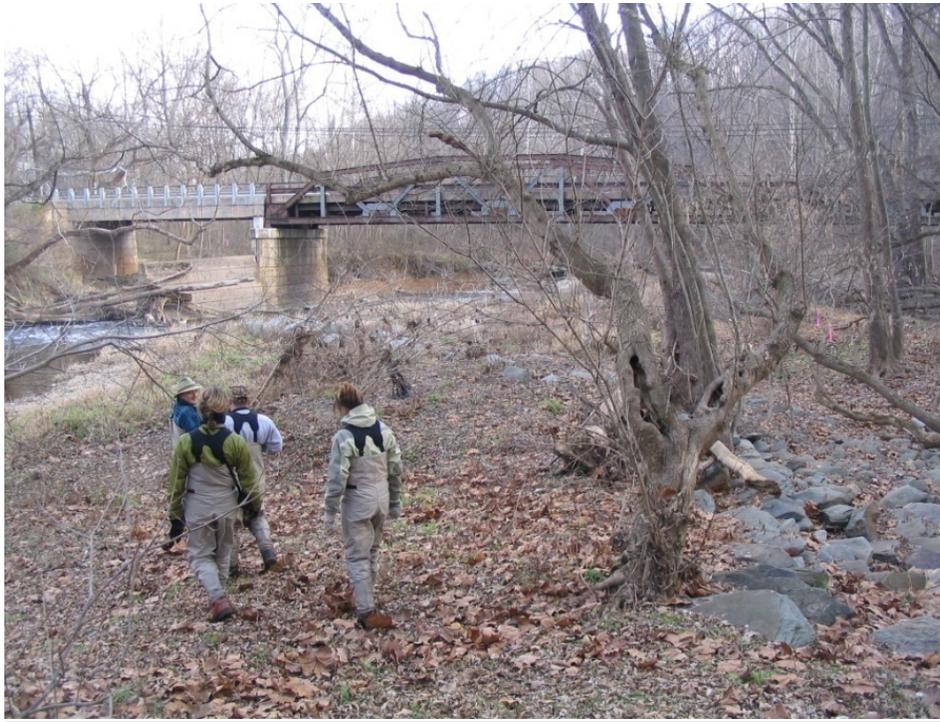
Photo 96: Stone mill dam extending from right bank to wall at Pier D.

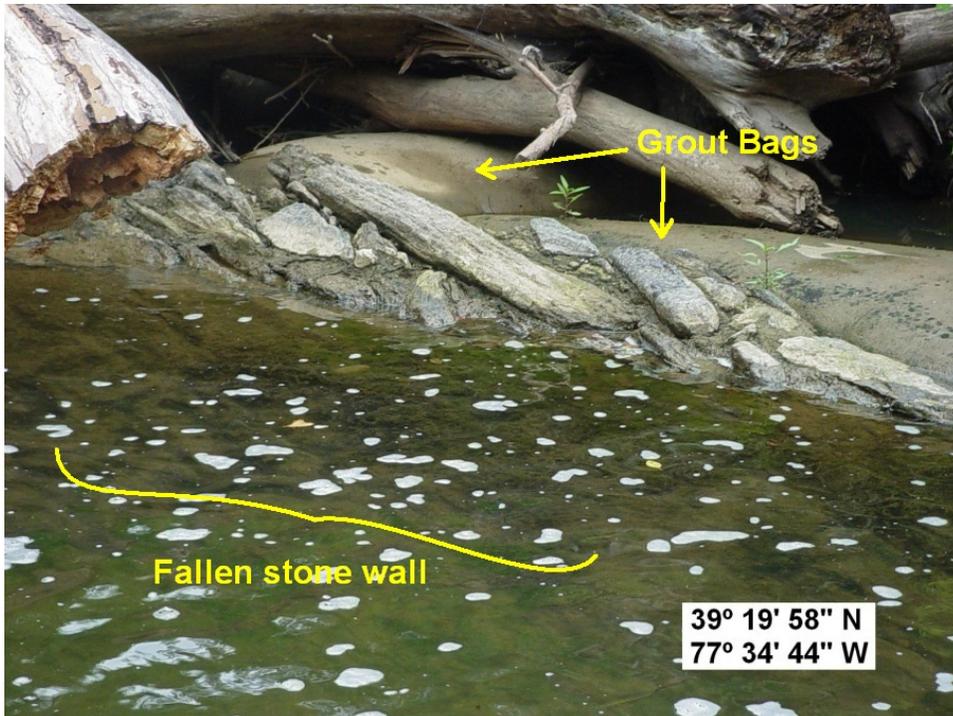
Photo 91: Broken stone wall and grout bags at upstream wall of Pier D.

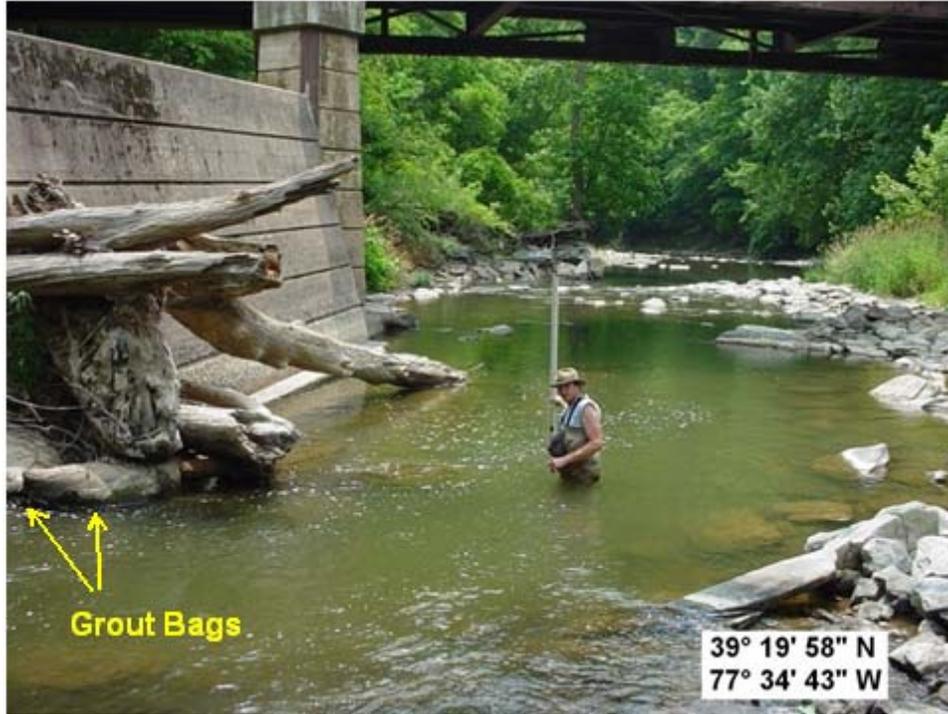
Photo 89: Scour hole (4.5' deep) and grout bags (left) at Pier D.

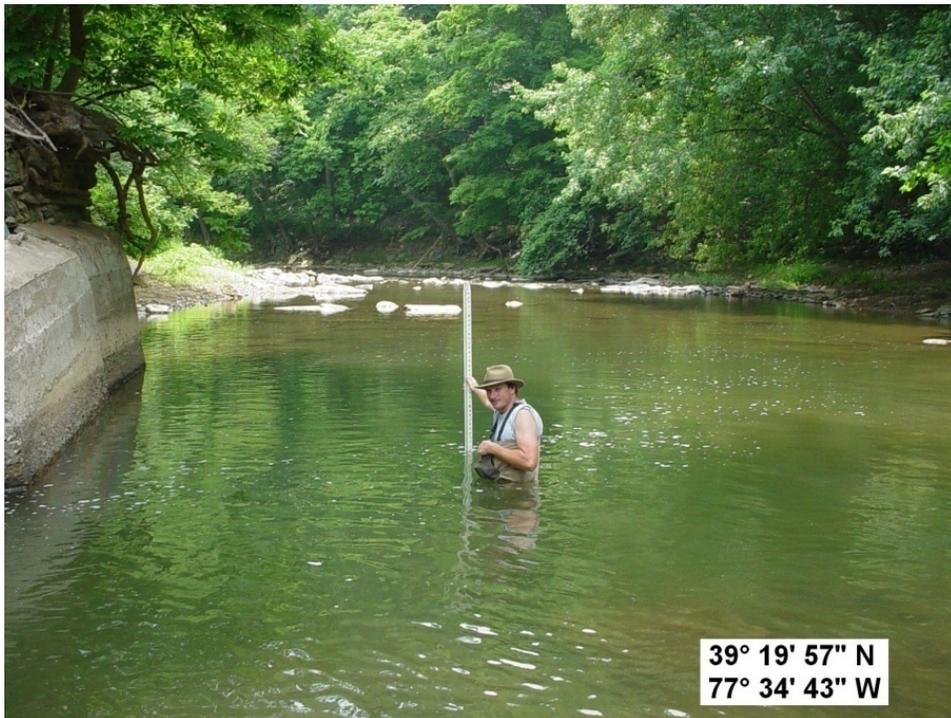
Photo 69: Scour hole (>5.5' deep) at old bridge abutment.

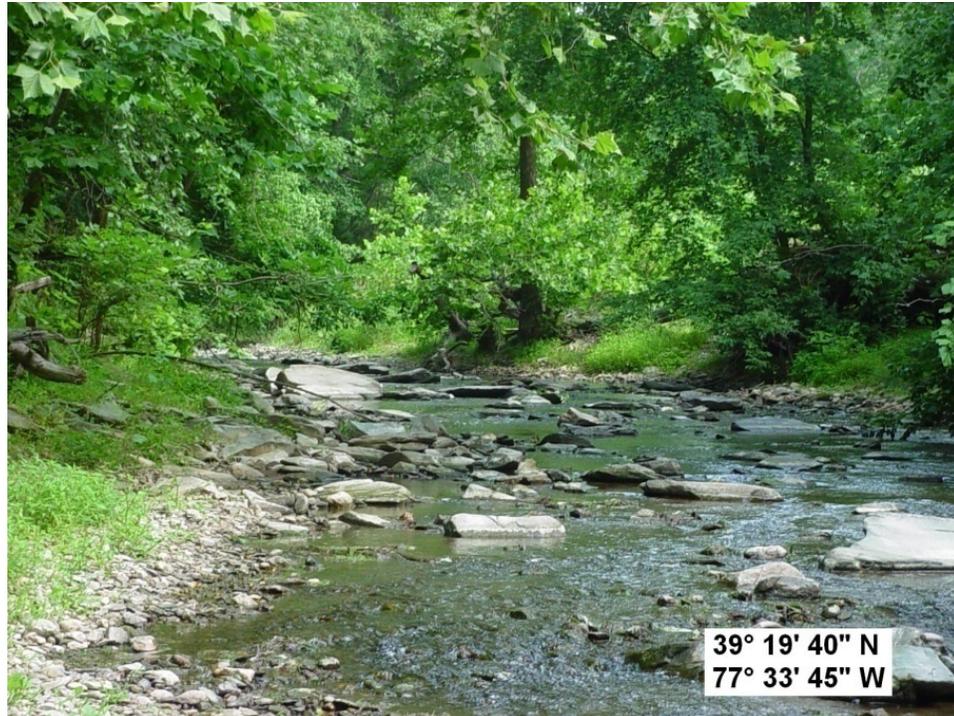
Photo 4: Degraded local base level point downstream of MD 464 Bridge.

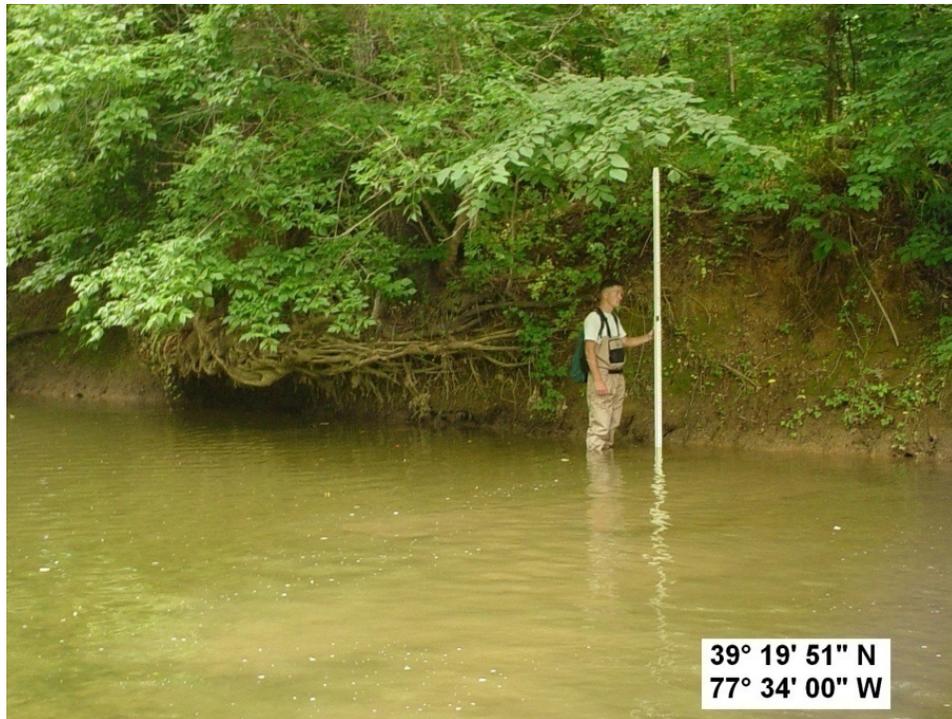
Photo 12: High vertical banks (9°) consisting of laminated sediments.

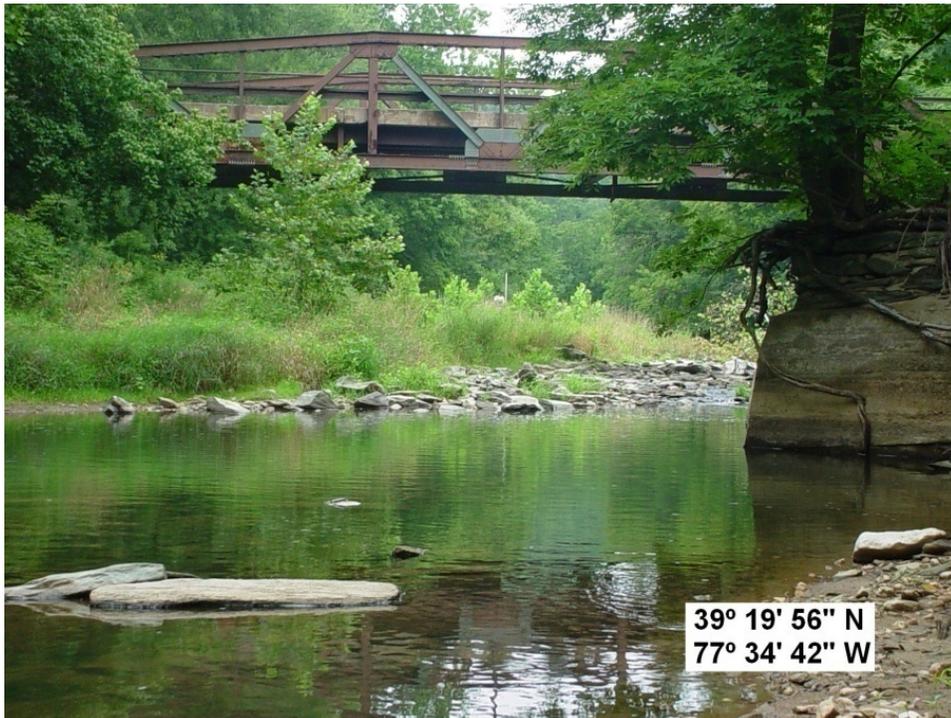
Photo 89: Looking downstream, scour hole at retaining wall above Pier D, pool depth 4'.

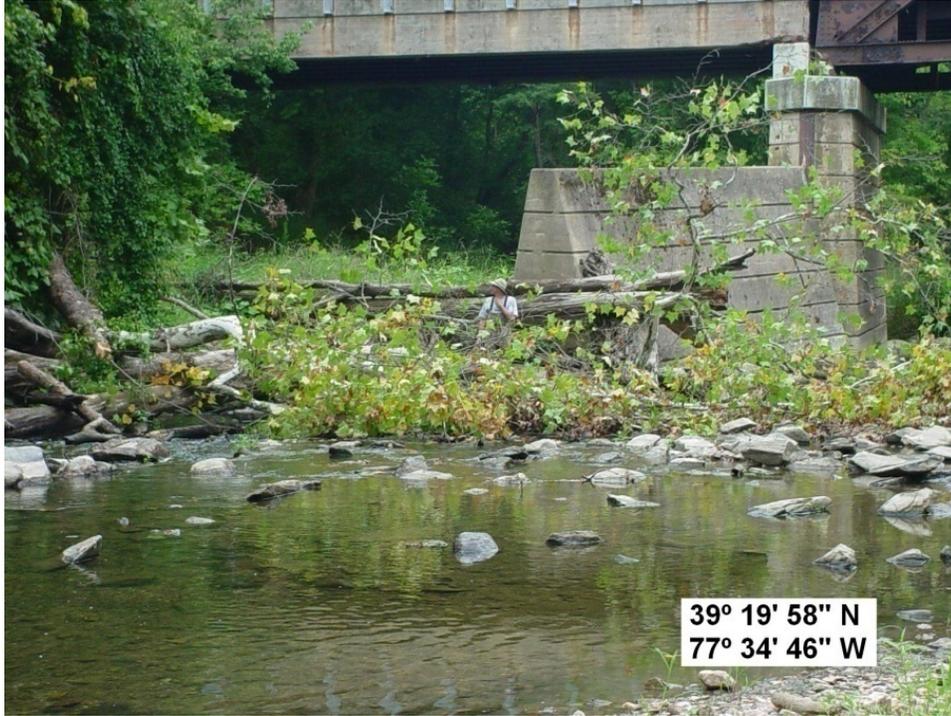
Photo 68: Looking upstream, deposition occurs throughout spans A-B, B-C, and C-D.

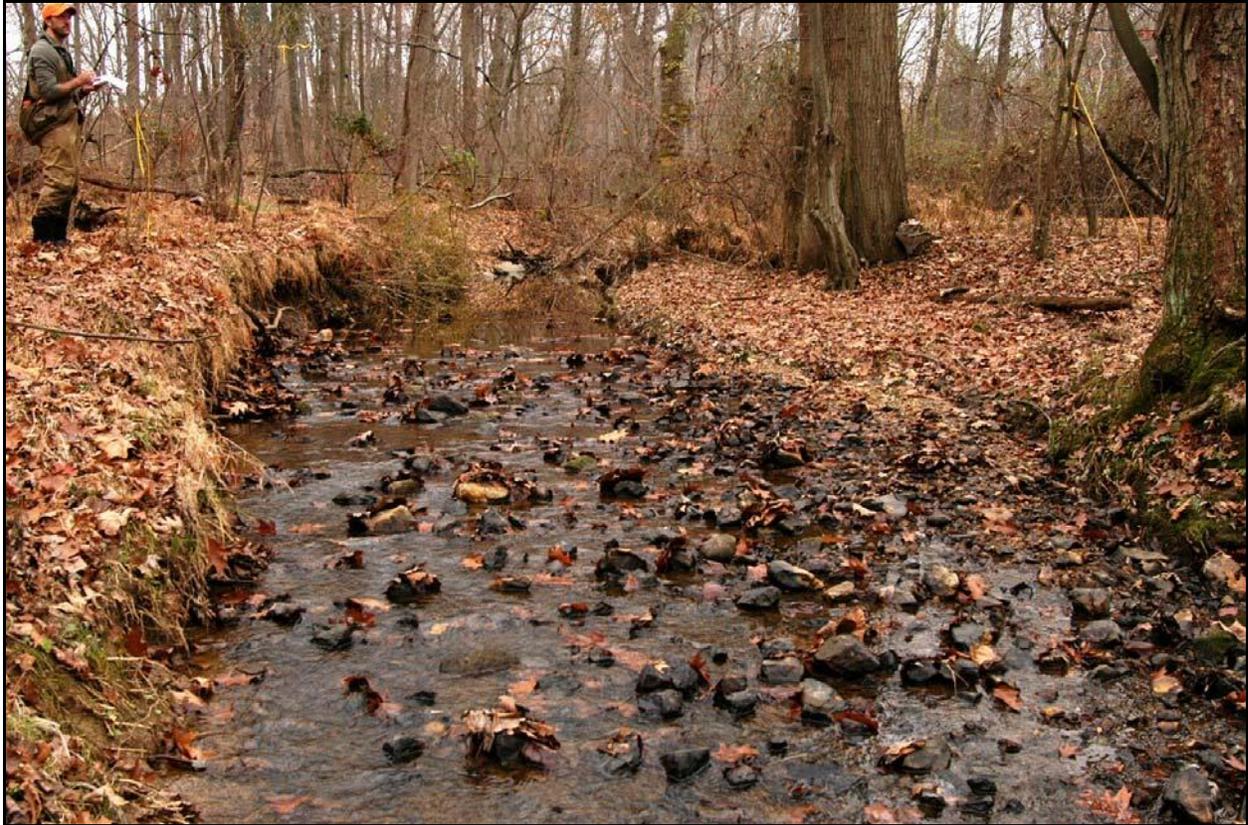
Figure 10 Reach used to assess sediment mobility and bankfull flow estimate. This channel section is typical of some reaches that have migrated away from the straightened alignment.

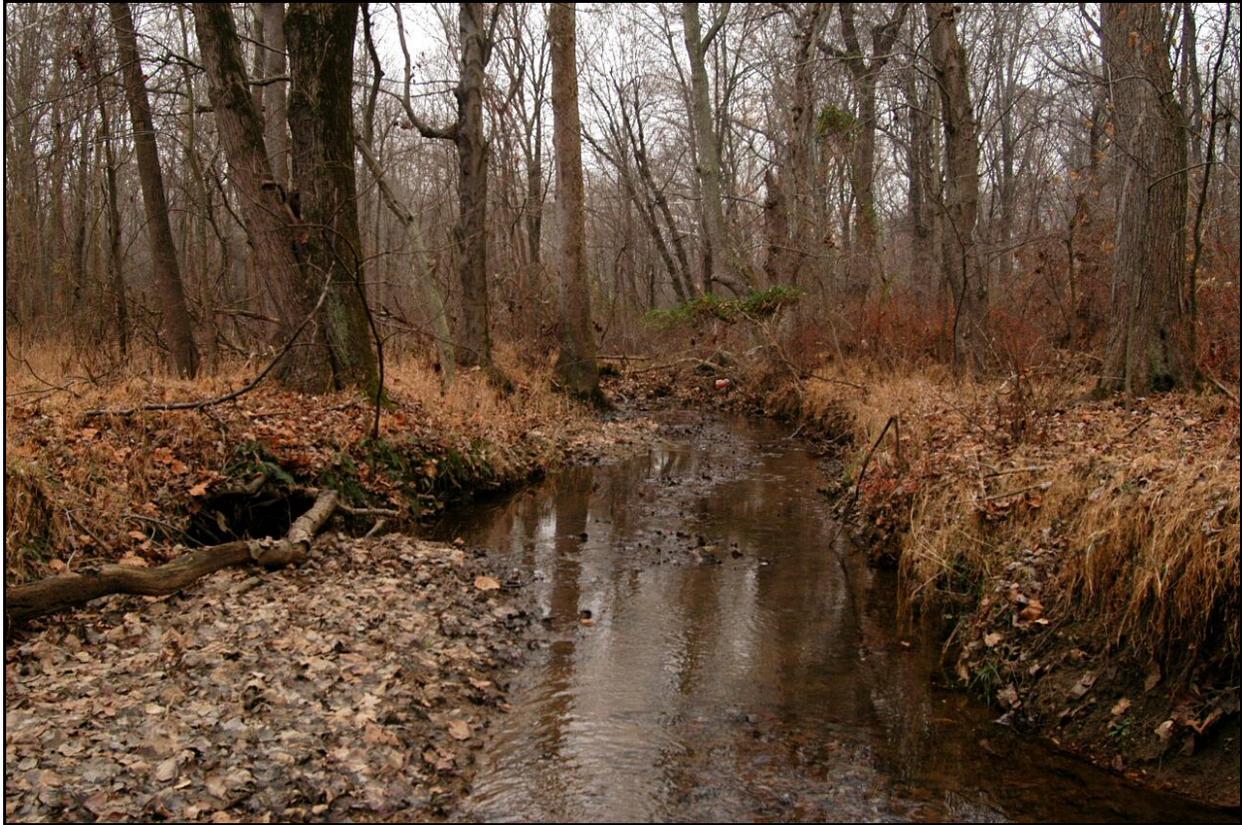
Figure 12 Typical conditions of the stream channel that is widening through bank erosion but has not migrated substantially from the straightened and channelized alignment. A debris jam downstream is causing deposition of fine grain sediment in the channel. View is downstream from Cross Section 2.
